Tree Impact Assessment Report

City and Southwest Metro Station Upgrade Works Package 5 & 6

P5 Document No. SMCSWSW5-DEW-WEC-EM-REP-000542

P6 Document No. SMCSWSW6-DEW-WEC-EM-REP-000632

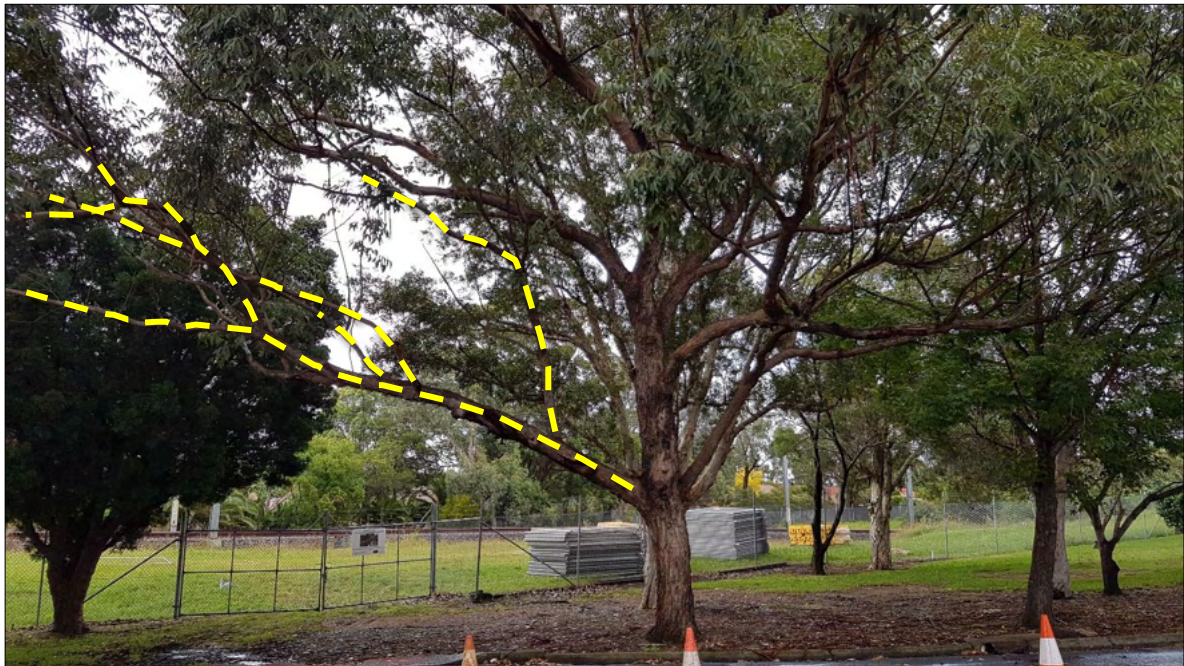
Tree 14 *Eucalyptus robusta* (Swamp Mahogany) identified pruning involves the removal of one first order branch at 2m height. The branch is approximately 300mm in diameter and constitutes 30% of the total canopy volume of the tree. A reduction in tree growth and physiological function can be expected as a result of the pruning works. Exposure of internal woody tissues at the site of the final pruning cut shall be susceptible to infection by decay causing fungi. The removal of the branch is not considered to significantly affect vocal amenity.

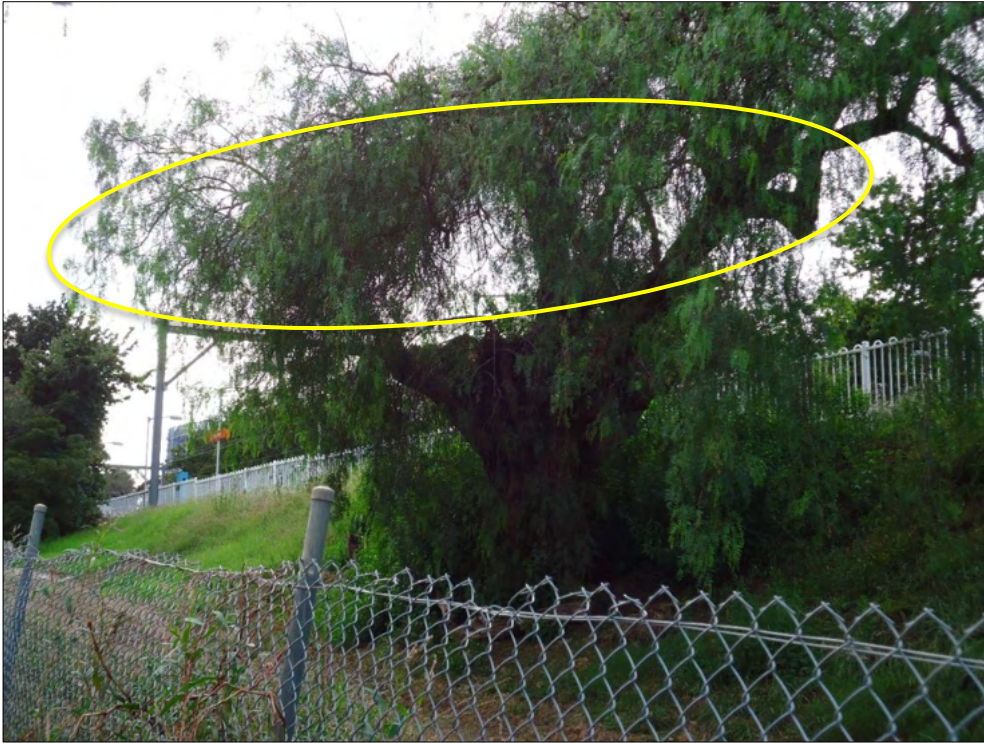
Pruning works were identified to be undertaken on tree 692 *Schinus molle* (Peppercorn Tree) to provide clearance along the rail corridor access track for plant and equipment. It is envisioned that pruning works shall involve the reduction and removal of selected branches up to 100mm in diameter and constitute approximately 25-30% of the total live canopy volume of the tree. Based upon the current health and condition of the tree these pruning works are considered to be significant and shall likely result in a reduction of tree growth and physiological function. All pruning works are to be undertaken by suitably qualified tree workers and meet the requirements of *AS4373-2007 Pruning of Amenity Trees*. Image 2 shows the tree and branches that overhang the access road.

Image 2: Yellow outline indicates branches from Tree 692, *Schinus molle* (Peppercorn Tree), that shall require selective removal to provide clearances along the rail corridor access track.

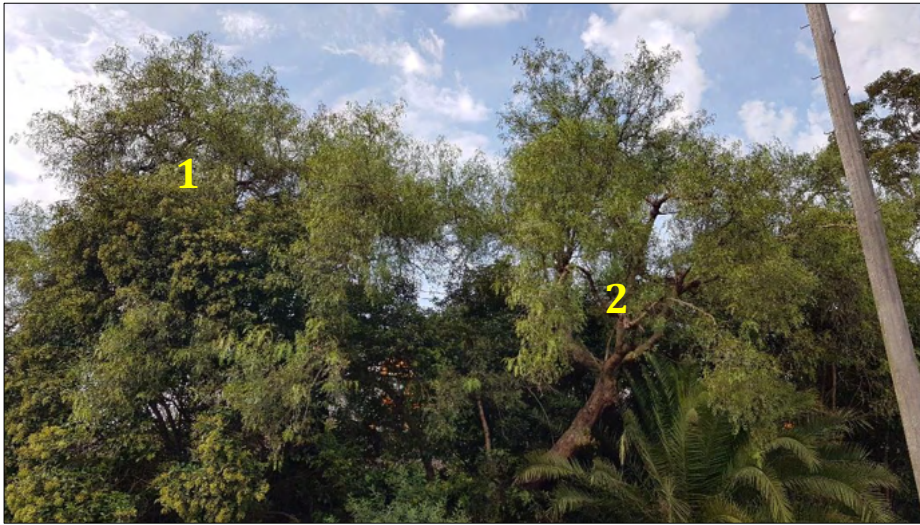
Photograph 1: Trees 1 and 2 *Schinus molle* (Peppercorn Tree) to be removed.

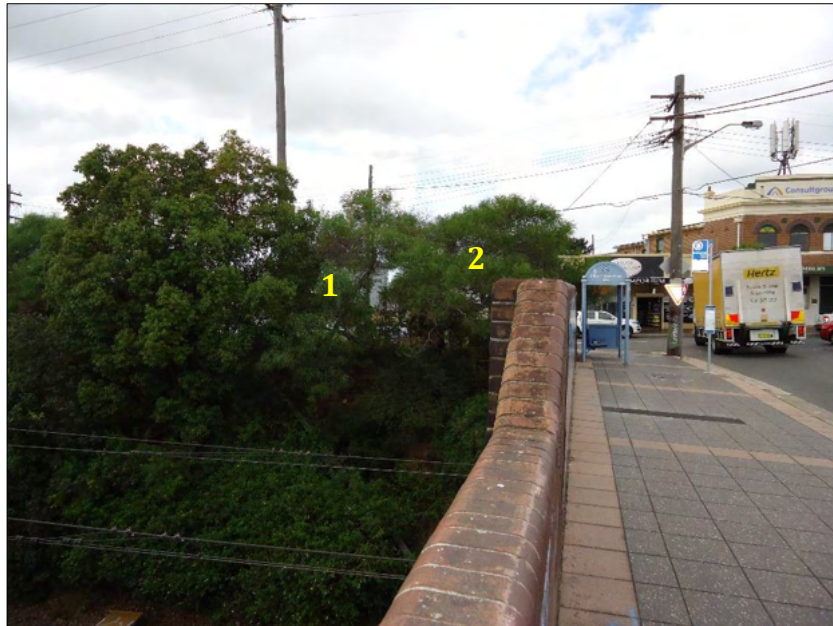
The two Wattles were identified for removal to accommodate soil nailing works. Image 2 shows the subject trees. The trees were found to have a short useful life expectancy given their species type and medium landscape significance. The trees provide some screening from the rail corridor and its associated infrastructure.

Image 2: Trees 1 and 2, Wattles require removal to accommodate soil pinning works adjacent the bridge.

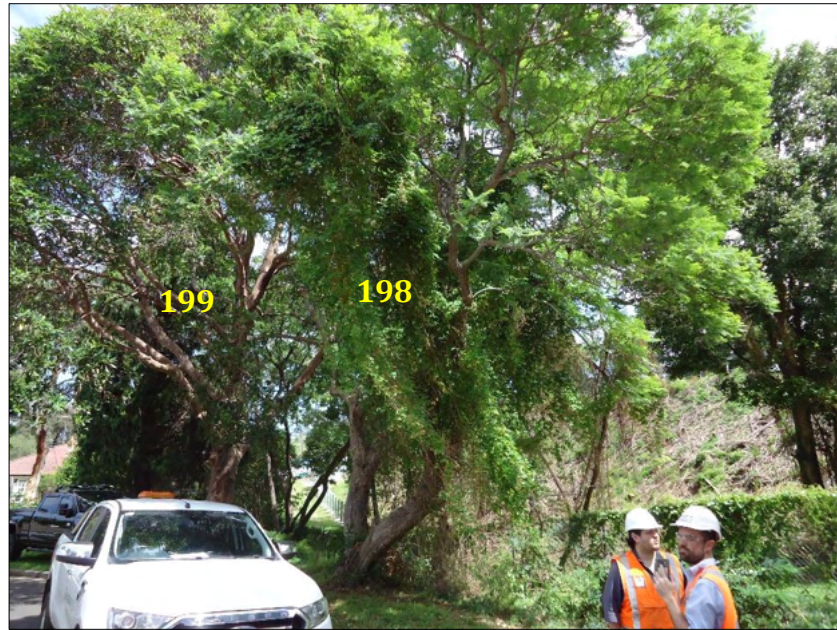
Image 5: Trees 198 and 199 as identified within the AIA report shall require removal for the Metro Services Building access road.

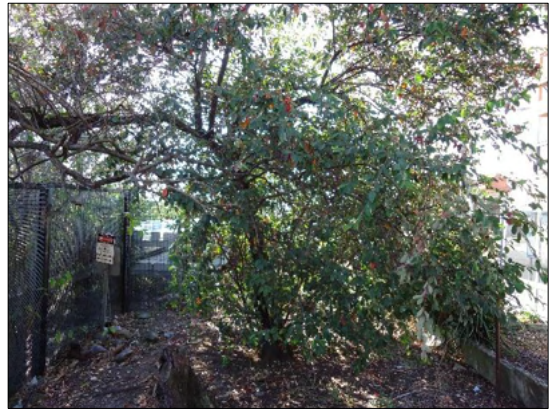
Photograph 2: Tree 516 *Leptospermum petersonii* (Lemon-scented Teatree) was found to be dead.

Trees 515, 516, 517 & 519 must be cleared to provide adequate construction access to the GST route on the Sydney Trains rail corridor embankment. The GST route can't be constructed from the track due to the topographical restrictions preventing the safe construction of the permanent asset

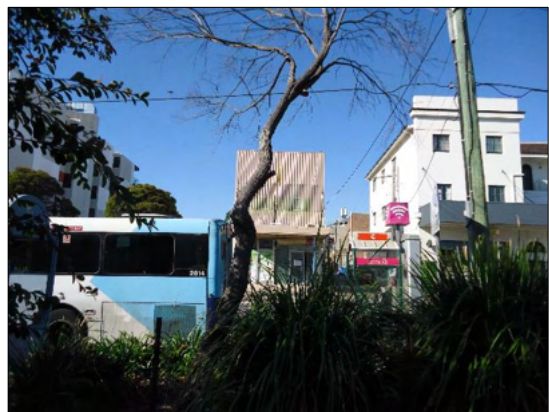
Photograph 3: Tree 517 *Pittosporum undulatum* (Sweet Pittosporum) was found to be dead.

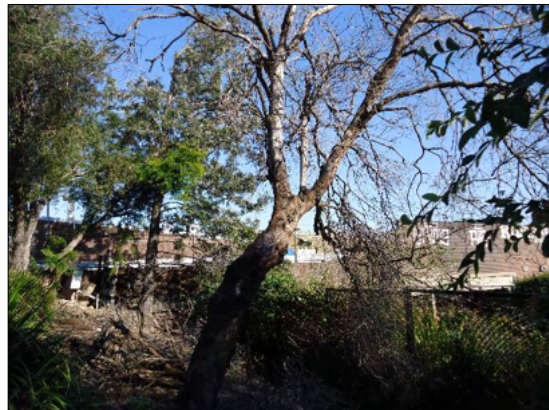
Photograph 4: Tree 519 *Callistemon viminalis* (Weeping Bottlebrush) located adjacent the northern side of South Parade.
