# Tree Impact Assessment Report

## City and Southwest Metro Station Upgrade Works Package 5 & 6

**Project wide: Hurlstone Park, Wiley Park, Belmore,  
Campsie, Dulwich Hill and Punchbowl**

**P5 Document No. SMCSWSW5-DEW-WEC-EM-REP-000542**

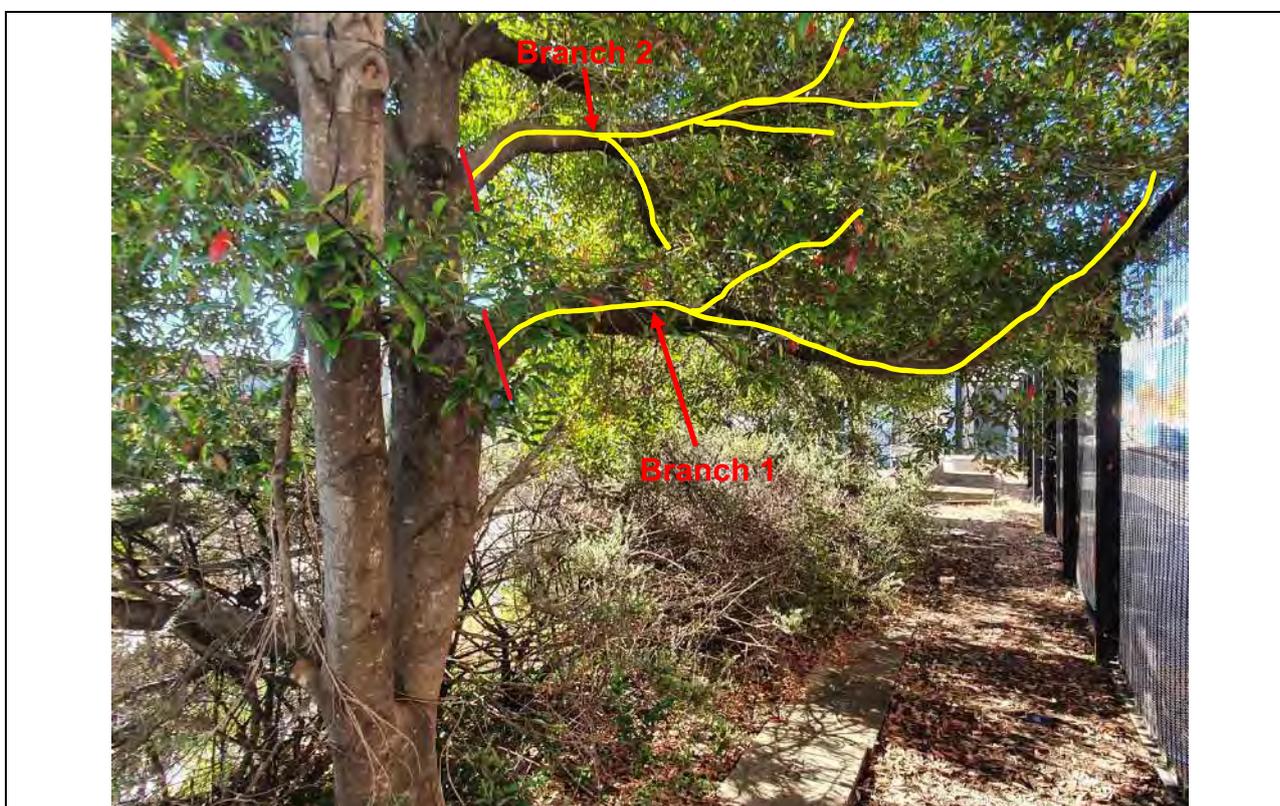
**Image 1:** Looking East from within the site towards tree 612, showing branch 1 and 2. The yellow lines indicate the branches to be removed, the red lines indicated the approximate location of the final pruning cuts.

The pruning specified above will result in removing 10-15% of the overall live crown. The pruning will not adversely impact the condition of the tree. The pruning is therefore considered minor and acceptable. All pruning can and must be carried out in accordance with section 7.2.4 of AS4373-2007 for selective pruning.<sup>8</sup> The final pruning cut must be to the branch collar/union.

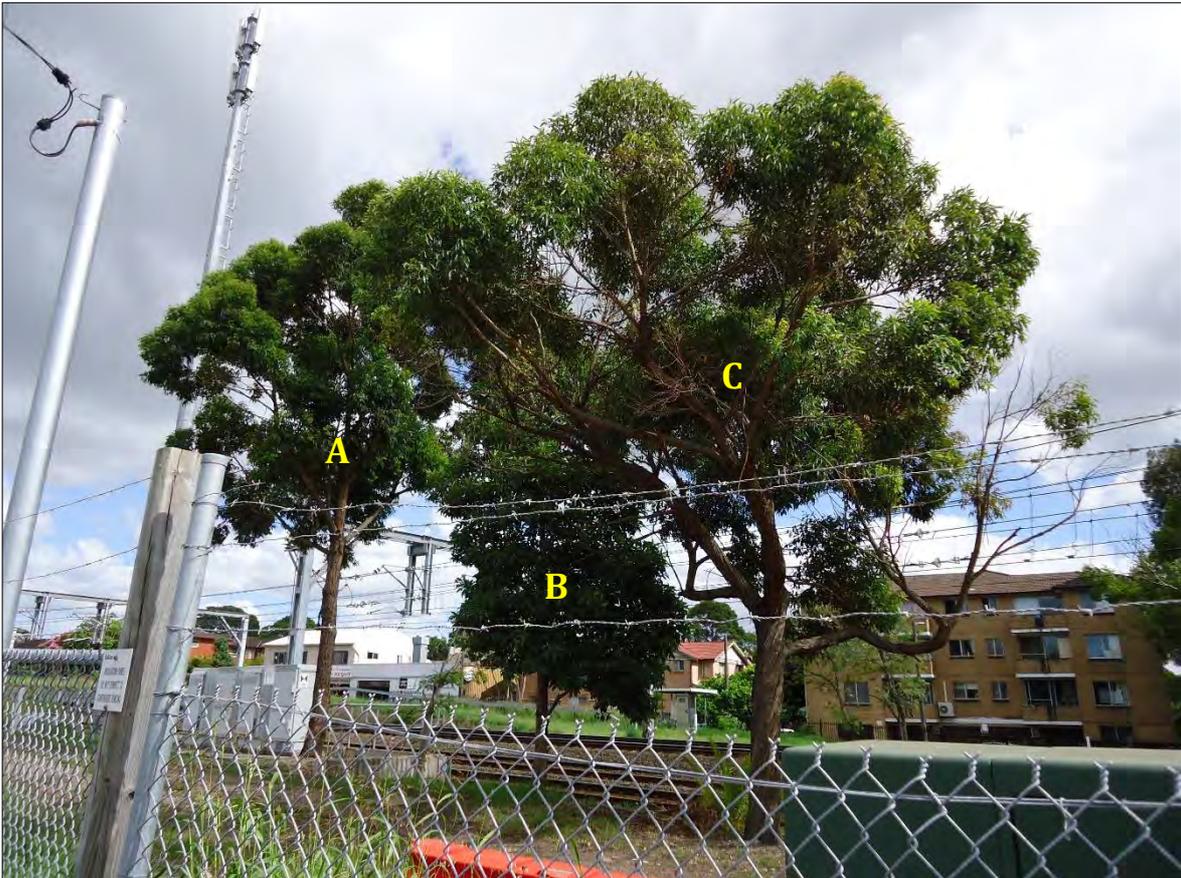
Trees A, Tallowwood and B Brush Box were found to be in good health and condition. They are considered to have a medium useful life expectancy and landscape significance. Tree C Tallowwood was found to have normal vigour and fair condition. Deadwood and canopy dieback was observed within the tree indicating a possible decline in health and condition. As such the tree is considered to have a short useful life expectancy. Image 2 shows the subject trees. The trees provide some screening and relief from the rail corridor and associated infrastructure along Lillian Street.

**Image 2:** The three additional trees identified for removal as part of the Southwest Metro Package works.

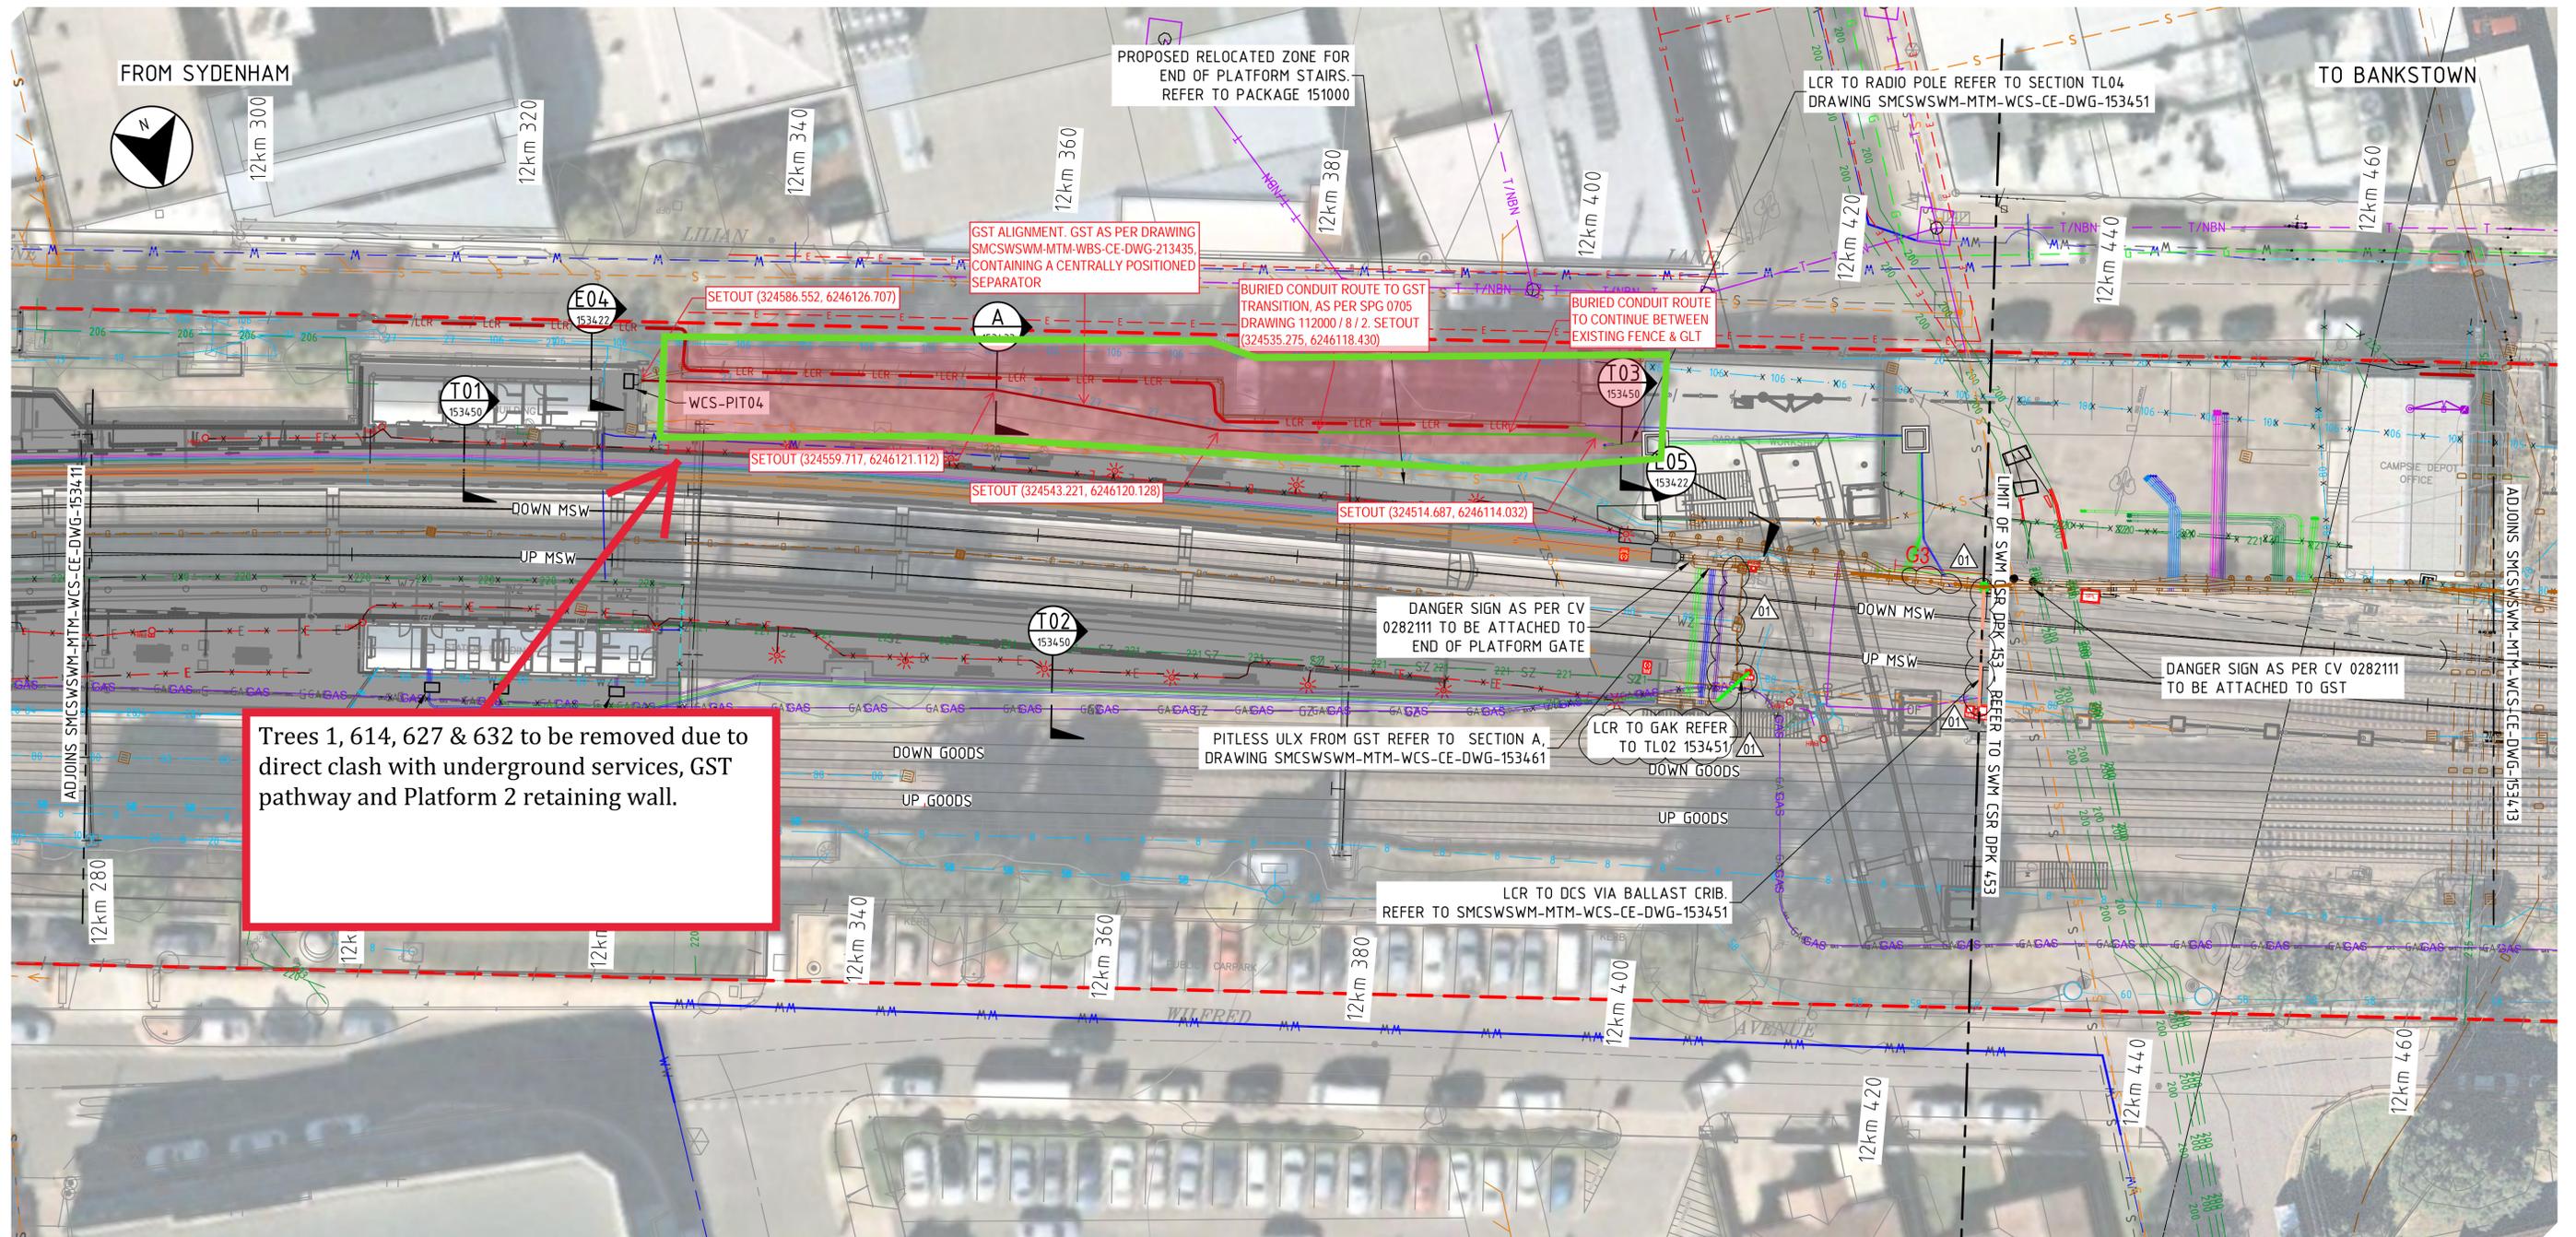
Trees 1, 614, 627 & 632 to be removed due to direct clash with underground services, GST pathway and Platform 2 retaining wall.

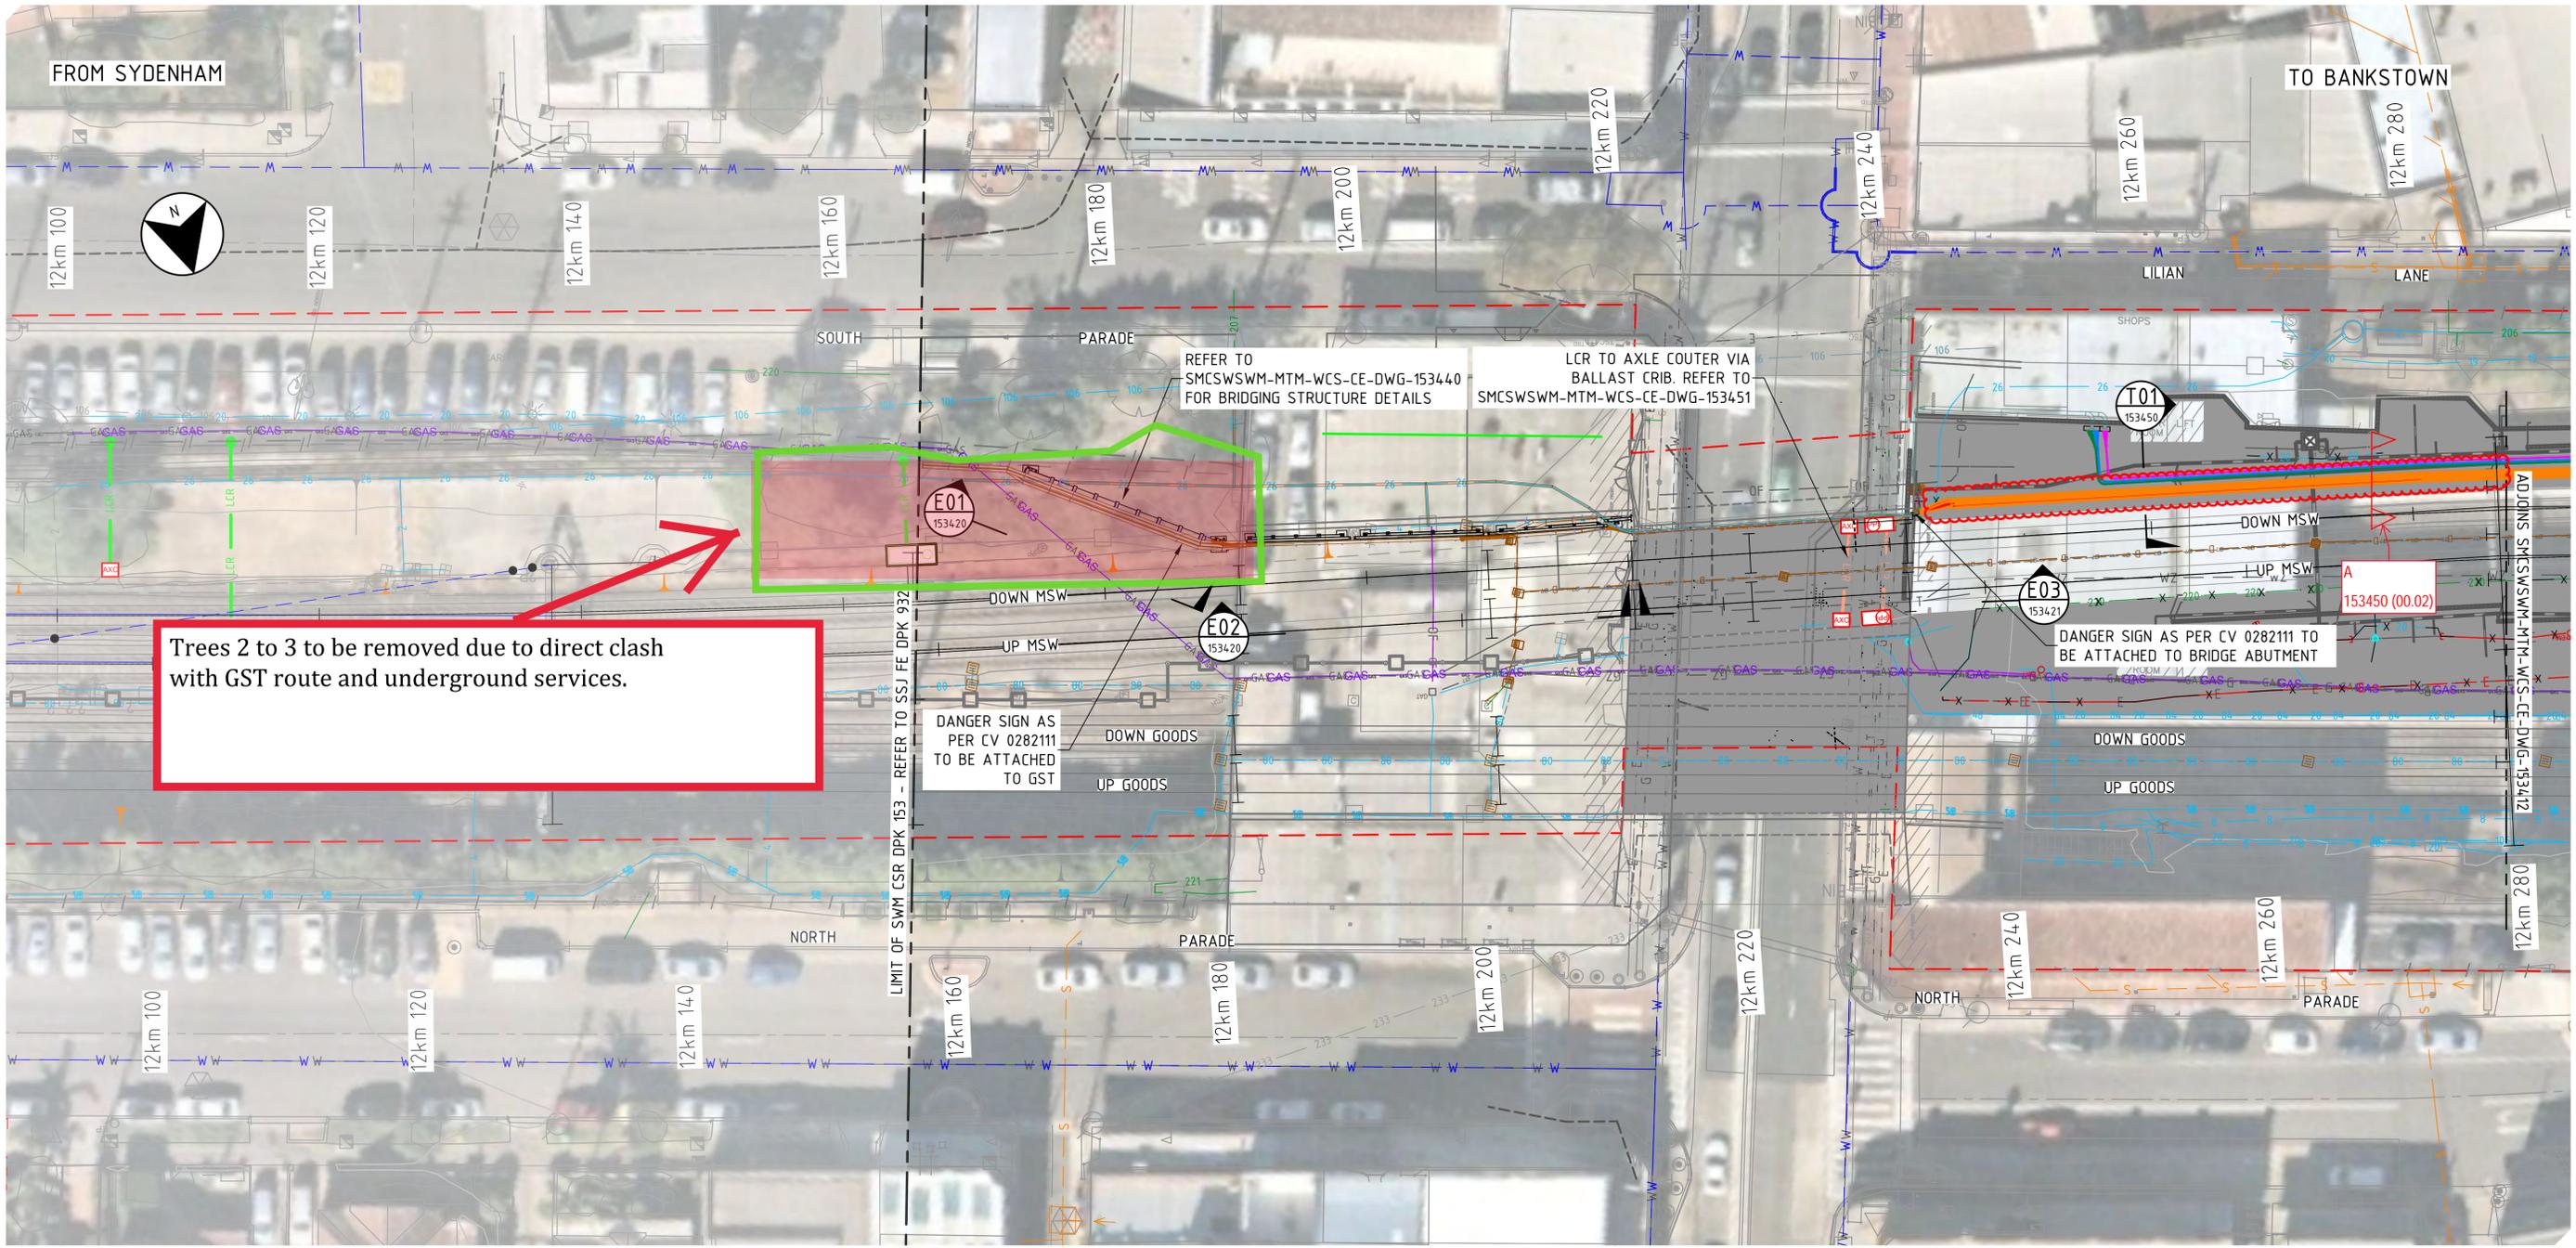
Trees 2 to 3 to be removed due to direct clash with GST route and underground services.

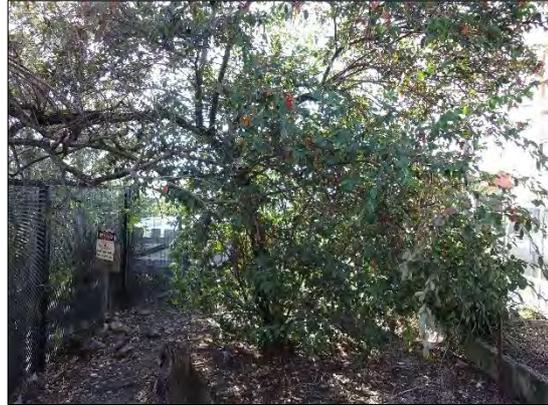
**Photograph 2:** Tree 516 *Leptosporum petersonii* (Lemon-scented Teatree) was found to be dead.

Trees 515, 516, 517 & 519 must be cleared to provide adequate construction access to the GST route on the Sydney Trains rail corridor embankment. The GST route can't be constructed from the track due to the topographical restrictions preventing the safe construction of the permanent asset

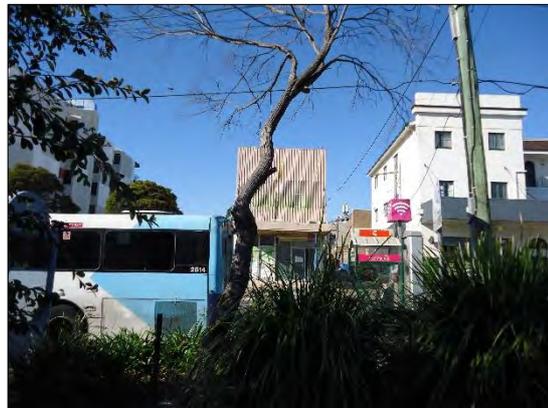
**Photograph 3:** Tree 517 *Pittosporum undulatum* (Sweet Pittosporum) was found to be dead.

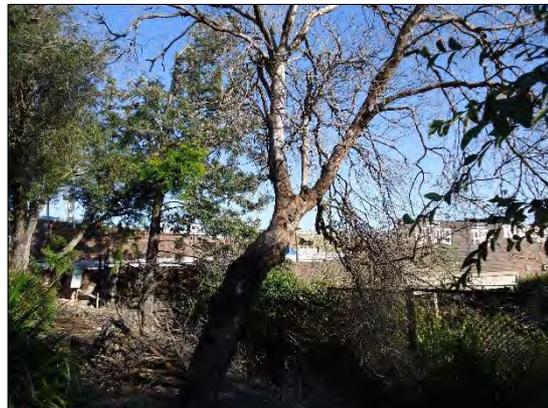
**Photograph 4:** Tree 519 *Callistemon viminalis* (Weeping Bottlebrush) located adjacent the northern side of South Parade.

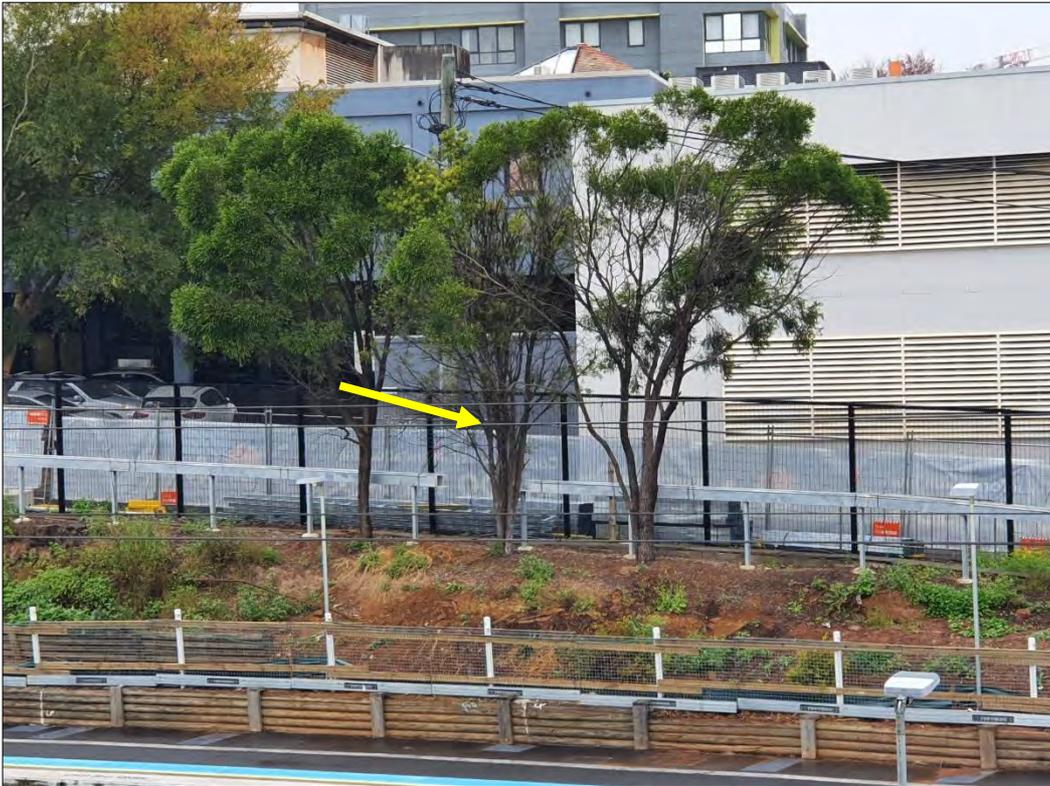
**Photograph 1:** Tree 618 *Callistemon viminalis* (Weeping Bottlebrush) as seen from the northern side of the rail corridor.

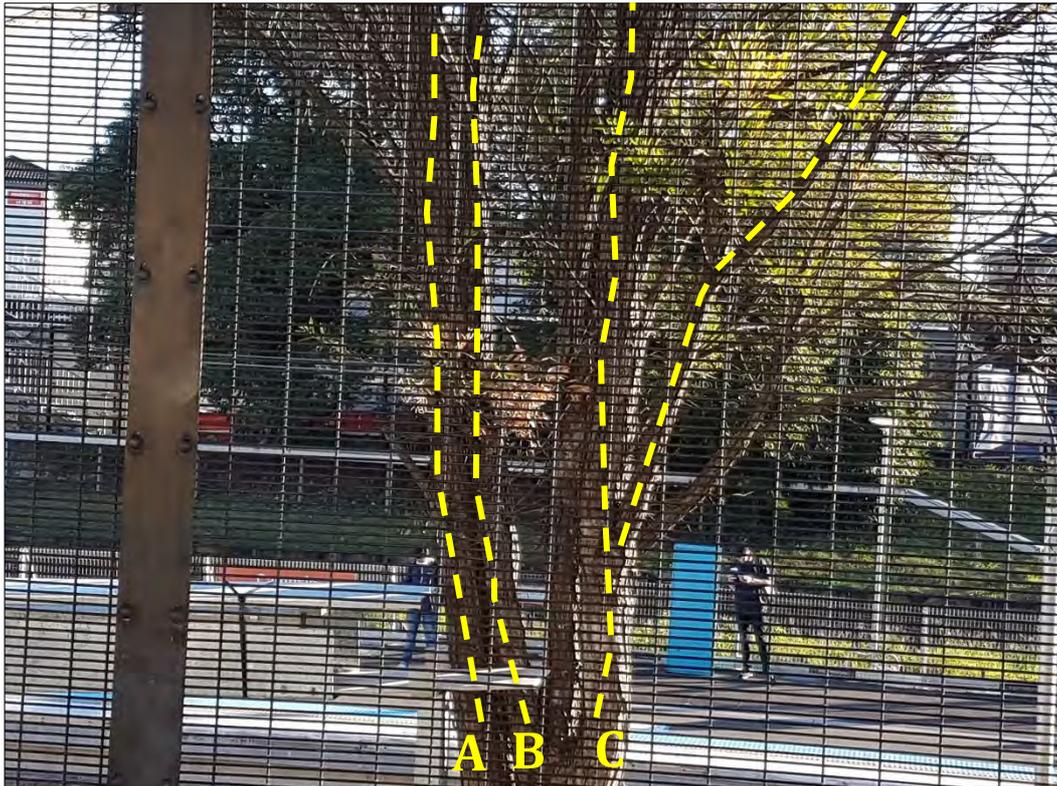
**Photograph 4:** Stems A, B and C to be removed. Stem A is 160mm in diameter and is to be reduced to below the GST (approx. 0.7m height). Stem s B and C are 90mm and 130mm in diameter and are to be removed to the nearest appreciate growth point. The two branches originate off the same stem.

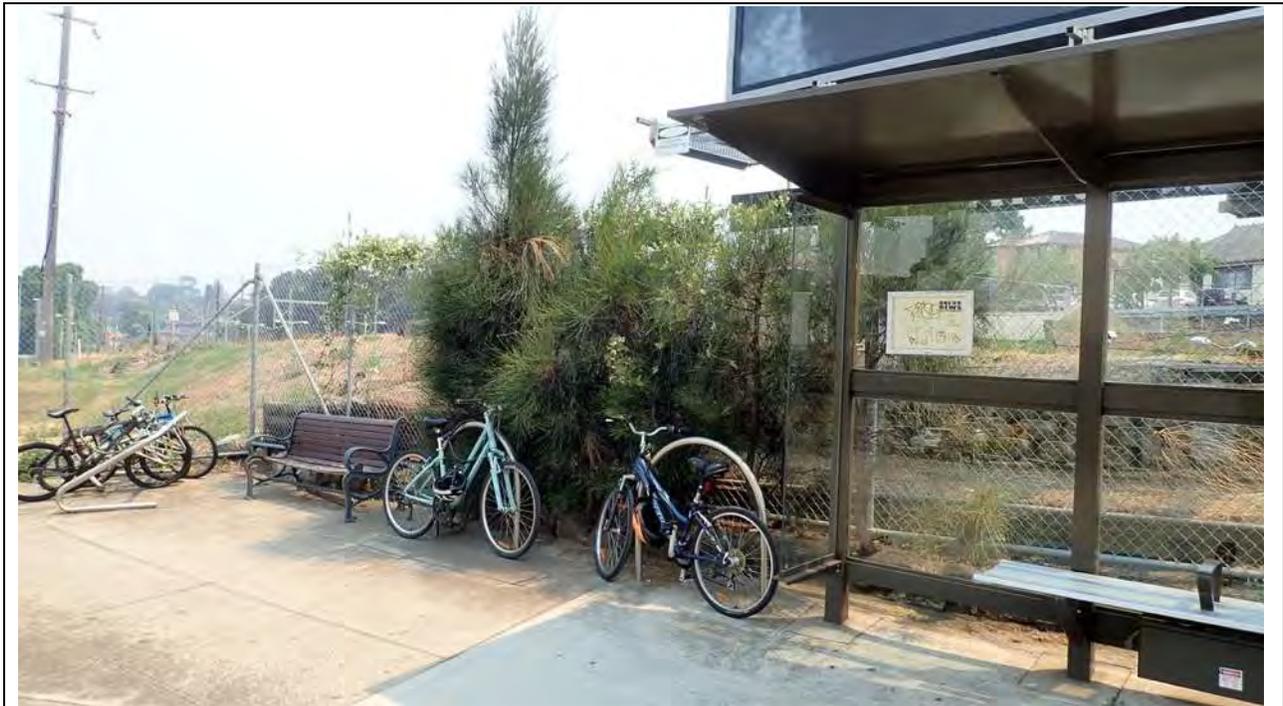
**Image 1:** Looking North towards trees 586, 587, 588, 589 and 590. The trees have been recommended for removal due to impacts from the proposed hard surfacing excavations.

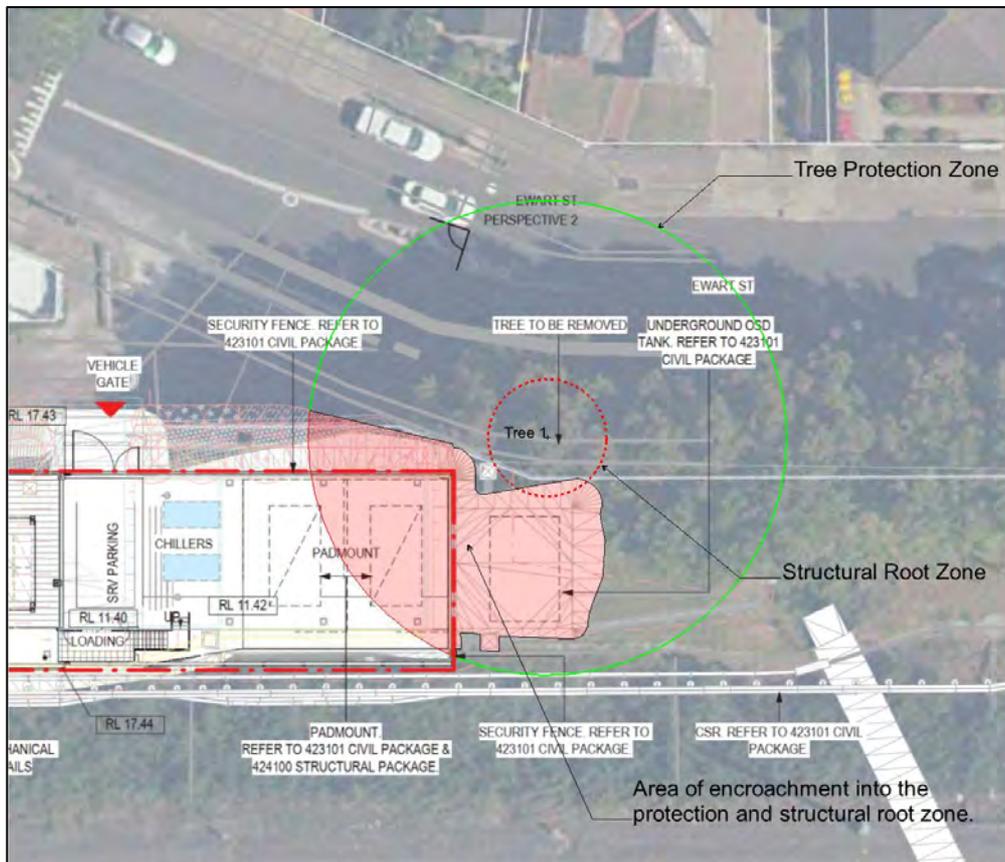
**Image 2:** Extract from Overall Arrangement Site Plan – Service Building showing the encroachment into the TPZ and SRZ of tree 1.

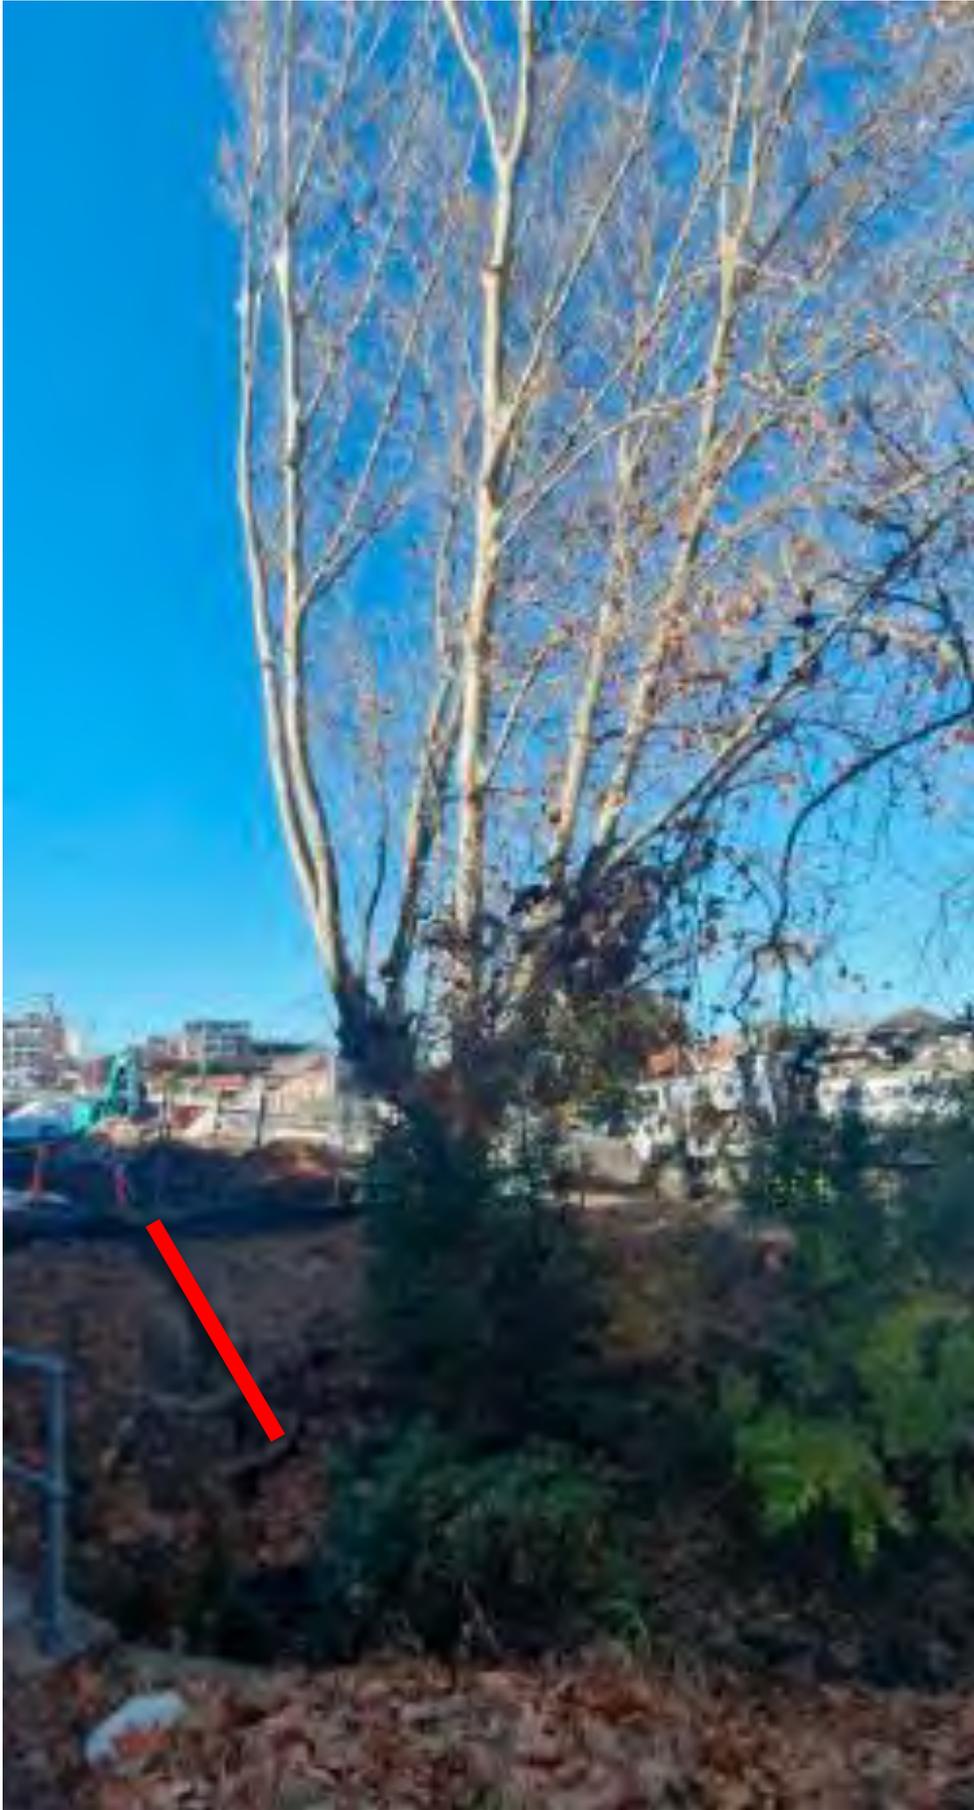
Image of the subject tree (Tree 94) taken on the 15<sup>th</sup> June 2021 (red line shows approximate location of required excavations).

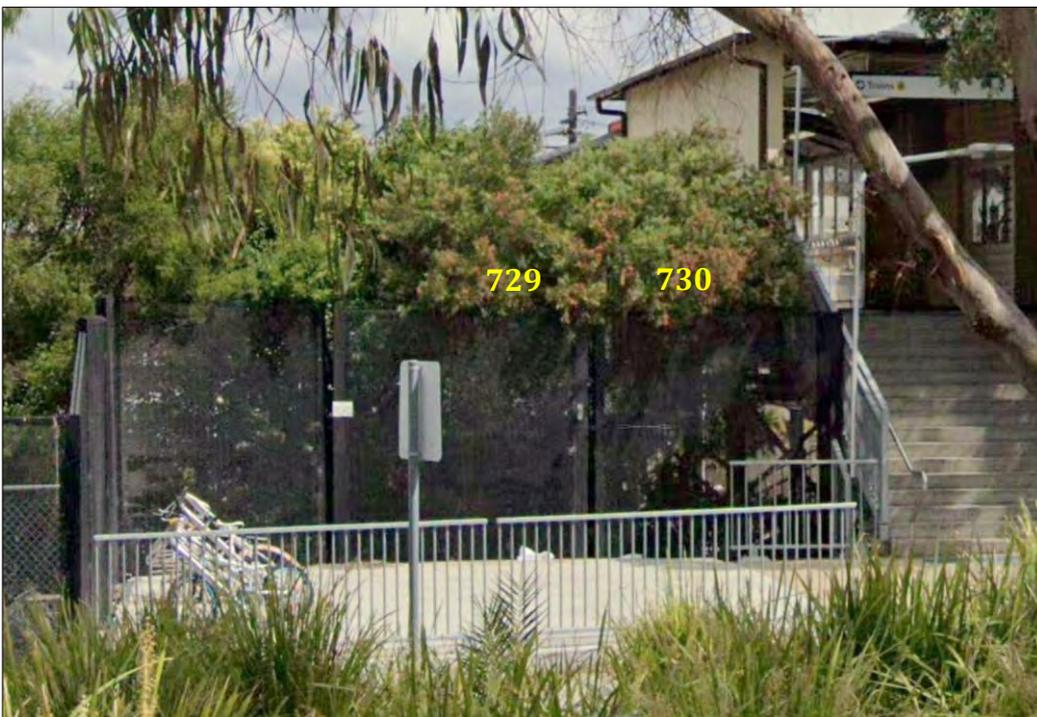
**Image 2:** Trees 729 and 730 are to be removed to accommodate the lift shaft works.

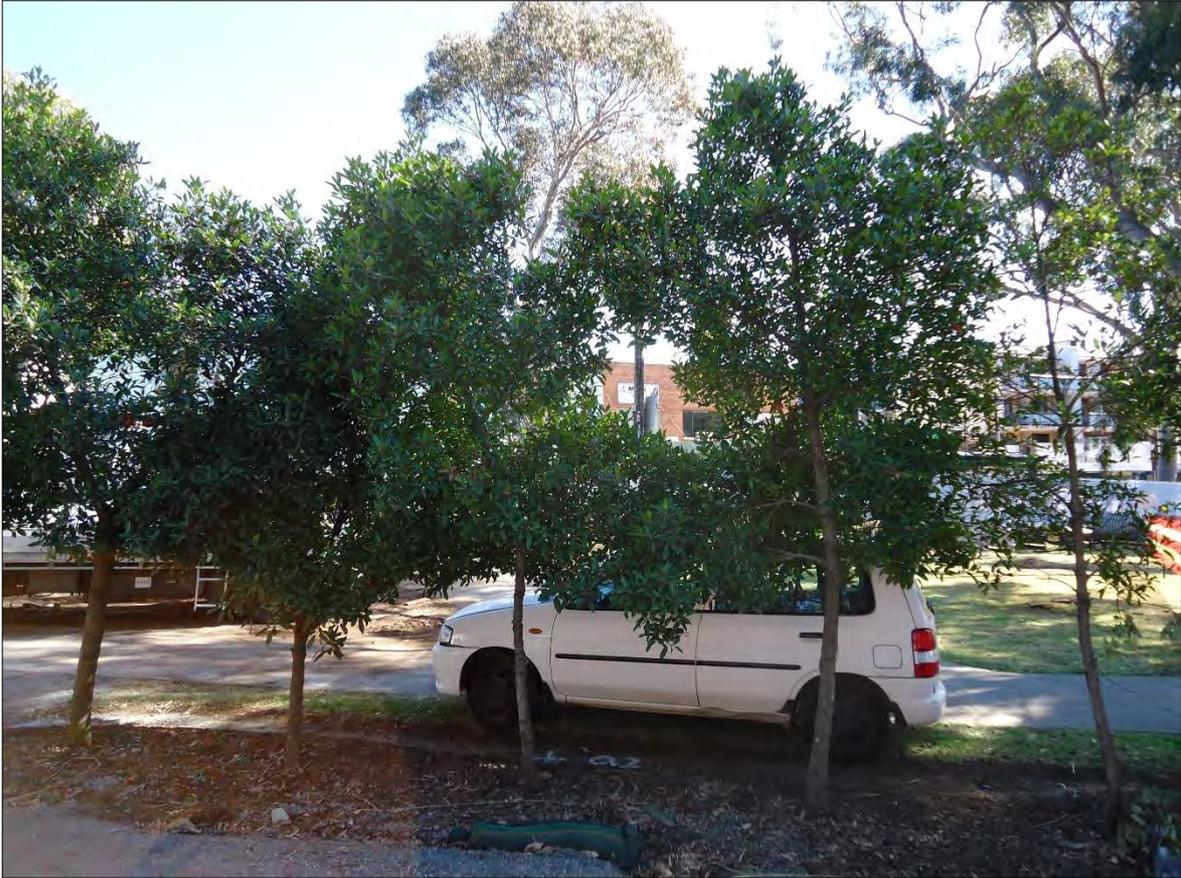
**Photograph 1:** Showing the five *Elaeocarpus reticulatus* (Blueberry Ash) to be removed.

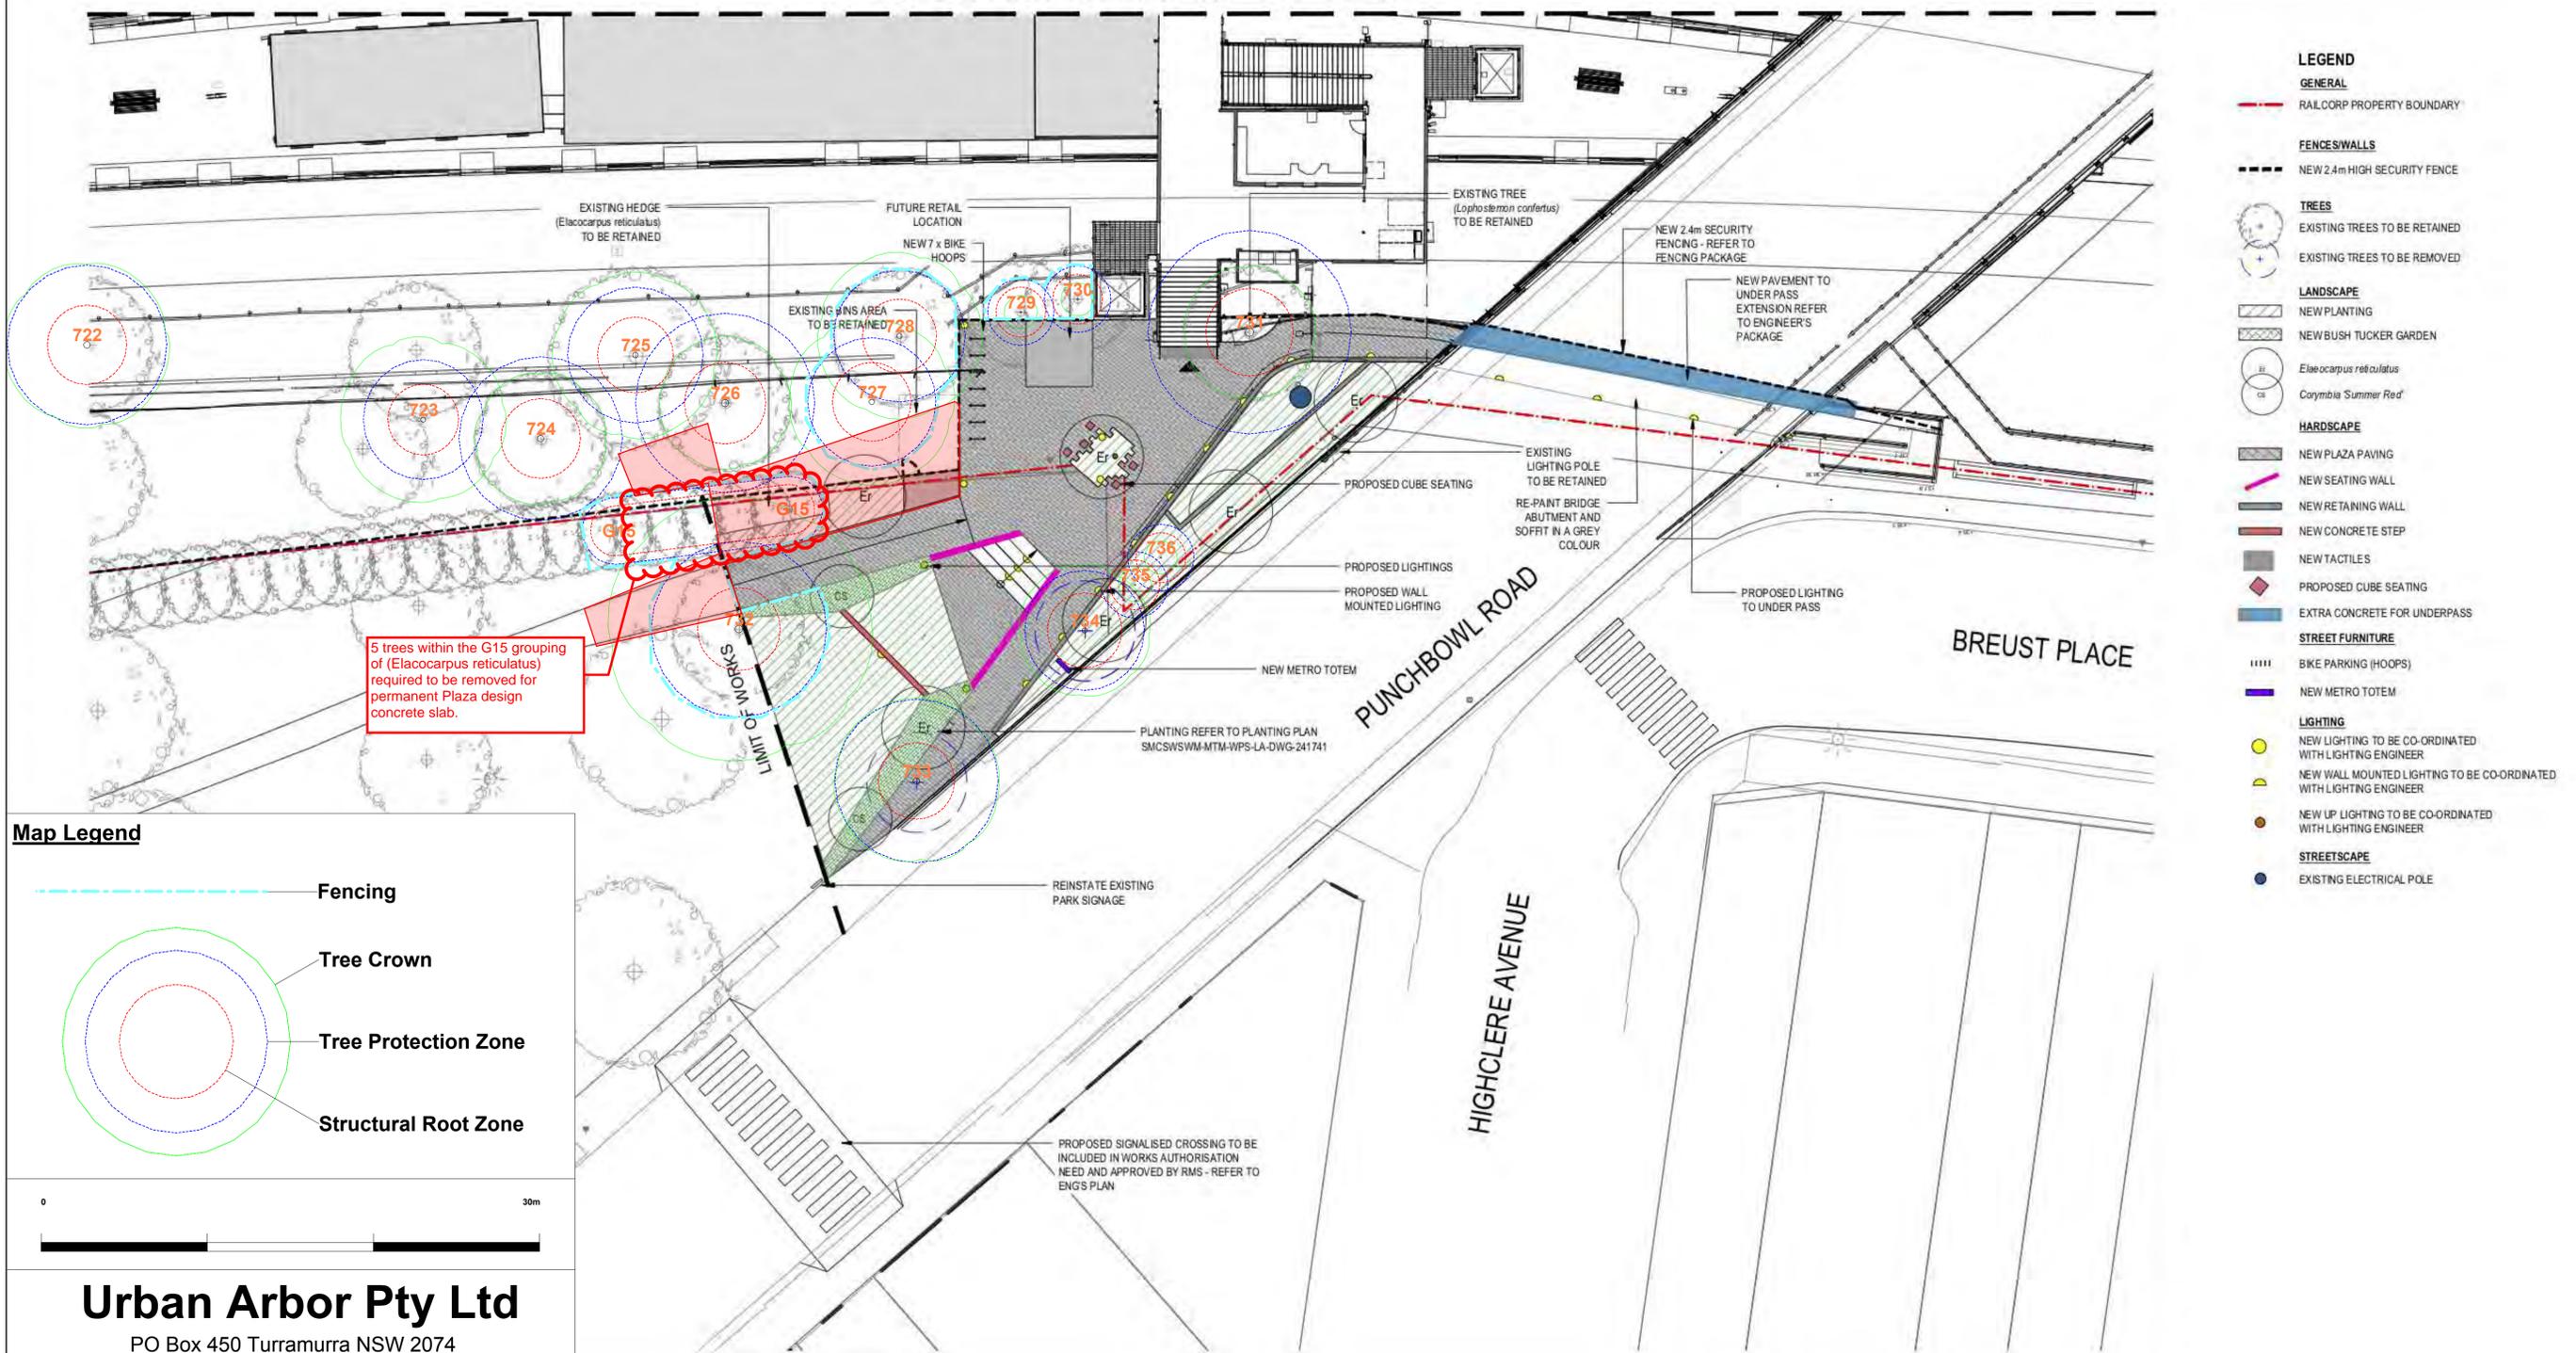
5 trees within the G15 grouping of (*Elacocarpus reticulatus*) required to be removed for permanent Plaza design concrete slab.

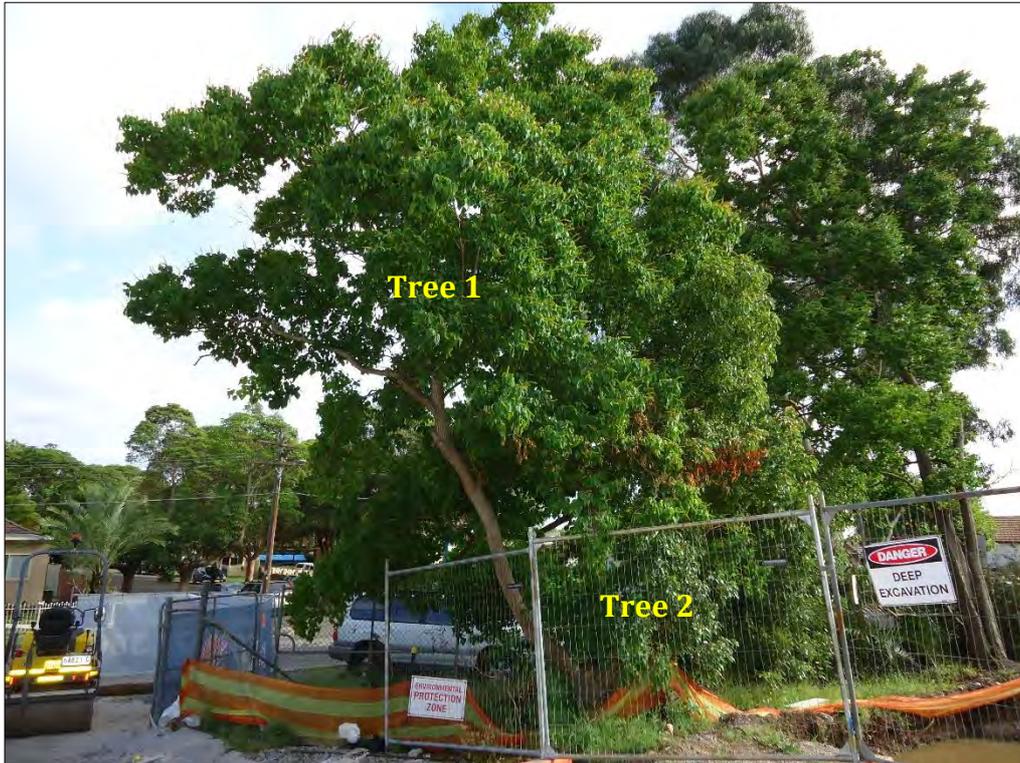
**Photograph 1:** The subject trees as seen from within the rail corridor. Tree 1 *Sapium sebiferum* (Chinese Tallowwood), tree 2 *Cinnamomum camphora* (Camphor Laurel).

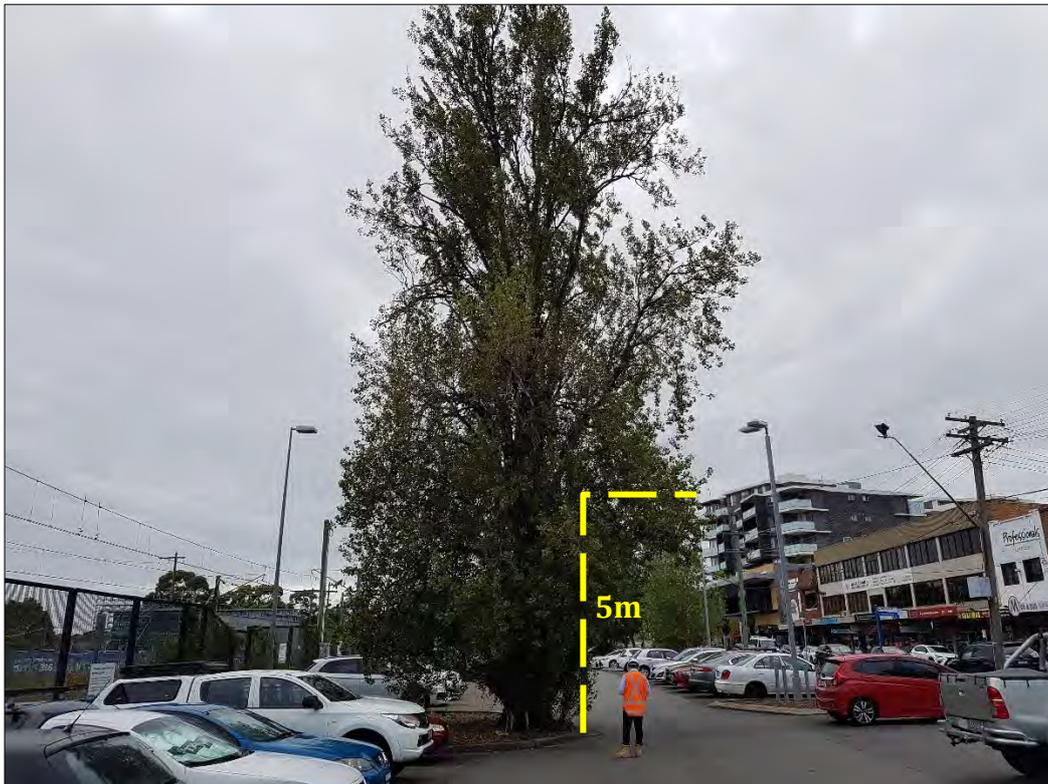
**Photograph 1:** Tree 1 *Populus nigra* 'Italica' (Lombardy Poplar as seen from the carpark area adjacent The Boulevard. 5m of vertical clearance is required from the outside edge of kerb adjacent the base of the tree.

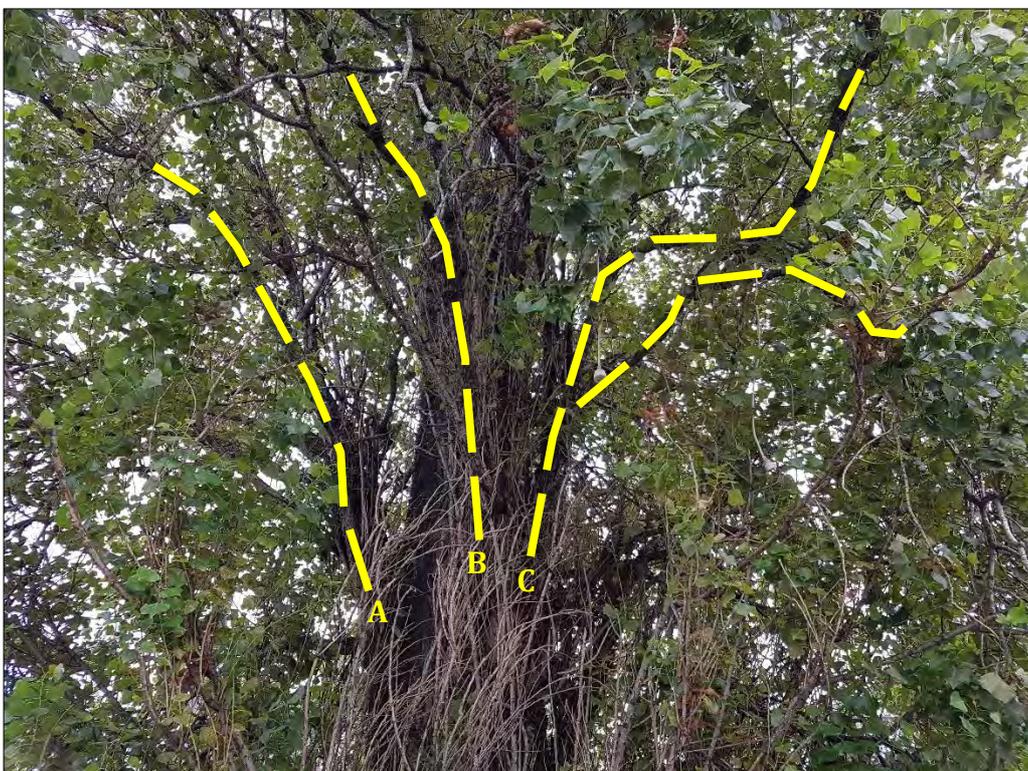
**Photograph 2:** Branches A, B and C identified for removal.
