# Tree Impact Assessment Report

## City and Southwest Metro Station Upgrade Works Package 5 & 6

**Project wide: Hurlstone Park, Wiley Park, Belmore,  
Campsie, Dulwich Hill and Punchbowl**

**P5 Document No. SMCSWSW5-DEW-WEC-EM-REP-000542**

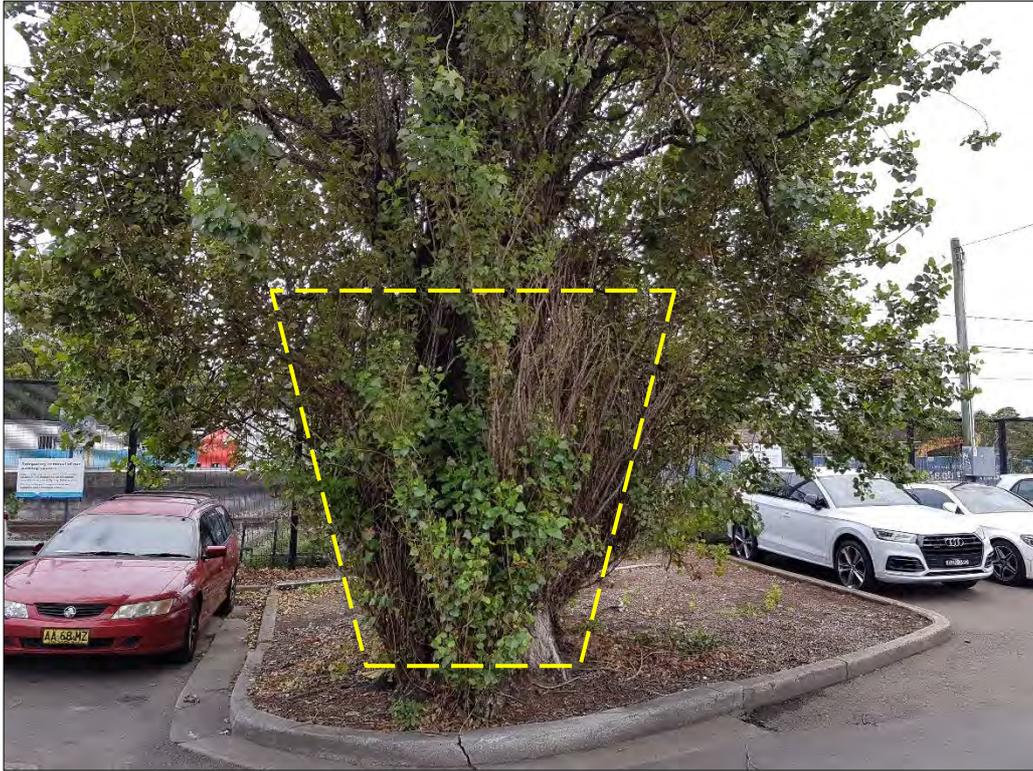
**Photograph 3:** Multiple epicormic shoots originating from the base of the trunk are to be removed.
