Tree Impact Assessment Report

City and Southwest Metro Station Upgrade Works Package 5 & 6

P5 Document No. SMCSWSW5-DEW-WEC-EM-REP-000542

P6 Document No. SMCSWSW6-DEW-WEC-EM-REP-000632

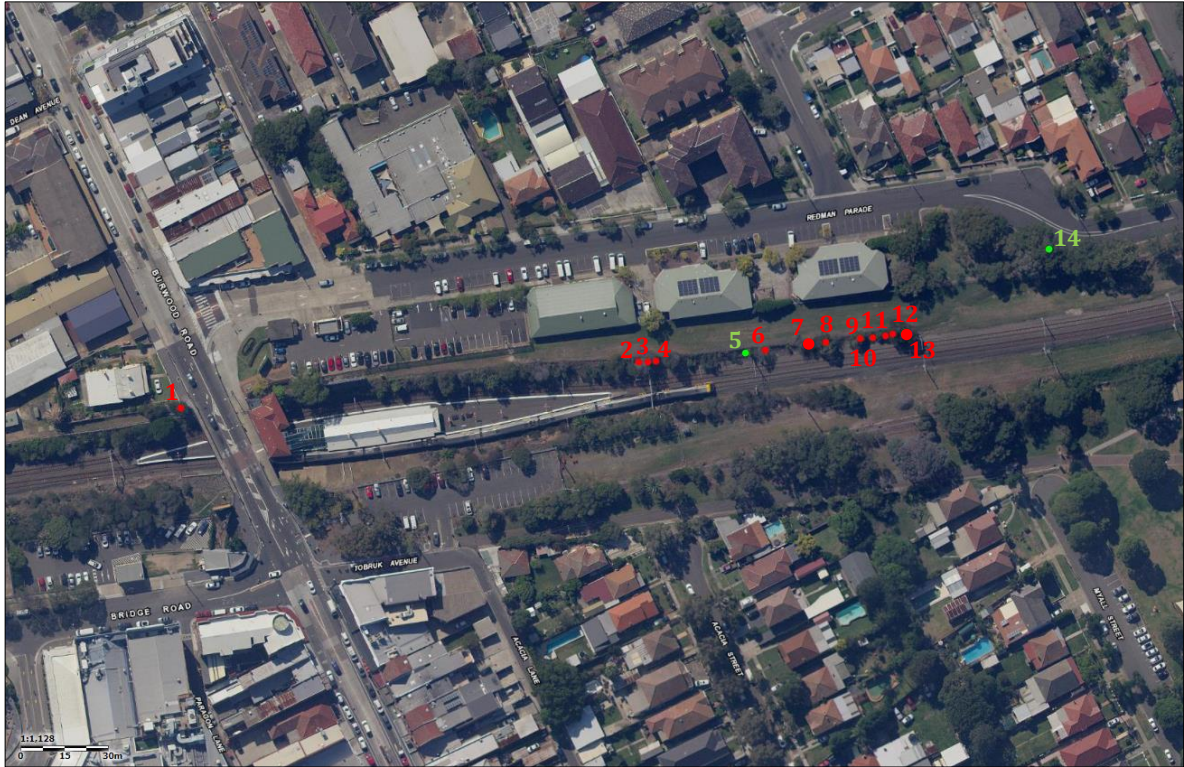
Image 1: Aerial image of Belmore station showing approximate tree locations. Red dots indicate trees to be removed, green dots indicate trees to be pruned.

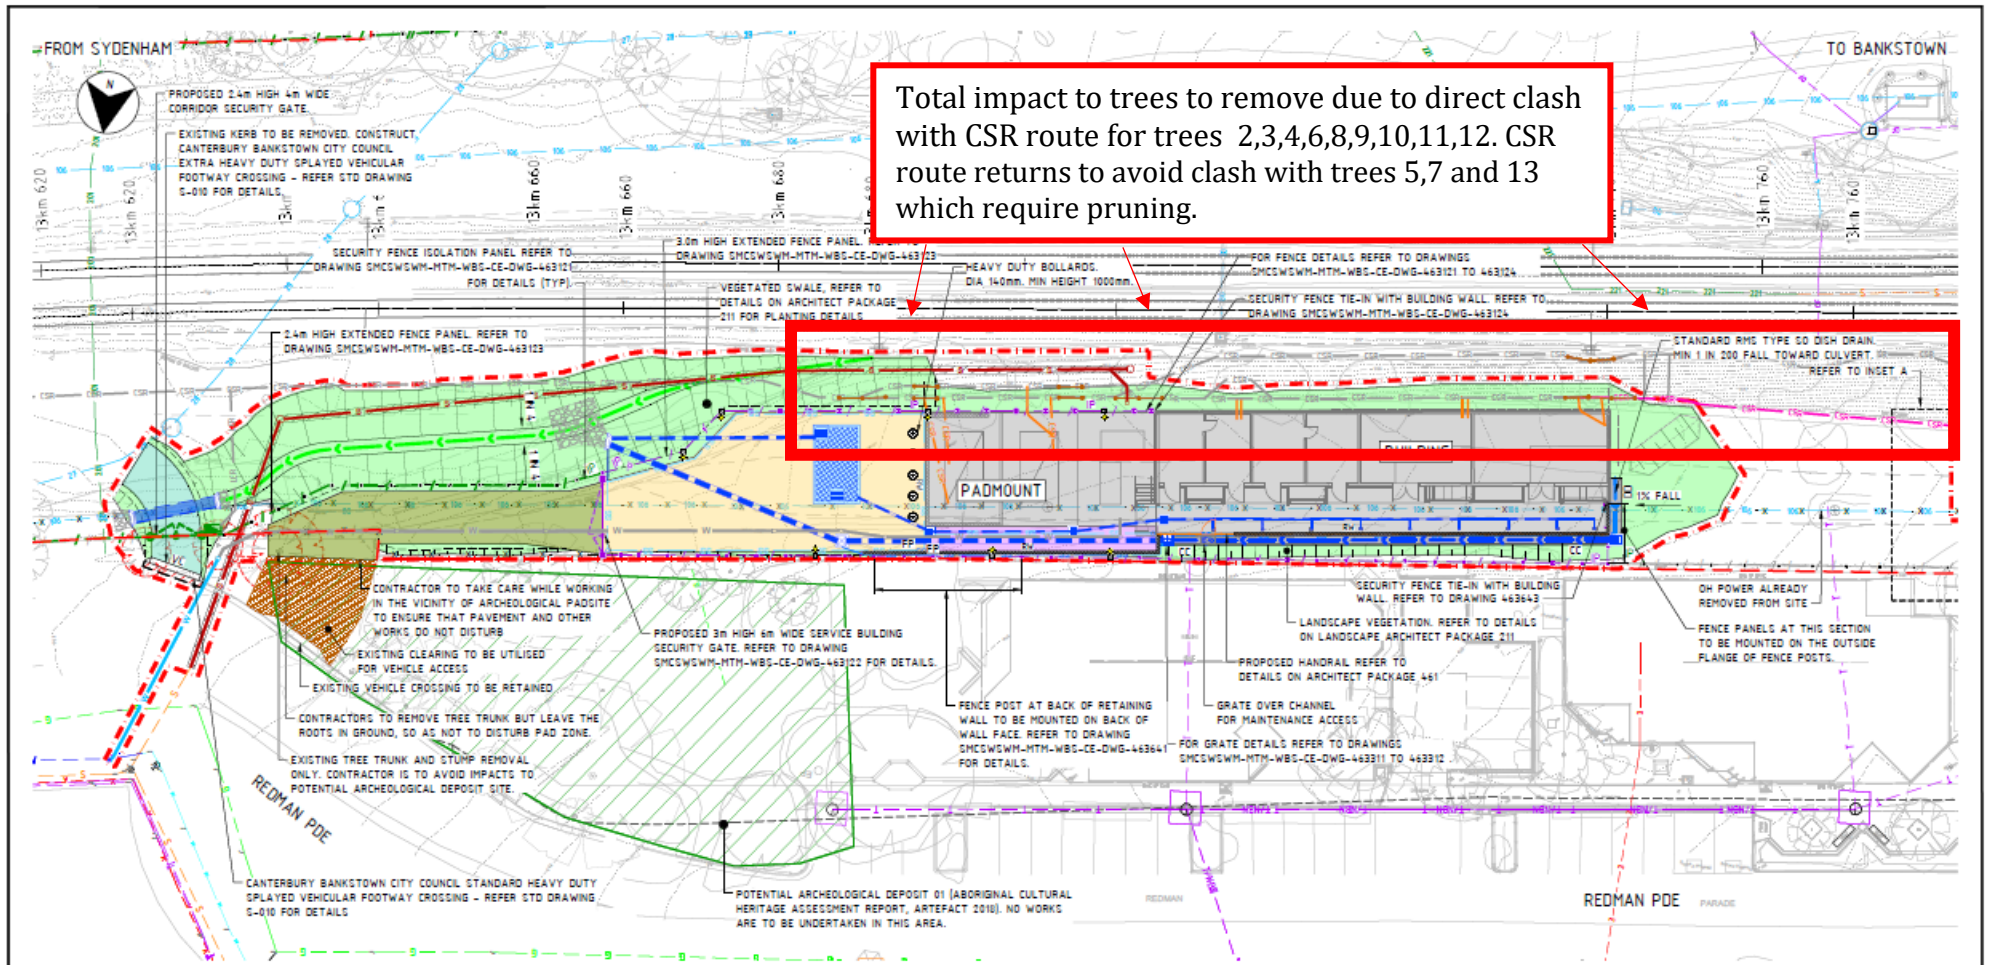
Total impact to trees to remove due to direct clash with CSR route for trees 2,3,4,6,8,9,10,11,12. CSR route returns to avoid clash with trees 5,7 and 13 which require pruning.

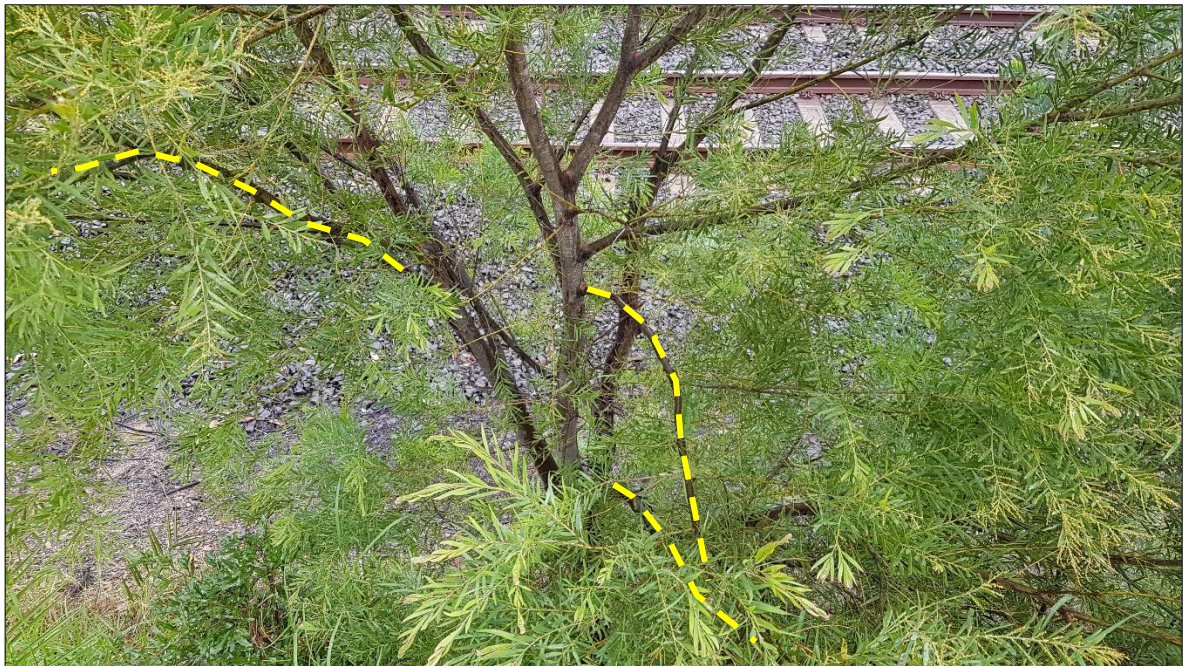
Tree 5 *Acacia* sp (Wattle) identified pruning involves the removal of approximately four branches up to 20mm in diameter and constitutes <10% of the total canopy volume. The pruning is not expected to have a significant impact upon the remaining stems.

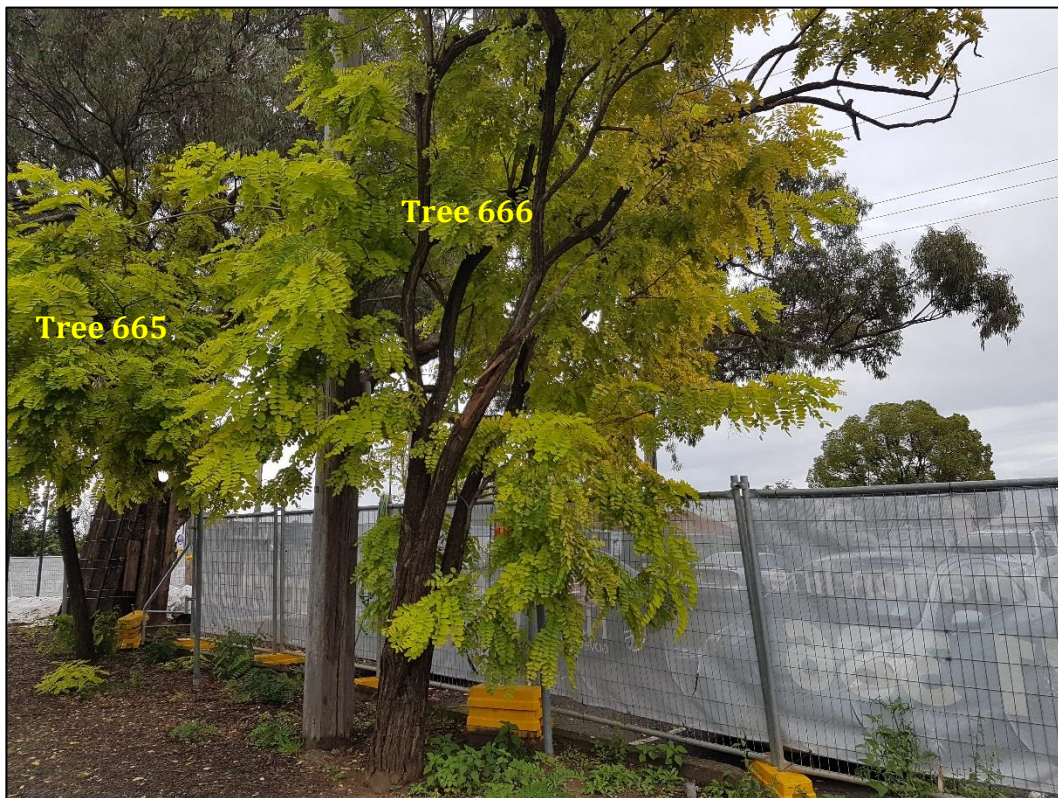
Photograph 1: Tree 665 and 666 as seen from within the site.

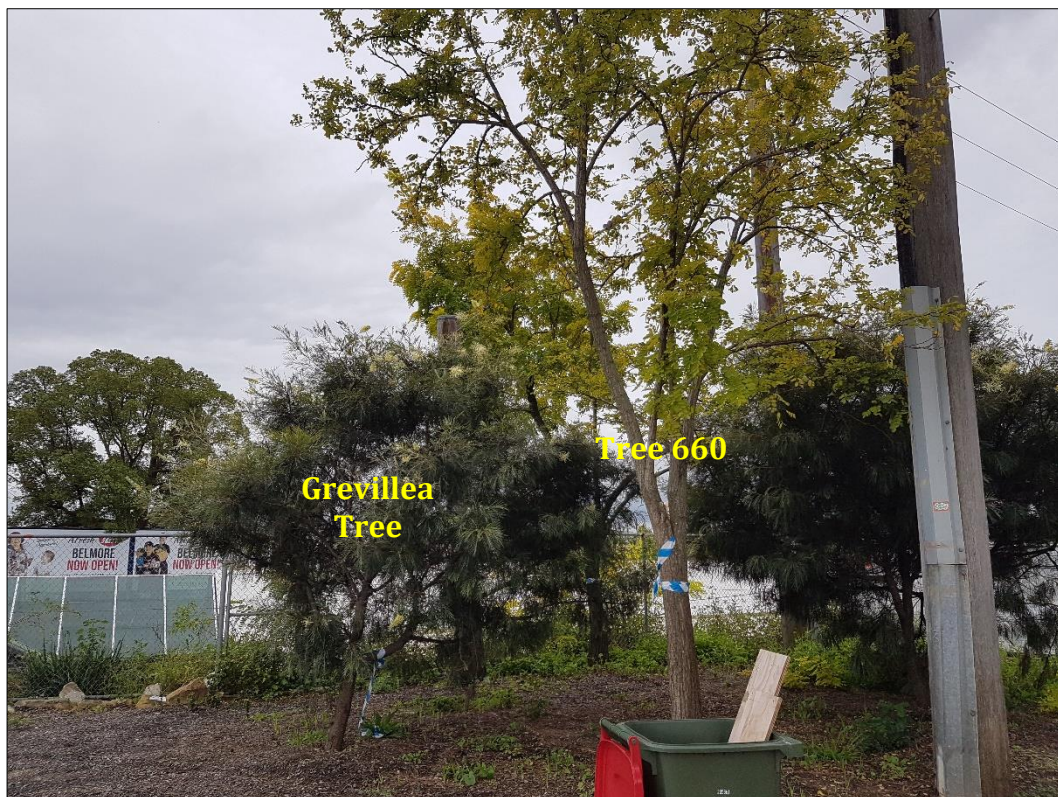
Photograph 2: Tree 660 and the Grevillea as seen from within the site.

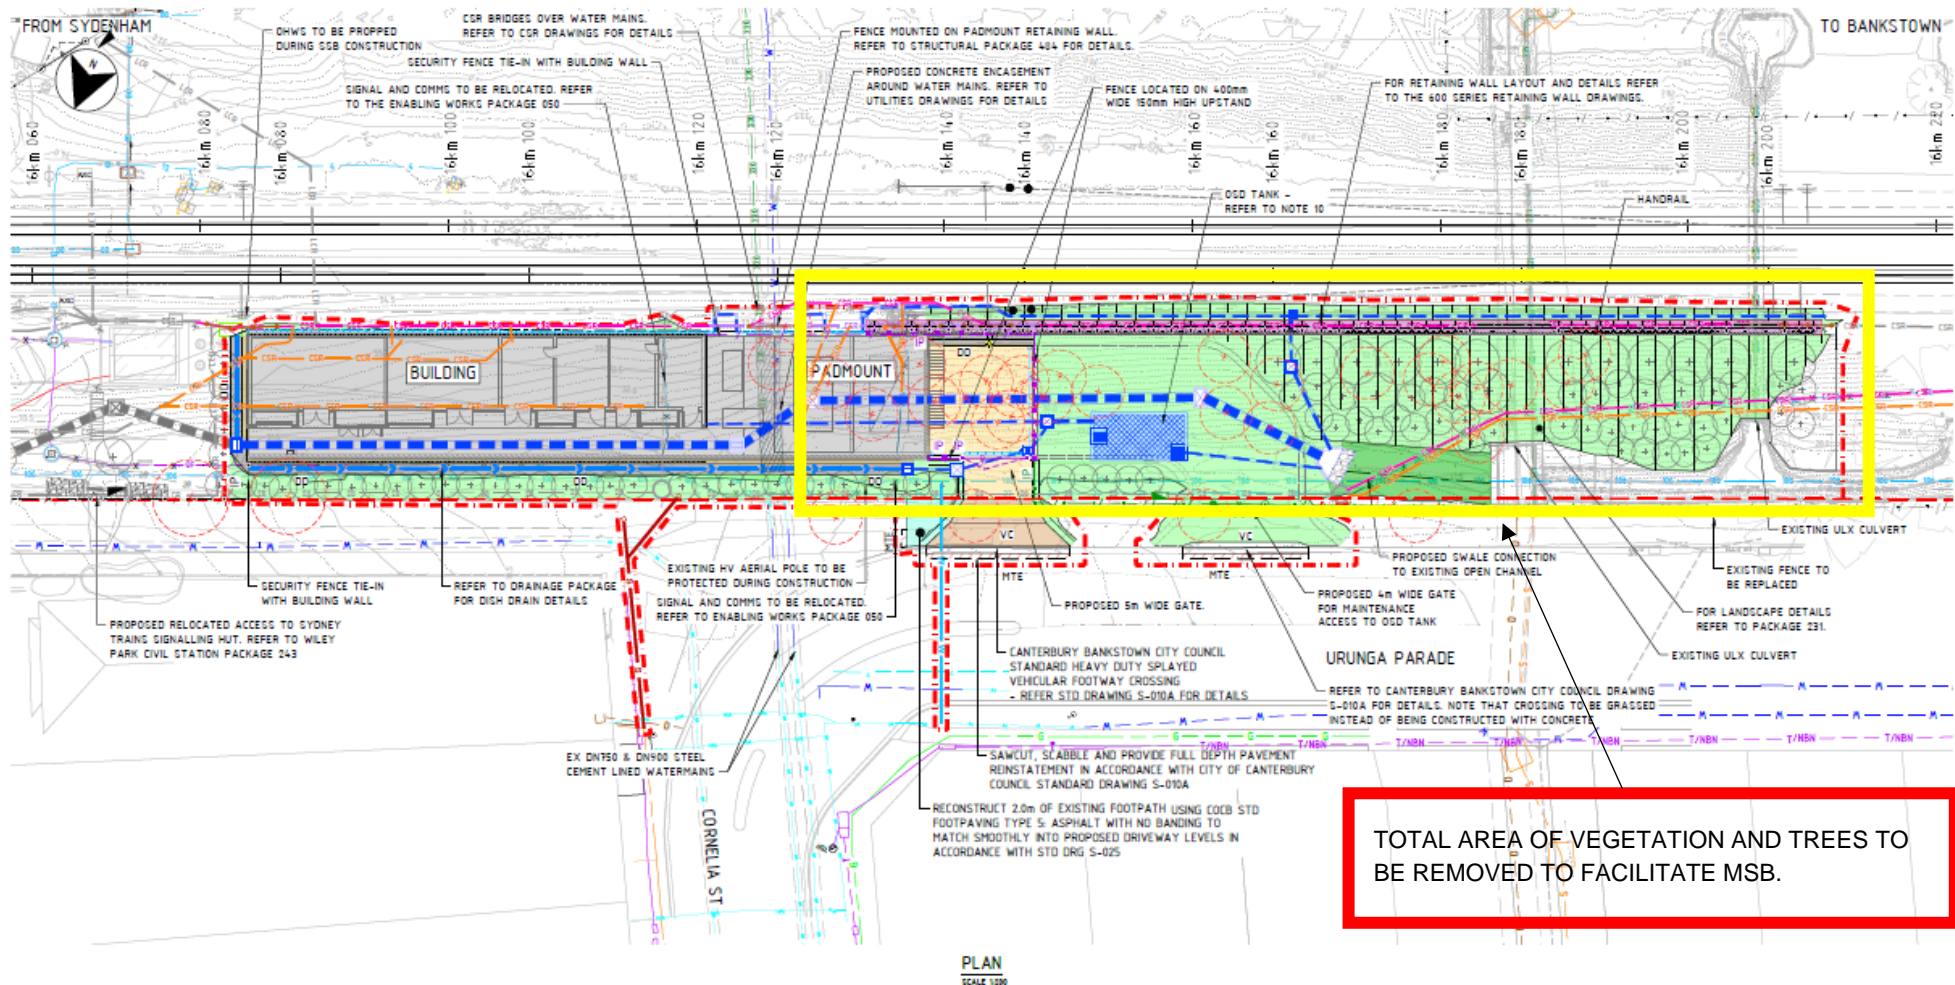
TOTAL AREA OF VEGETATION AND TREES TO BE REMOVED TO FACILITATE MSB.

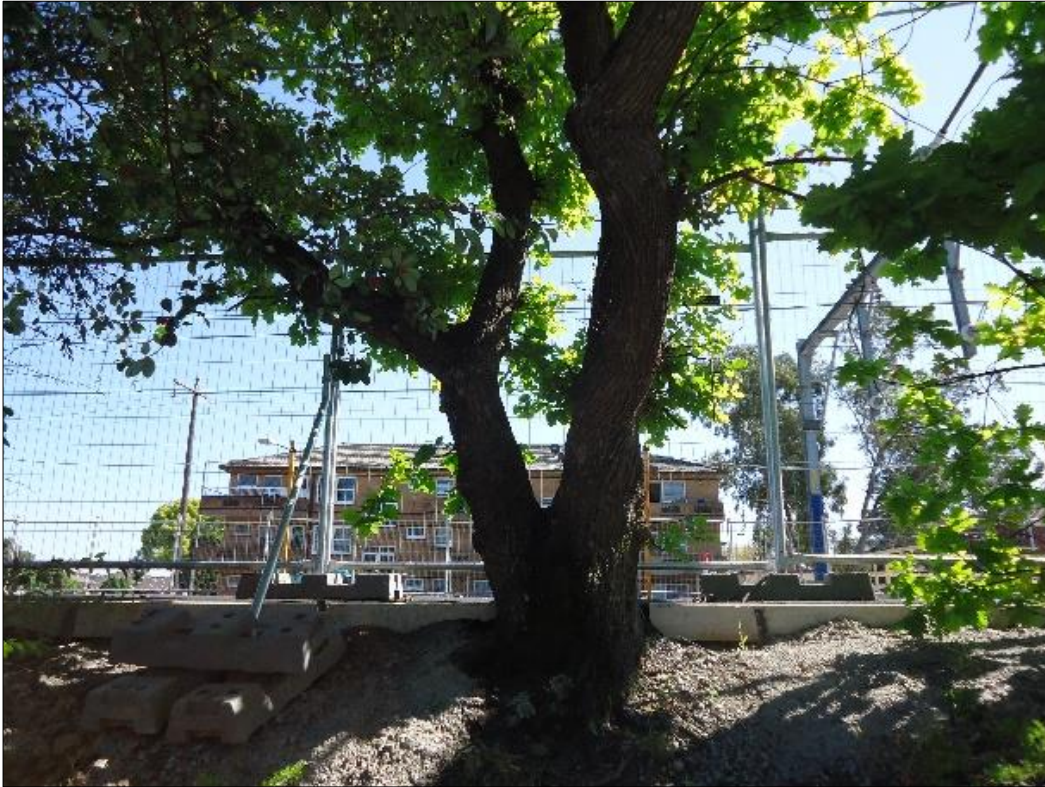
Photograph 1: Tree 711 *Quercus robur* (Common Oak).

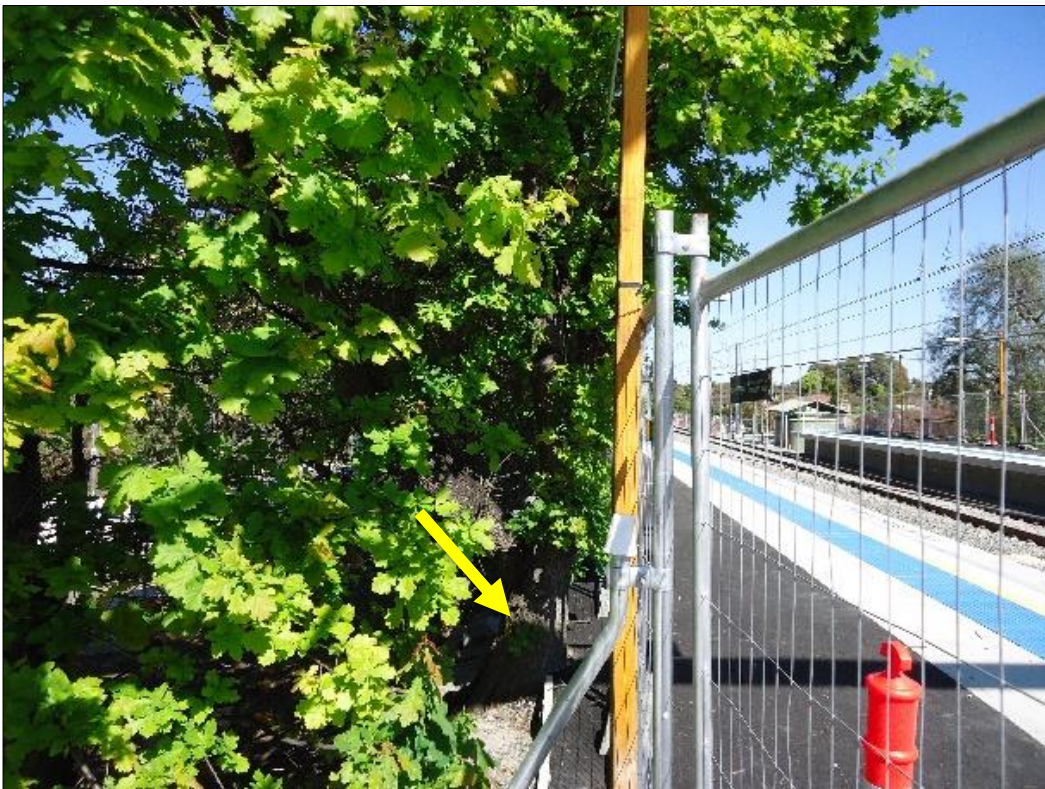
Photograph 2: The position of tree 711 with regards to the alignment of Platform 2 and proposed fence.

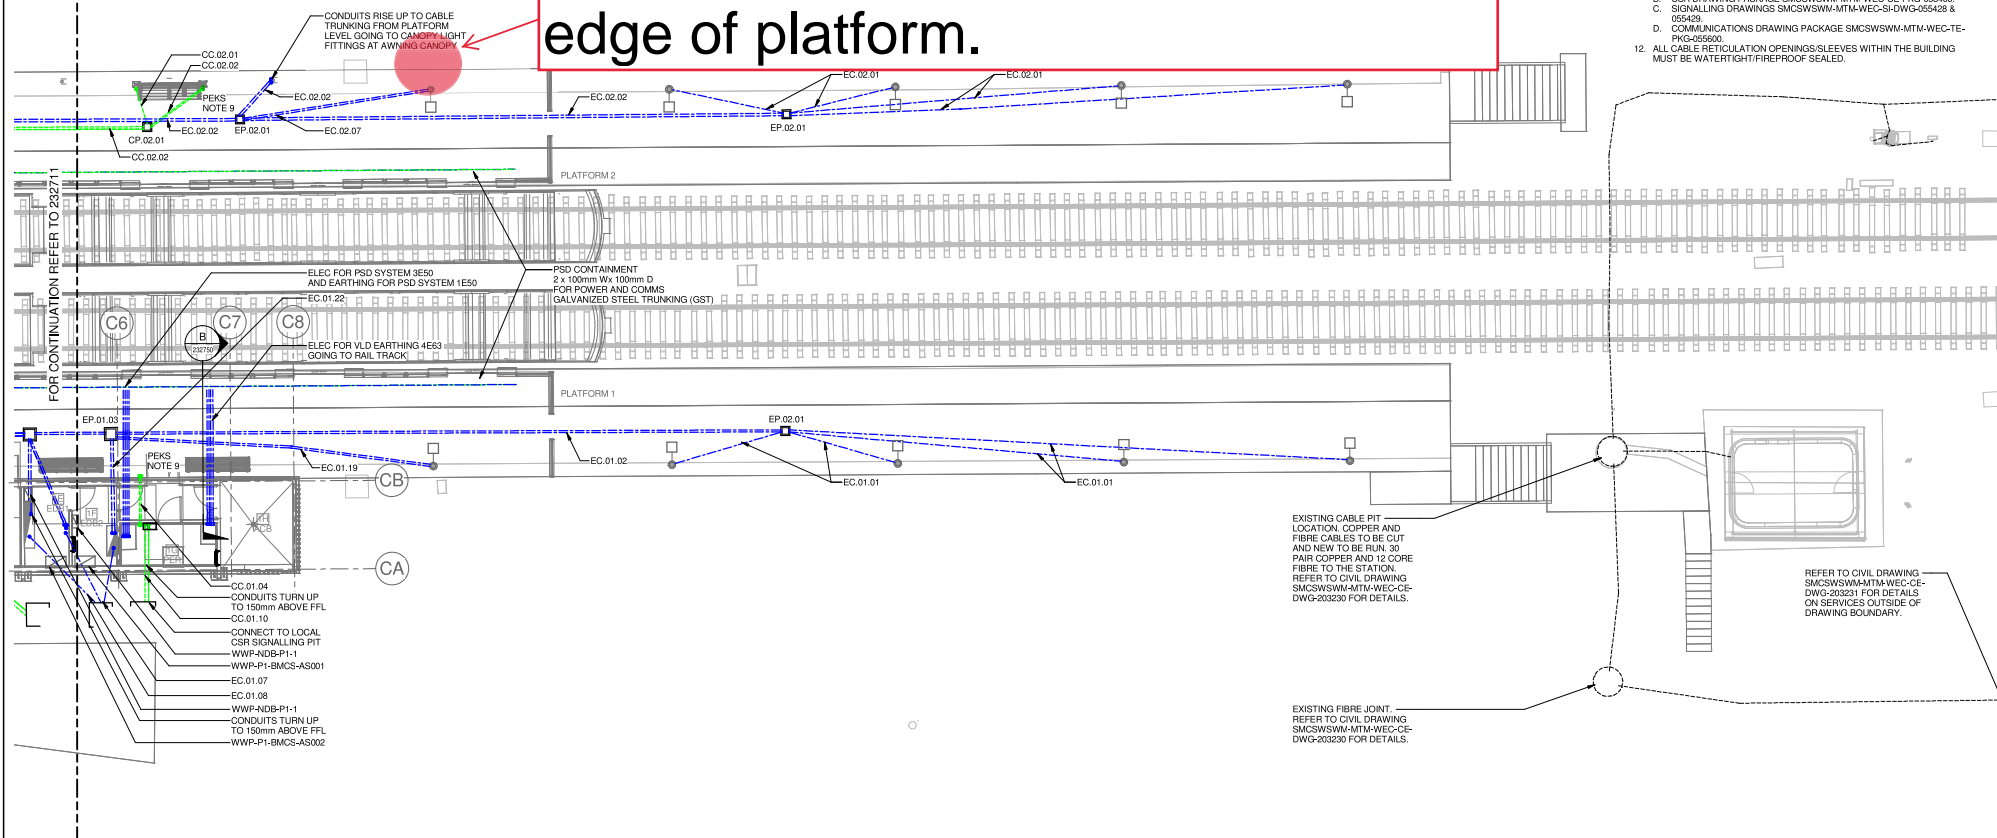
Tree 1 to be removed due to direct clash with permanent platform 2 footprint and security fencing along edge of platform.

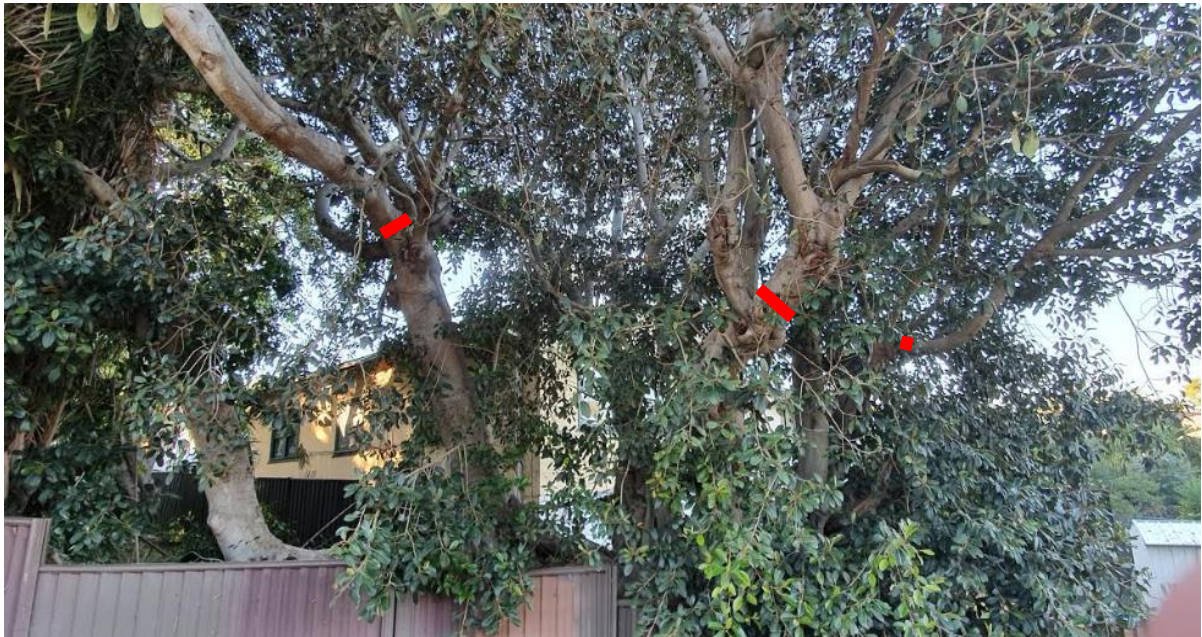
Figure 2: Cut locations of limbs to be pruned marked in red.

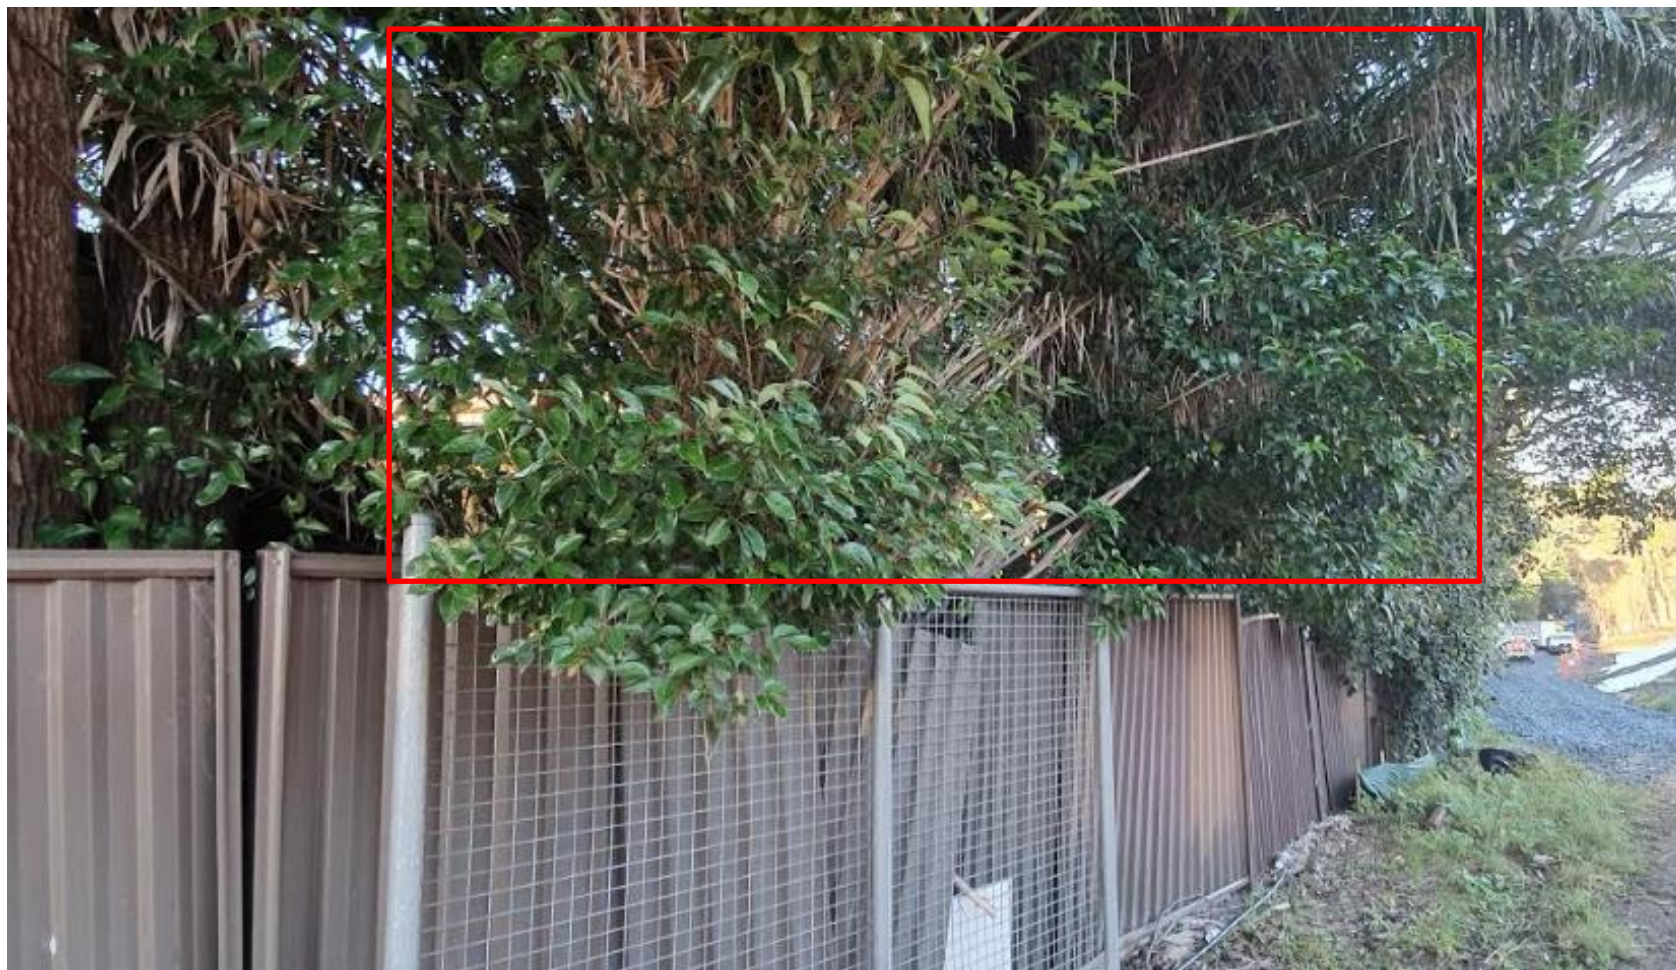
This area of foliage is minor regrowth from weed species and is requested to be pruned back to the fence line.

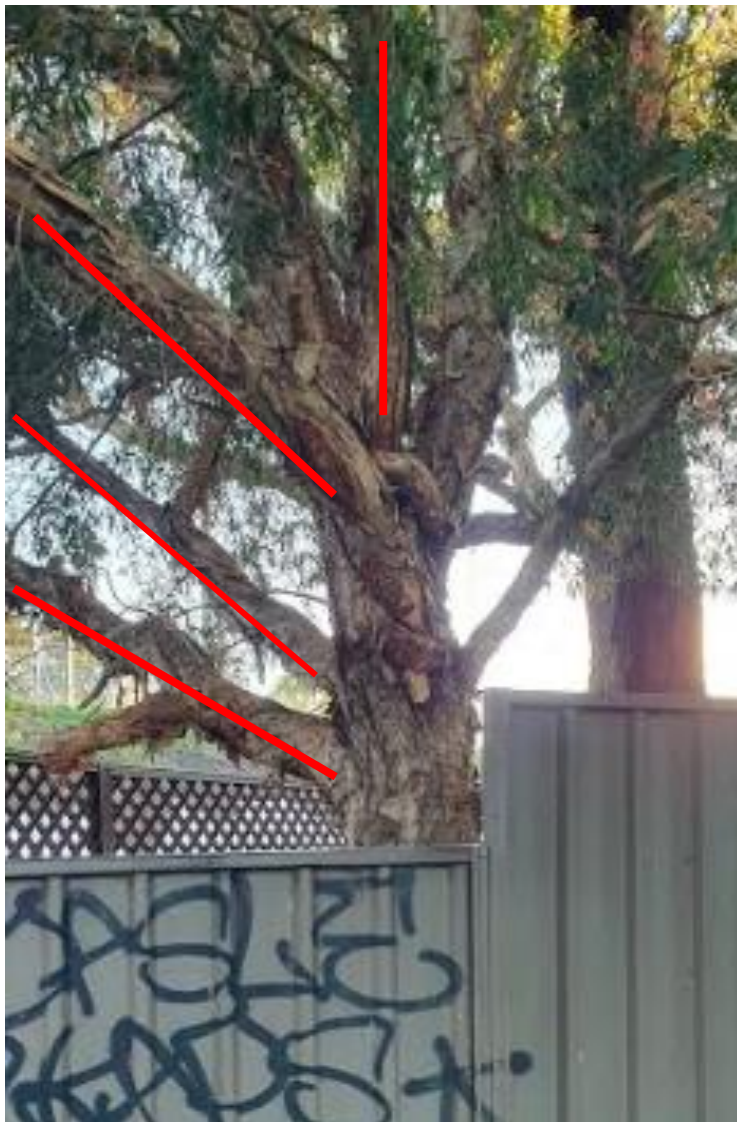
Figure 2:Limbs to be pruned marked in red.

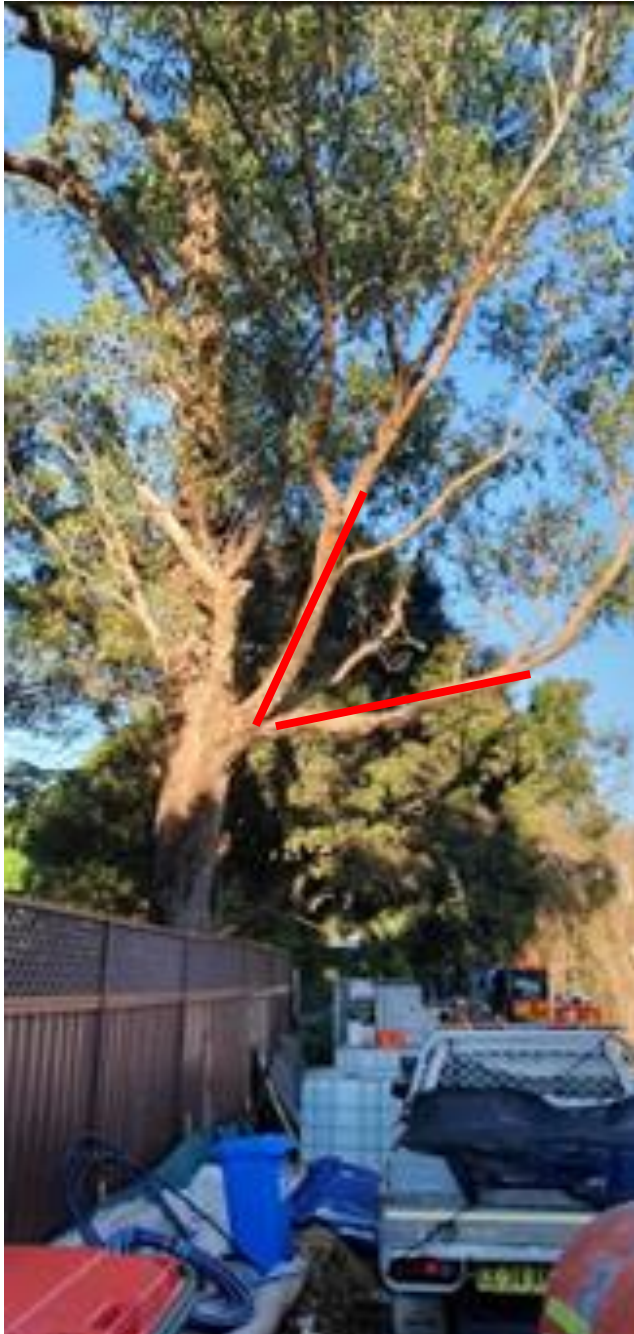
Figure 3: Limbs to be pruned marked in red.
