# Tree Impact Assessment Report

## City and Southwest Metro Station Upgrade Works Package 5 & 6

**P5 Document No. SMCSWSW5-DEW-WEC-EM-REP-000542**

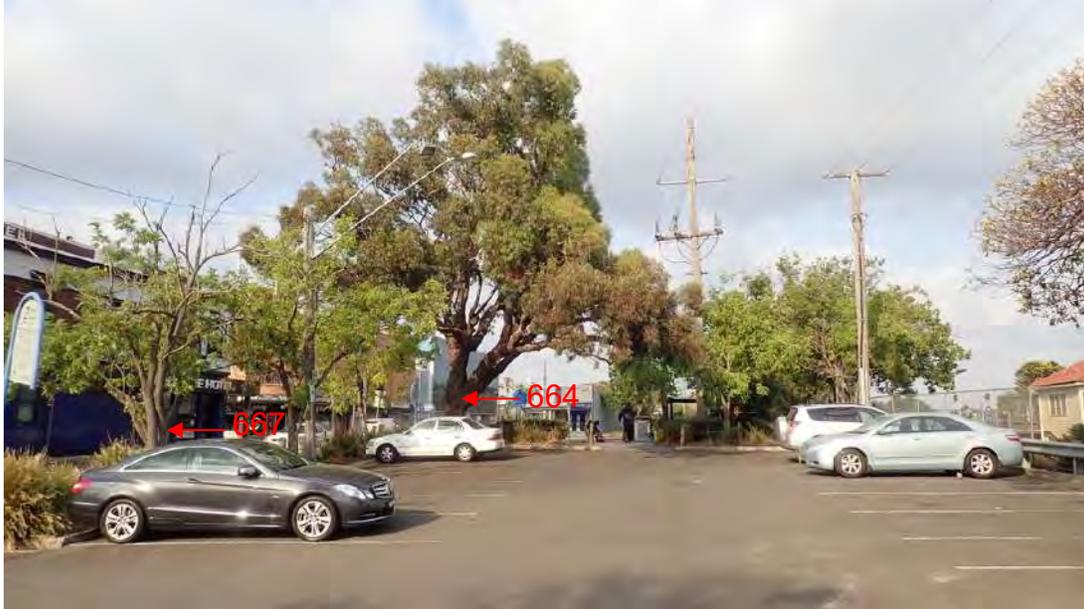
**Image 1:** Looking West towards tree 664 and 667. The proposed construction must be completed in accordance with section 9.2 to ensure tree 664 is not significantly impacted by the proposed works. Tree 667 is in poor health/advanced stages of decline and is recommended for removal due to its current condition and impacts from the proposed development.

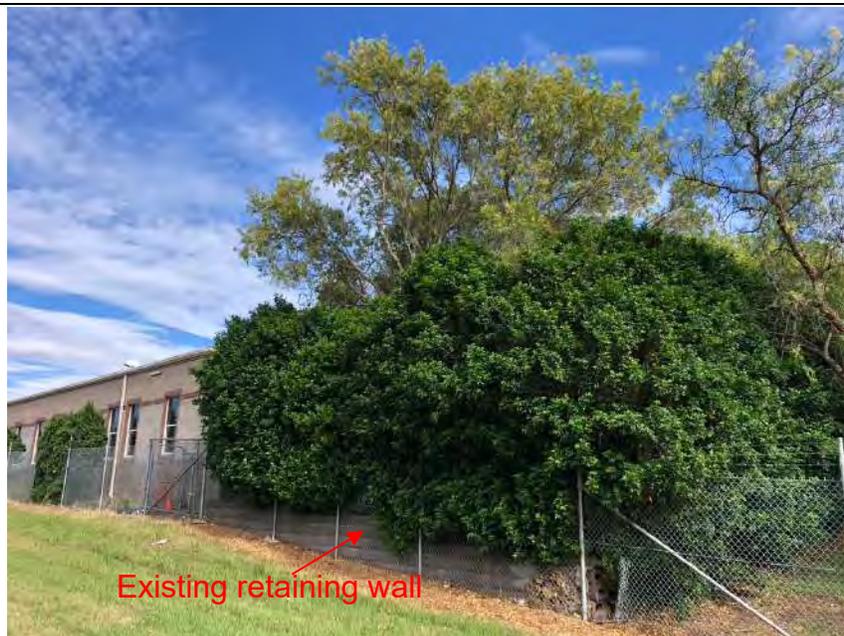
**Image 2:** Looking towards tree 3316, 3317, 3318, 3319 and 3320, showing the existing boundary retaining wall. The existing boundary retaining wall appears to be restricting root growth into the corridor, therefore, the proposed works within the corridor will not impact the trees. Minor canopy pruning may be required for tree 3316, 3317, 3319 and 3320. The proposed canopy pruning will result in the removal of less than 10% of the live foliage area of the trees and will not significantly impact the trees.

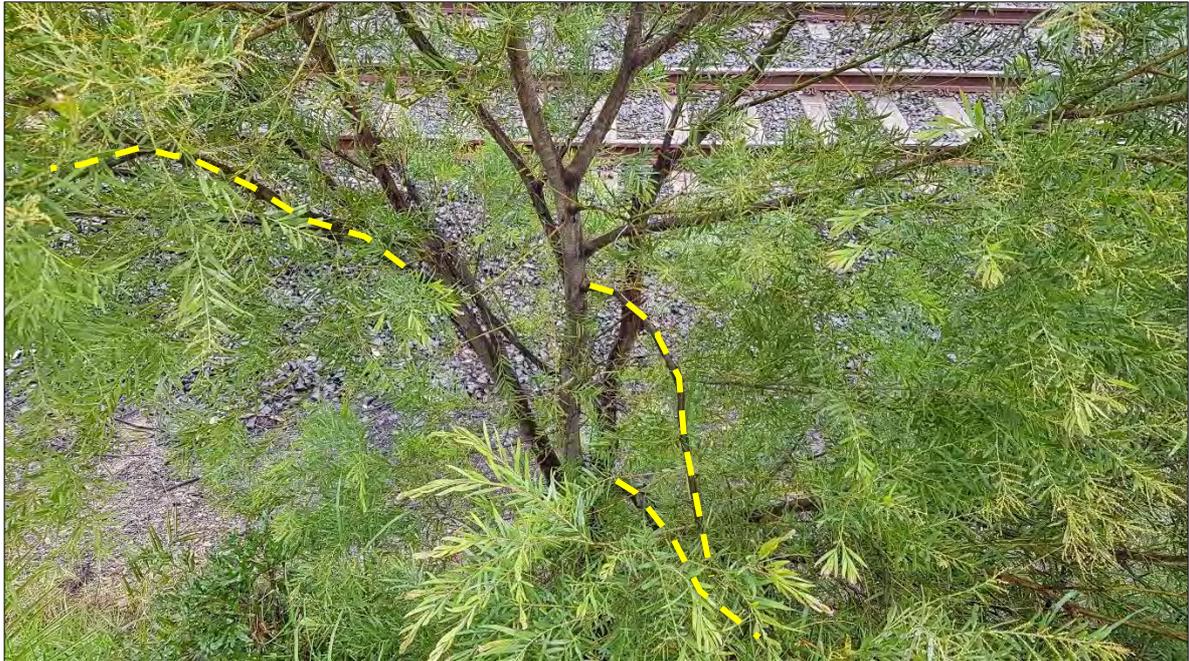
Tree 5 *Acacia* sp (Wattle) identified pruning involves the removal of approximately four branches up to 20mm in diameter and constitutes <10% of the total canopy volume. The pruning is not expected to have a significant impact upon the remaining stems.

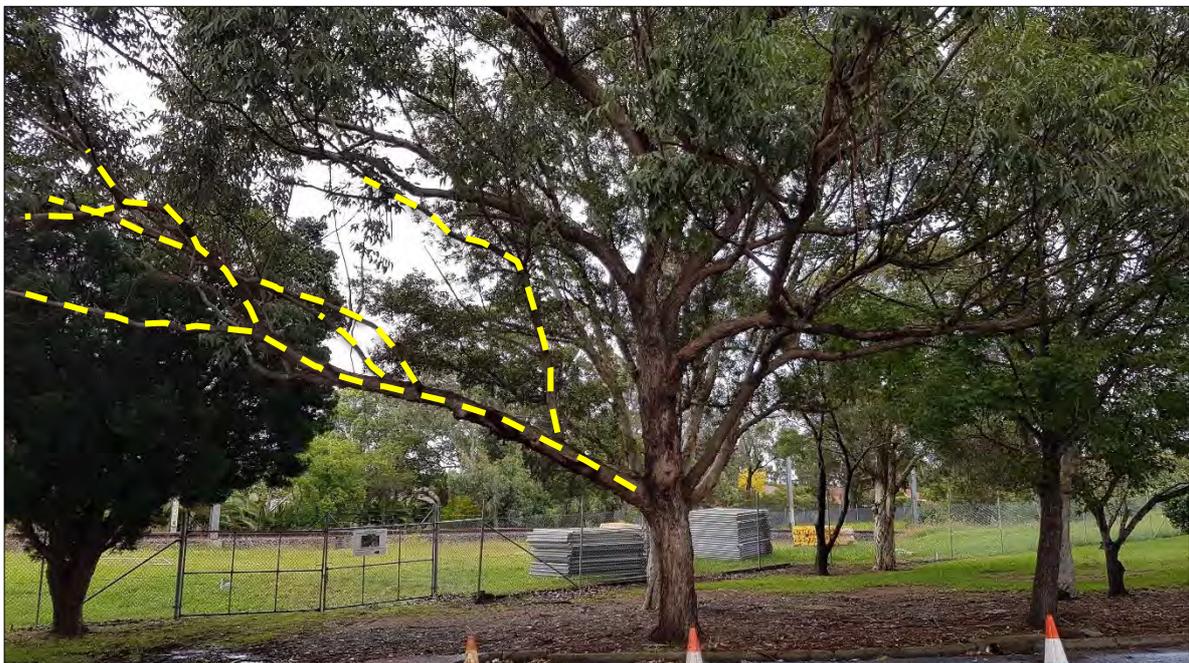
Tree 14 *Eucalyptus robusta* (Swamp Mahogany) identified pruning involves the removal of one first order branch at 2m height. The branch is approximately 300mm in diameter and constitutes 30% of the total canopy volume of the tree. A reduction in tree growth and physiological function can be expected as a result of the pruning works. Exposure of internal woody tissues at the site of the final pruning cut shall be susceptible to infection by decay causing fungi. The removal of the branch is not considered to significantly affect vocal amenity.

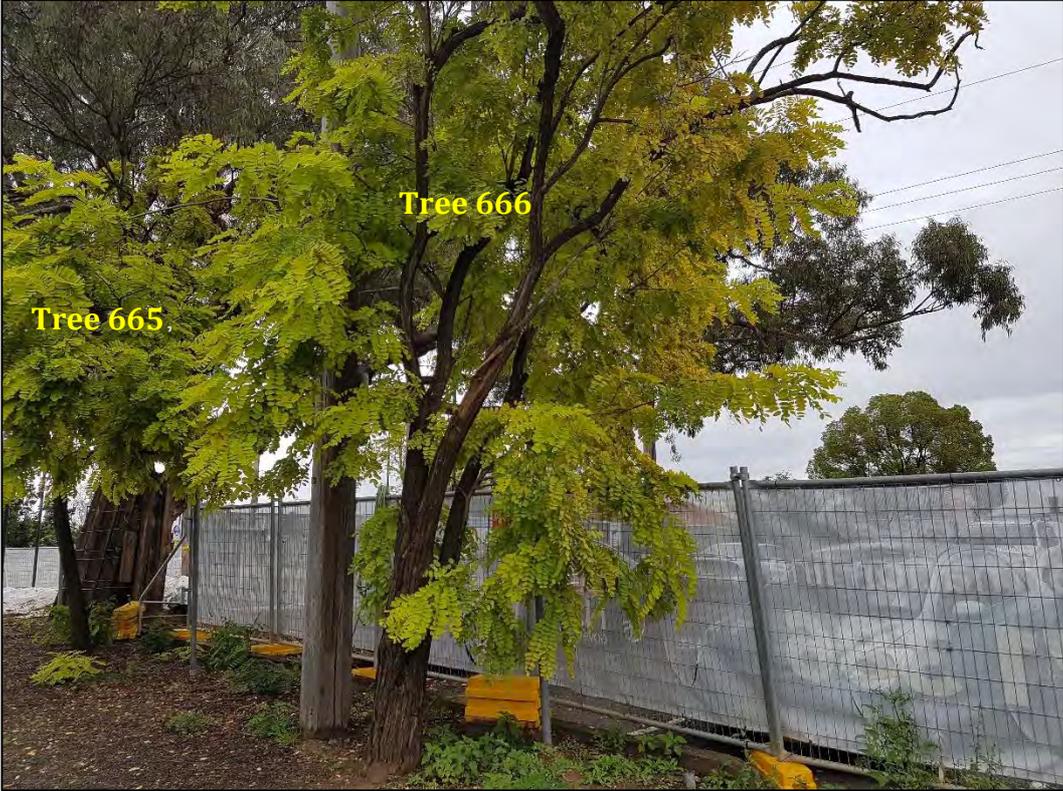
**Photograph 1:** Tree 665 and 666 as seen from within the site.

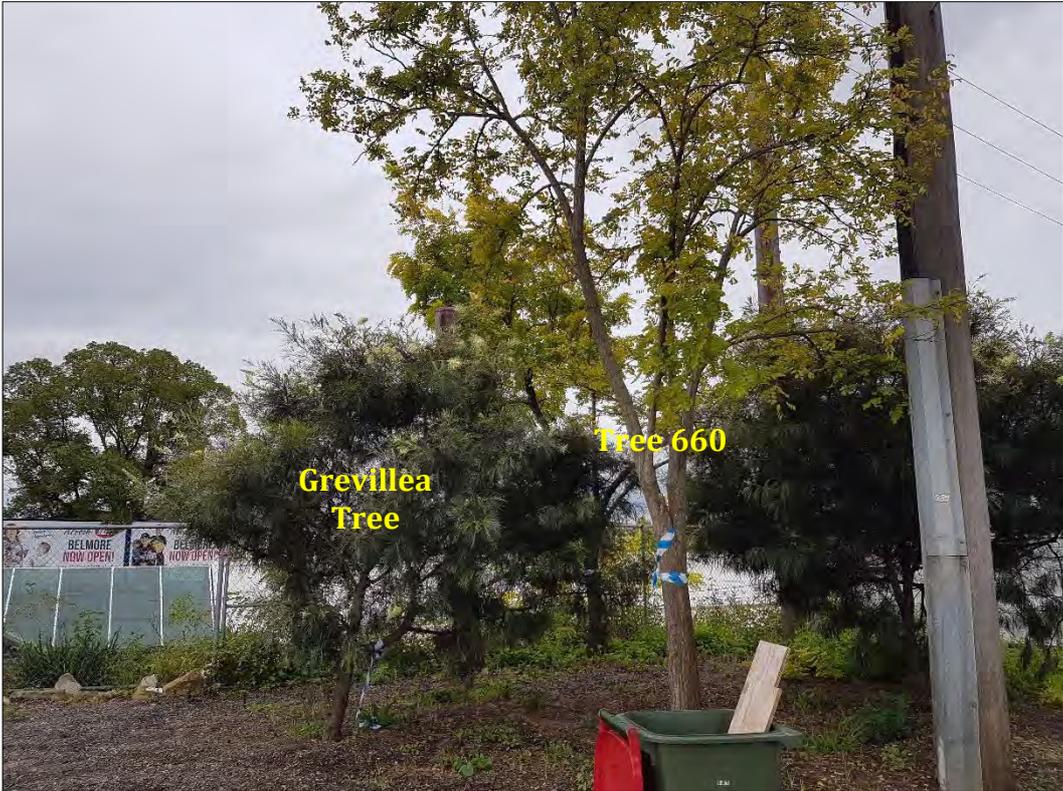
**Photograph 2:** Tree 660 and the Grevillea as seen from within the site.

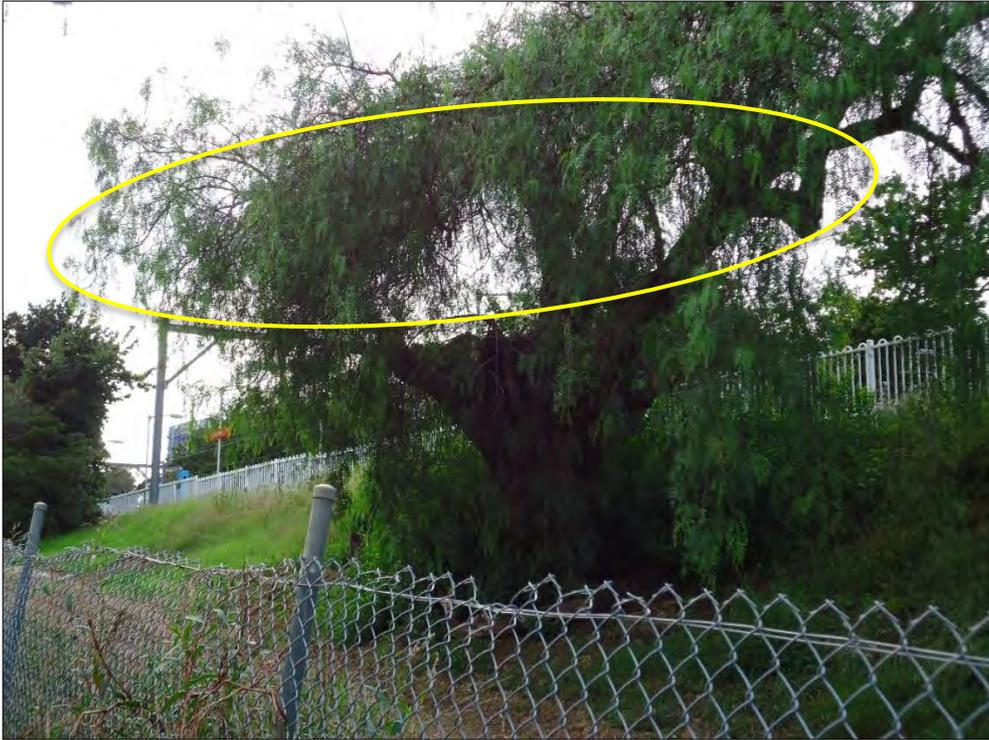
Pruning works were identified to be undertaken on tree 692 *Schinus molle* (Peppercorn Tree) to provide clearance along the rail corridor access track for plant and equipment. It is envisioned that pruning works shall involve the reduction and removal of selected branches up to 100mm in diameter and constitute approximately 25-30% of the total live canopy volume of the tree. Based upon the current health and condition of the tree these pruning works are considered to be significant and shall likely result in a reduction of tree growth and physiological function. All pruning works are to be undertaken by suitably qualified tree workers and meet the requirements of *AS4373-2007 Pruning of Amenity Trees*. Image 2 shows the tree and branches that overhang the access road.

**Image 2:** Yellow outline indicates branches from Tree 692, *Schinus molle* (Peppercorn Tree), that shall require selective removal to provide clearances along the rail corridor access track.

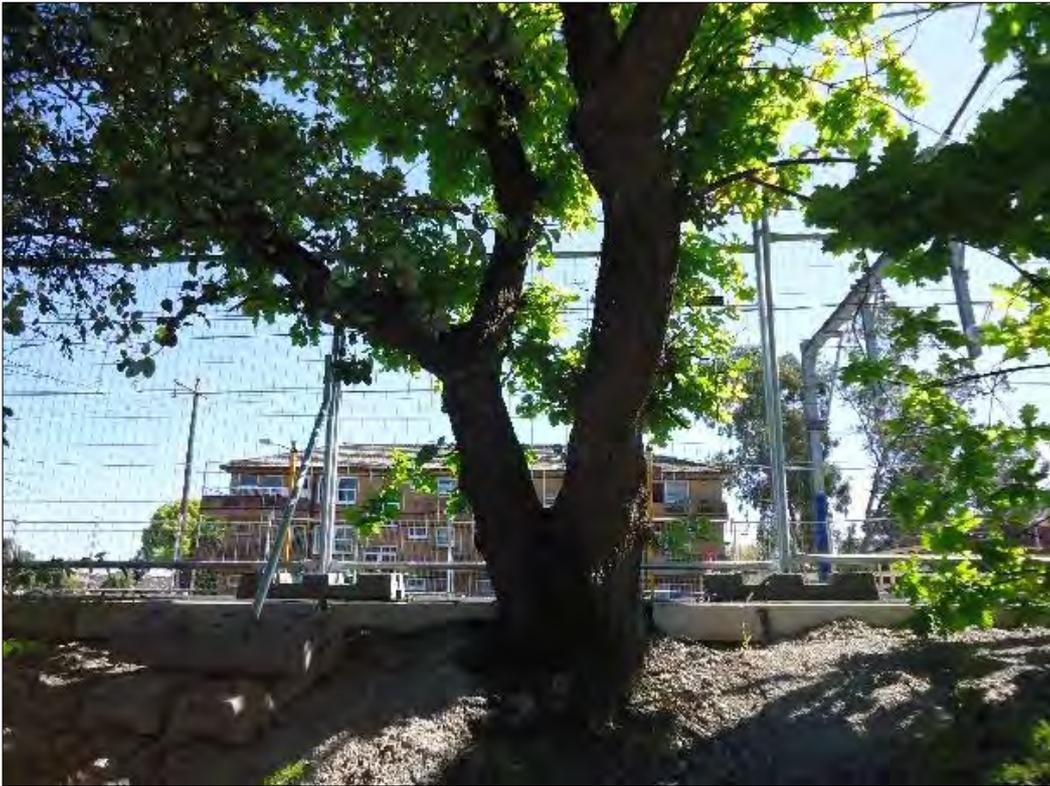
**Photograph 1:** Tree 711 *Quercus robur* (Common Oak).

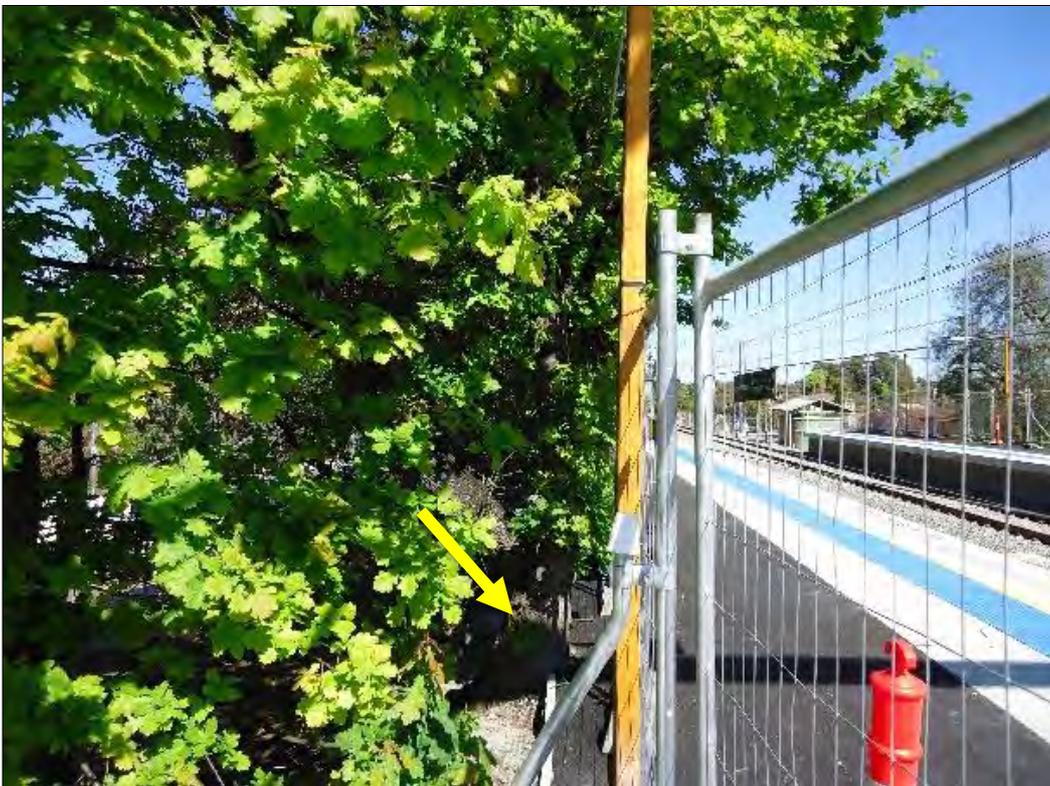
**Photograph 2:** The position of tree 711 with regards to the alignment of Platform 2 and proposed fence.

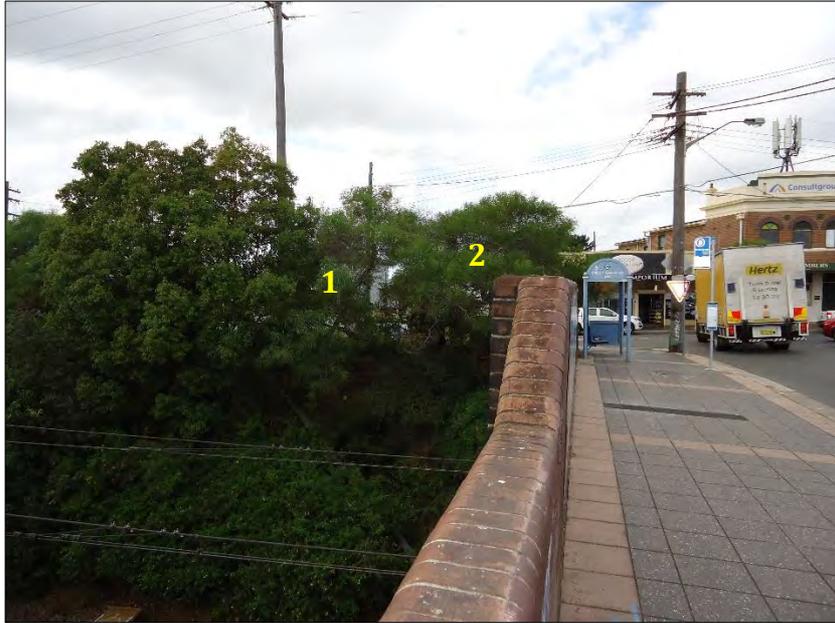
**Image 2:** Trees 1 and 2, Wattles require removal to accommodate soil pinning works adjacent the bridge.

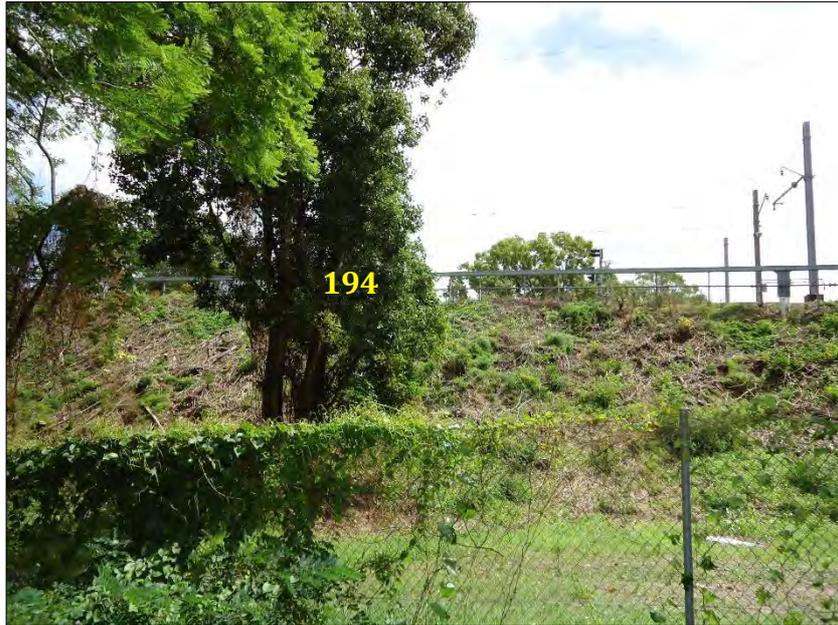
**Image 4:** Tree 194 as identified within the AIA report shall require removal to accommodate the relocation of the concrete pad. Note the rail embankment to the rear of the tree has been cleared of woody vegetation.

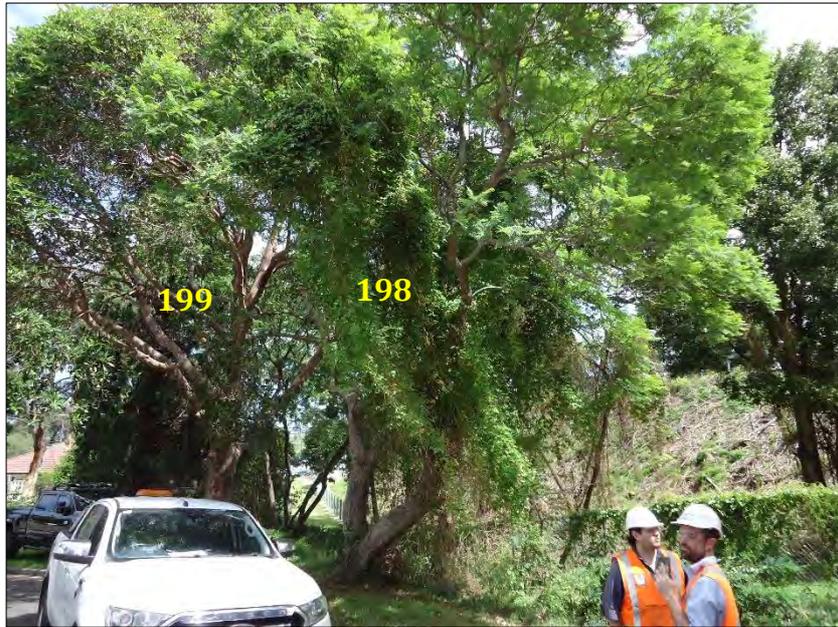
**Image 5:** Trees 198 and 199 as identified within the AIA report shall require removal for the Metro Services Building access road.

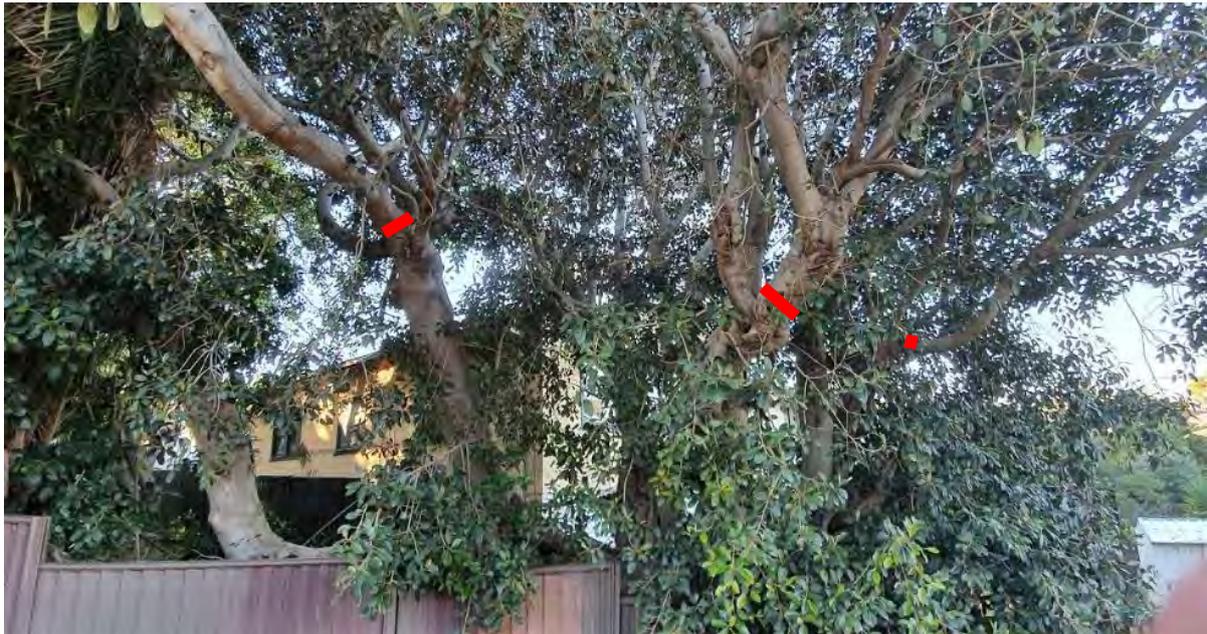
Figure 2: Cut locations of limbs to be pruned marked in red.

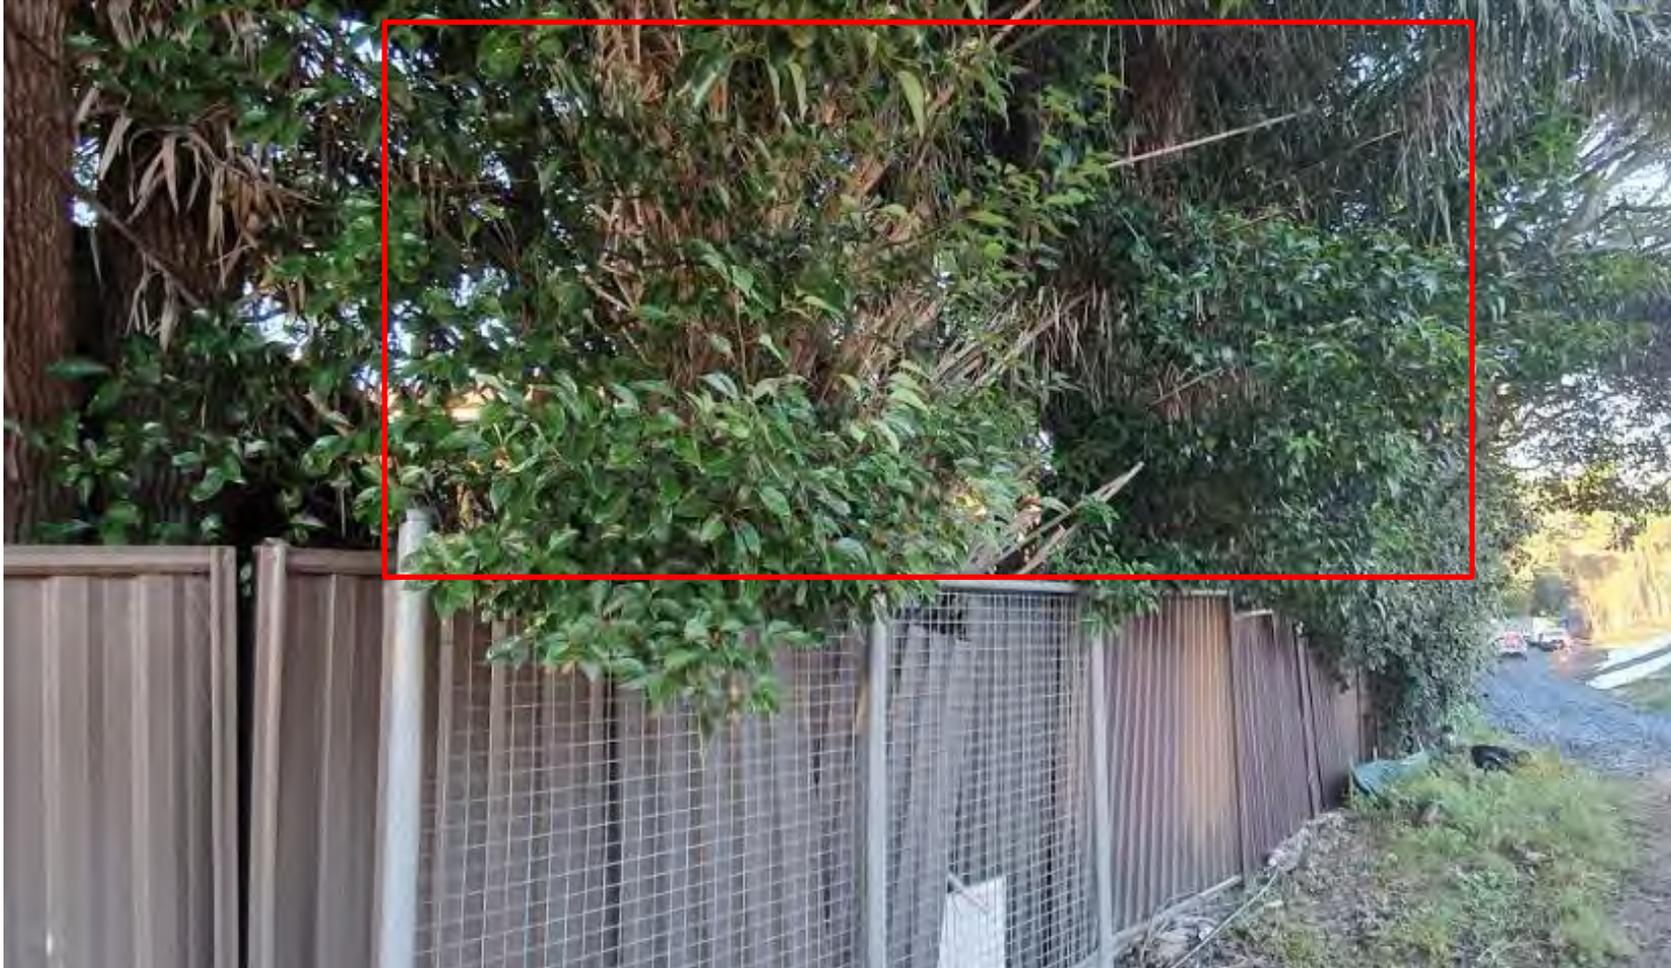
This area of foliage is minor regrowth from weed species and is requested to be pruned back to the fence line.

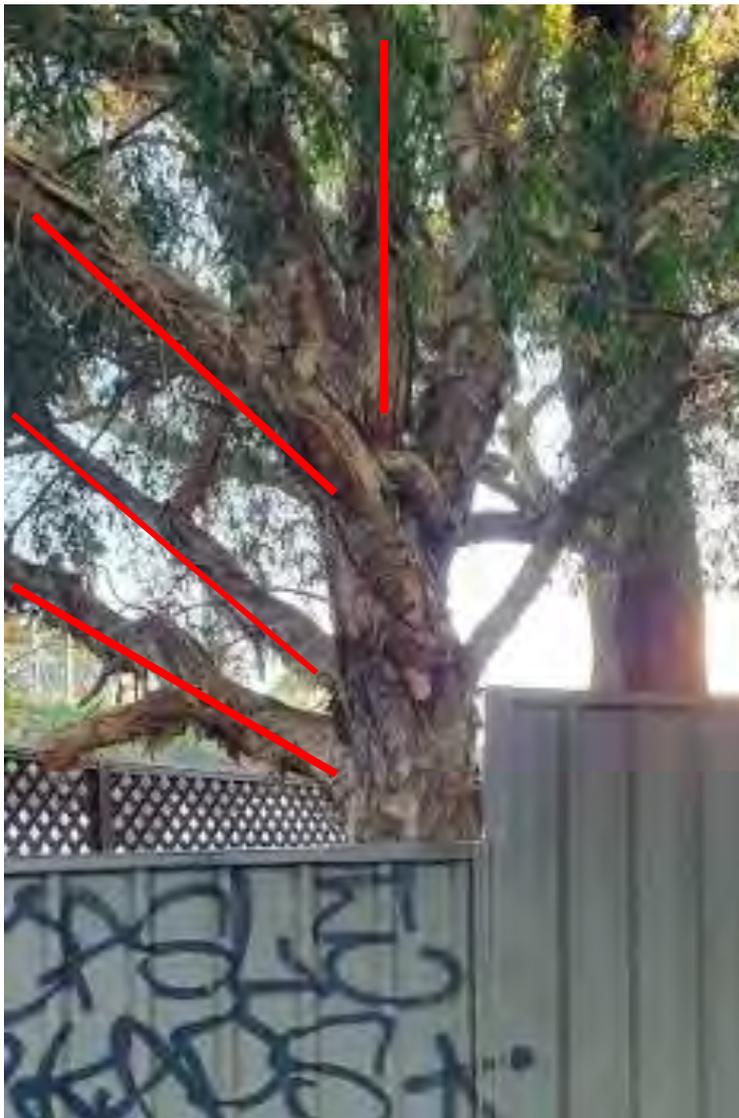
Figure 2:Limbs to be pruned marked in red.

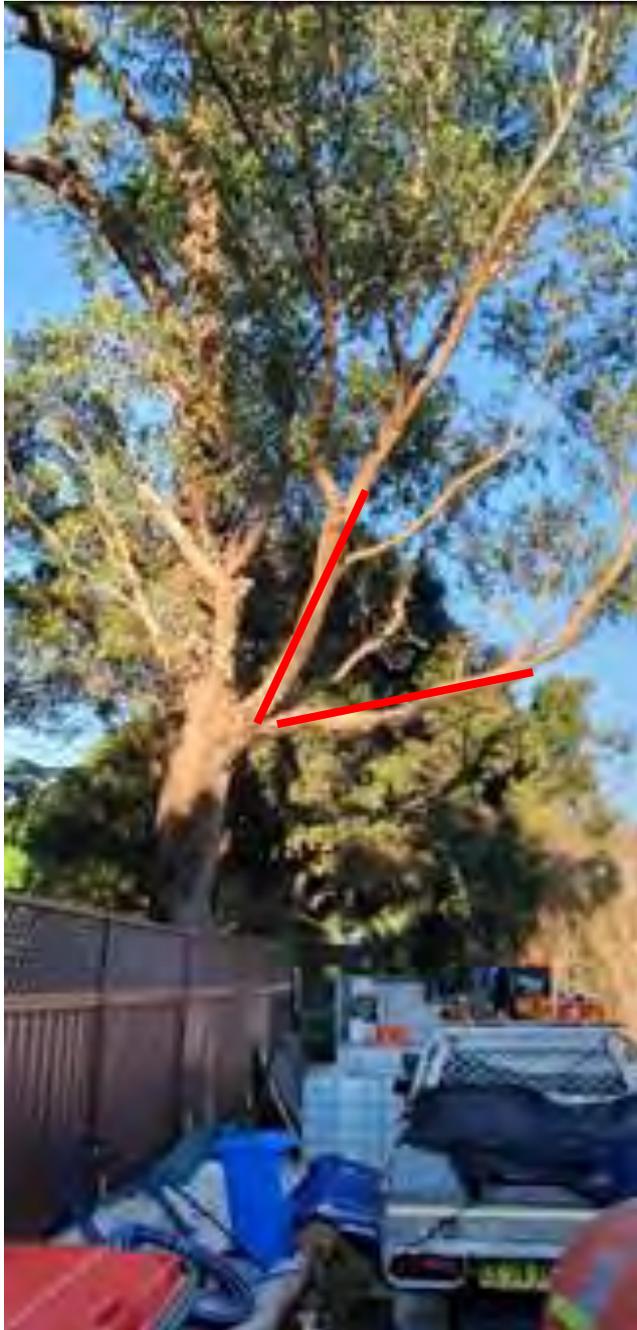
Figure 3: Limbs to be pruned marked in red.

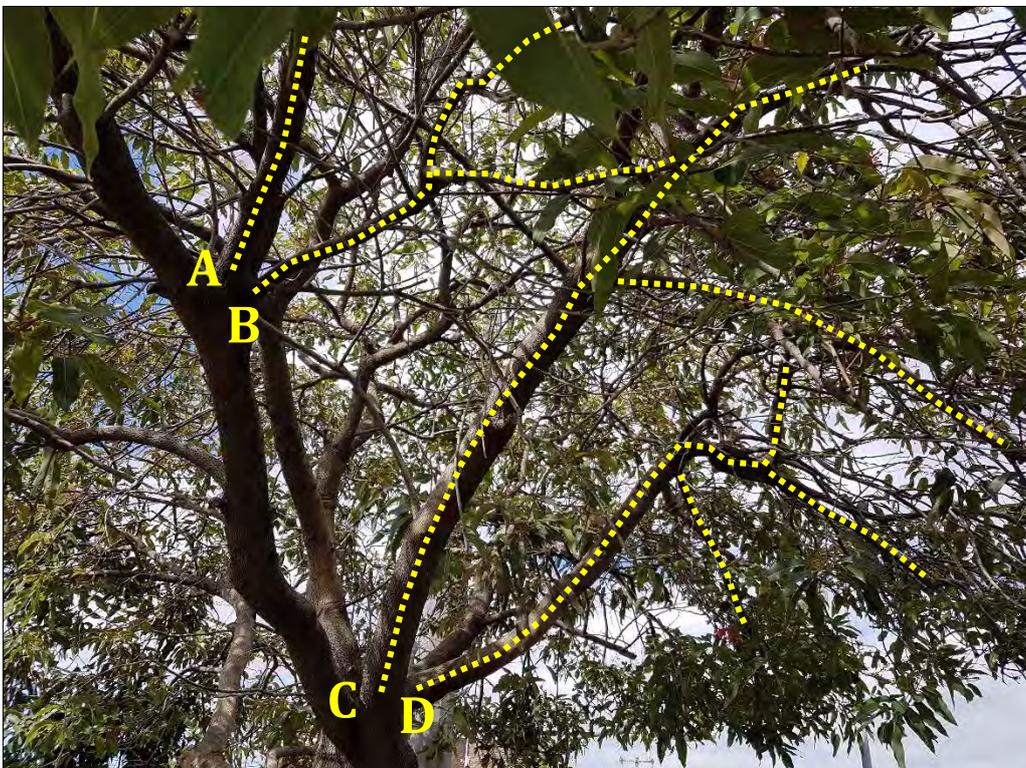
**Photograph 3:** Branches identified for removal from tree 591 to provide clearance for the proposed concourse roof structure. Branch A is 40mm in diameter at 2.7m height, branch B is 20mm in diameter at 2.7m height, branch C is 120mm in diameter at 2.1m height, branch D is 120mm in diameter at 2.2m height. The removal of identified branches constitutes approximately 35% of the total live canopy volume of the tree.
