CONSTRUCTION MONITORING REPORT

NOVEMBER 2021 TO APRIL 2022

Sydney Metro City & Southwest

Package 5 & 6

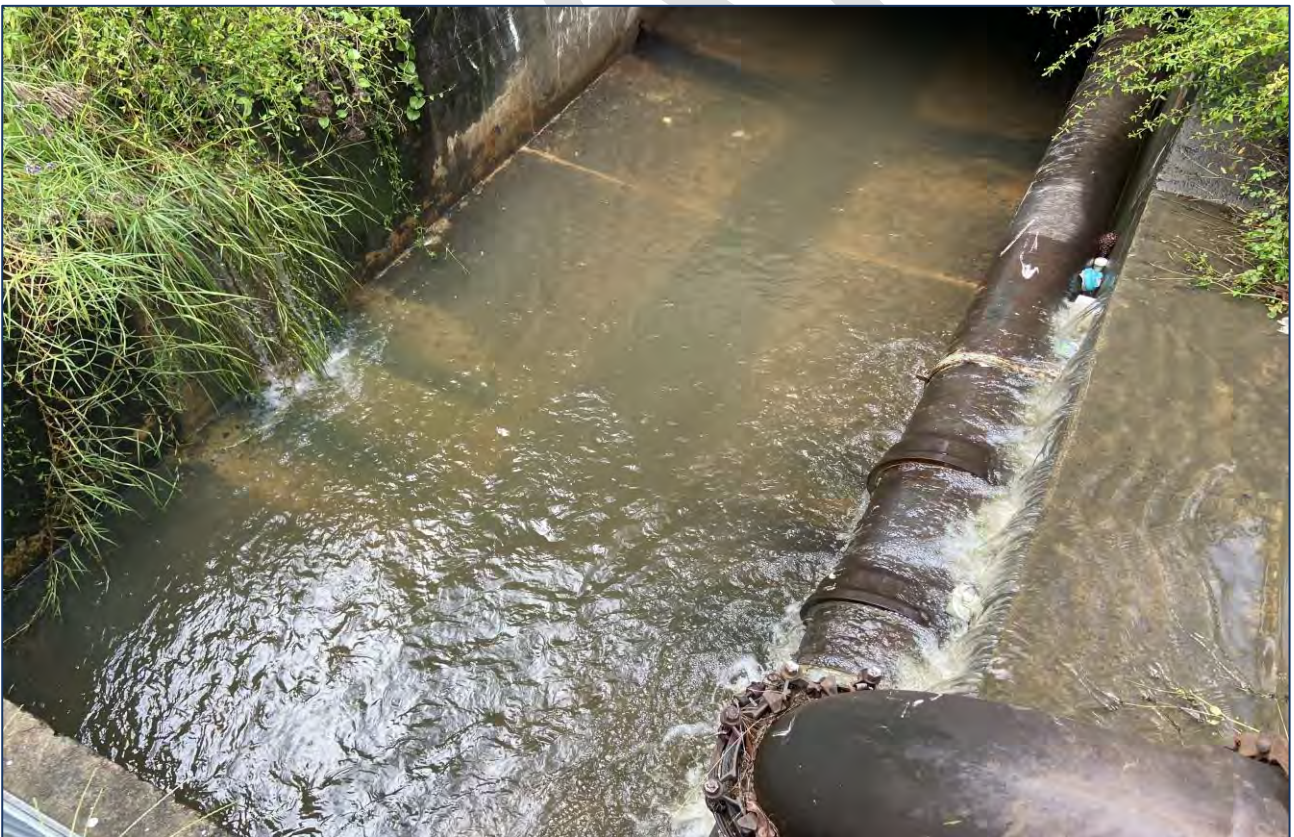
flow contribution from both discharge points were observed at the time of sampling. It is noted that WP2-DP2 was observed to have greater flow contribution than WP2-DP1.

Photograph 4. High stormwater in-flow observed from both discharge points WP2-DP1 and WP2-DP2 which were located within the rail corridor and immediately upstream/south from WP2. Date: 23 February 2022.

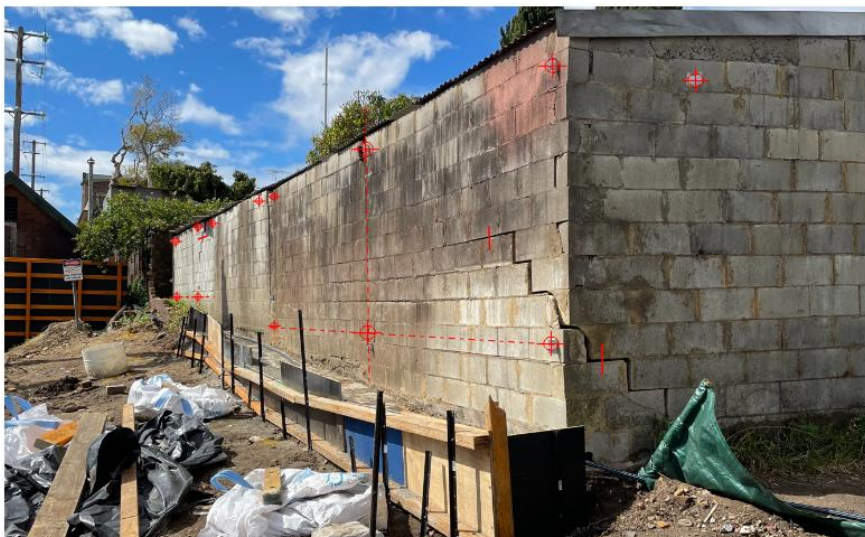
- Visually monitor the condition of the garage wall during construction activities on a daily basis
- Inspect and record results of the survey and crack gauge position on a daily basis during rock breaking activities otherwise weekly
- Should any vertical or translation movement exceed 3mm refer to Lindsay Dynan for review
- Should any crack width increase by 1mm or greater refer to Lindsay Dynan for review (Note: 1mm limit is based on a Very Slight damage category in accordance with AS 2870. Refer appendix A for further details)

— Denotes location and orientation for crack gauge (pack out and bond to blockwork) (3 locations)
