CONSTRUCTION MONITORING REPORT
APRIL 2022 TO November 2022
Sydney Metro City & Southwest
Package 5 & 6
Customer: Sydney Metro

Project Document Code	Latest Version Number	Latest Version Date
Package 5 - SMCSWSW5-DEW-WEC-EM-REP-001600	Rev B	25/11/2022
Package 6 - SMCSWSW6-DEW-WEC-EM-REP-001499

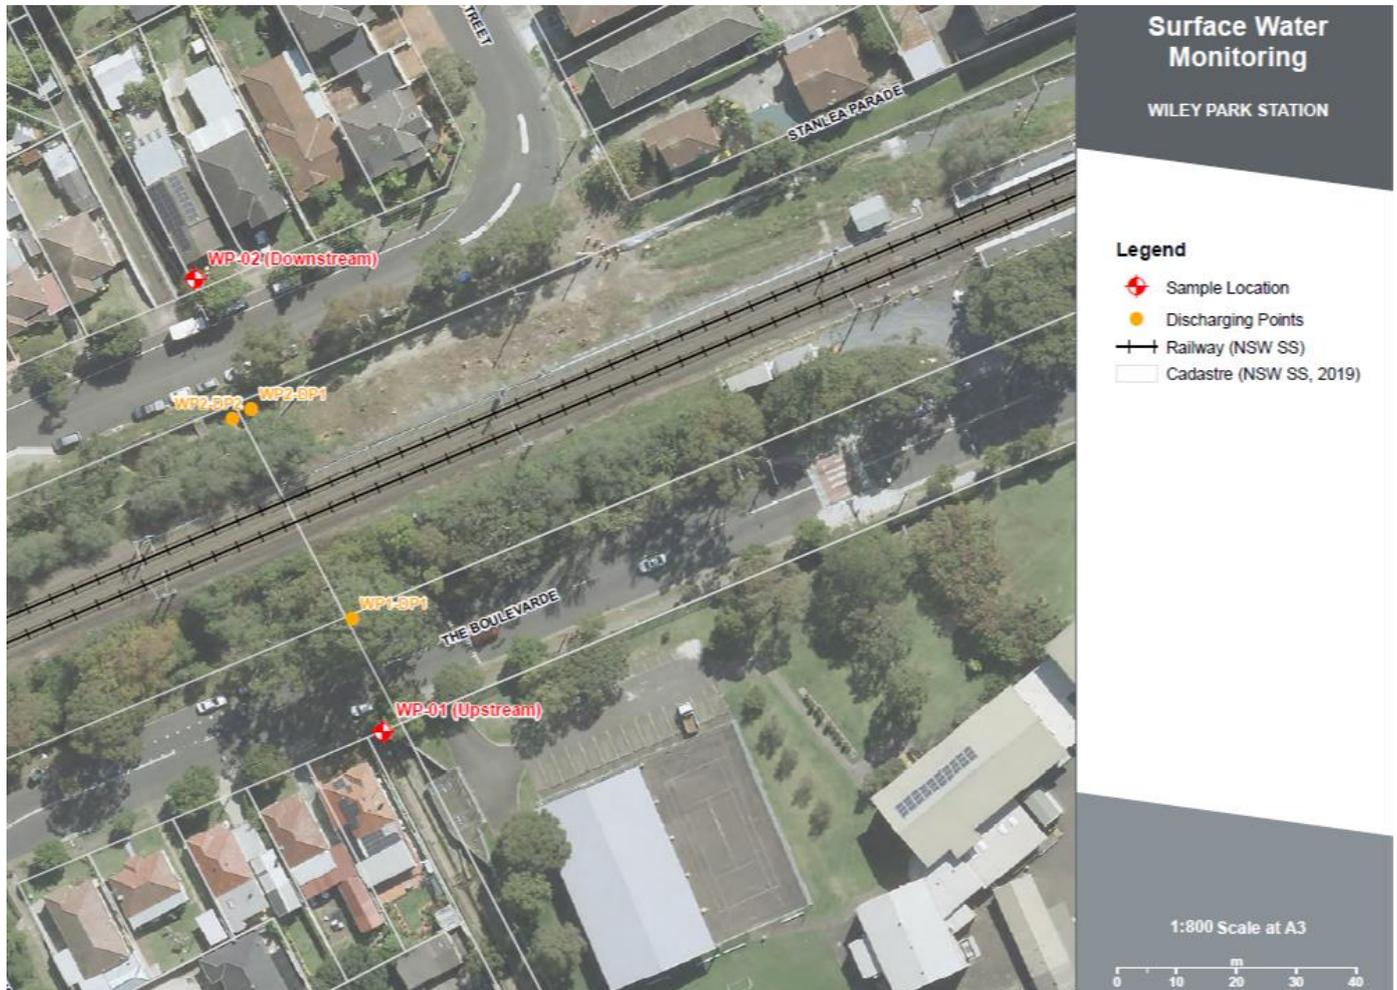
Figure 1: WP1 and WP2 location map. Please note that only WP1-DP1 and WP2-DP1 are Downer's discharge points.

At the time of sampling, WP2-DP2 (downstream western discharge point) was dry, not contributing to the water body and one discharge point (WP1-DP1) was observed immediately downstream / north of WP1 (upstream of work area) with low flow contribution. Refer to **Figure 1** for approximate location of WP1-DP1.

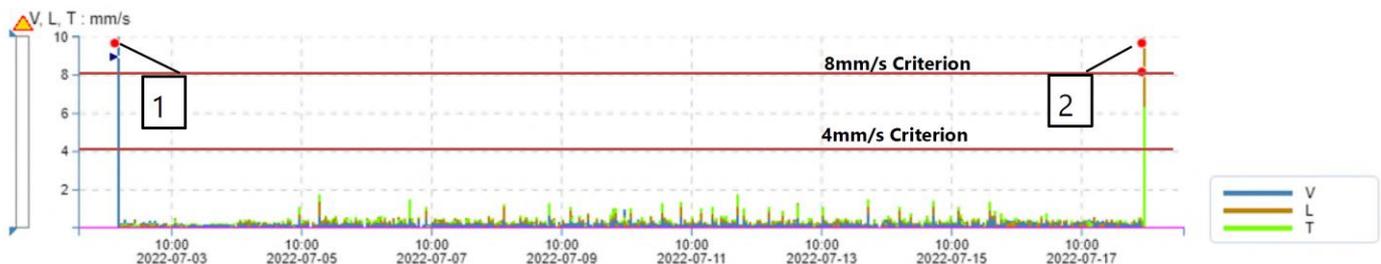
Figure 3 – Unattended vibration monitoring results for 3A Commons Street between 02/07/2022 and 18/07/2022

In accordance with the Hurlstone Park Station Vibration Monitoring Plan, the vibration levels produced from the vibration intensive works in the vicinity of the affected garage structure were below 4 mm/s as shown in Figure 3. Note that there were two events that resulted in an instantaneous vibration level of above 4 mm/s, however this event was not caused by the nearby construction activities, as justified in table below.

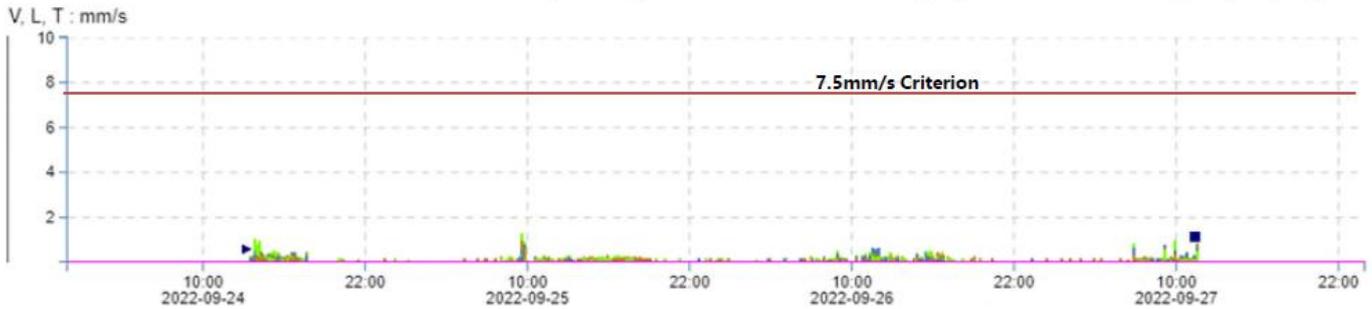
Figure 9 – Unattended vibration monitoring at Punchbowl Station between 24/09/2022 and 27/09/2022

As shown in Figure 9, the vibration levels produced from the vibration intensive works in the proximity of the station lift at Punchbowl Station are below 7.5mm/s.

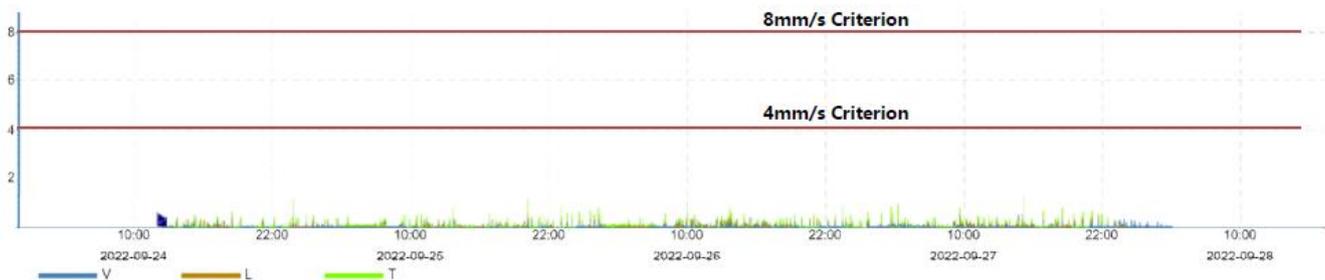
Figure 10 – Unattended vibration monitoring at 3A Commons Street, Hurlstone Park between 24/09/2022 and 27/09/2022.

As shown in Figure 10, the vibration levels produced from the vibration intensive works nearby the garage structure at 3A Commons Street are below 4mm/s.

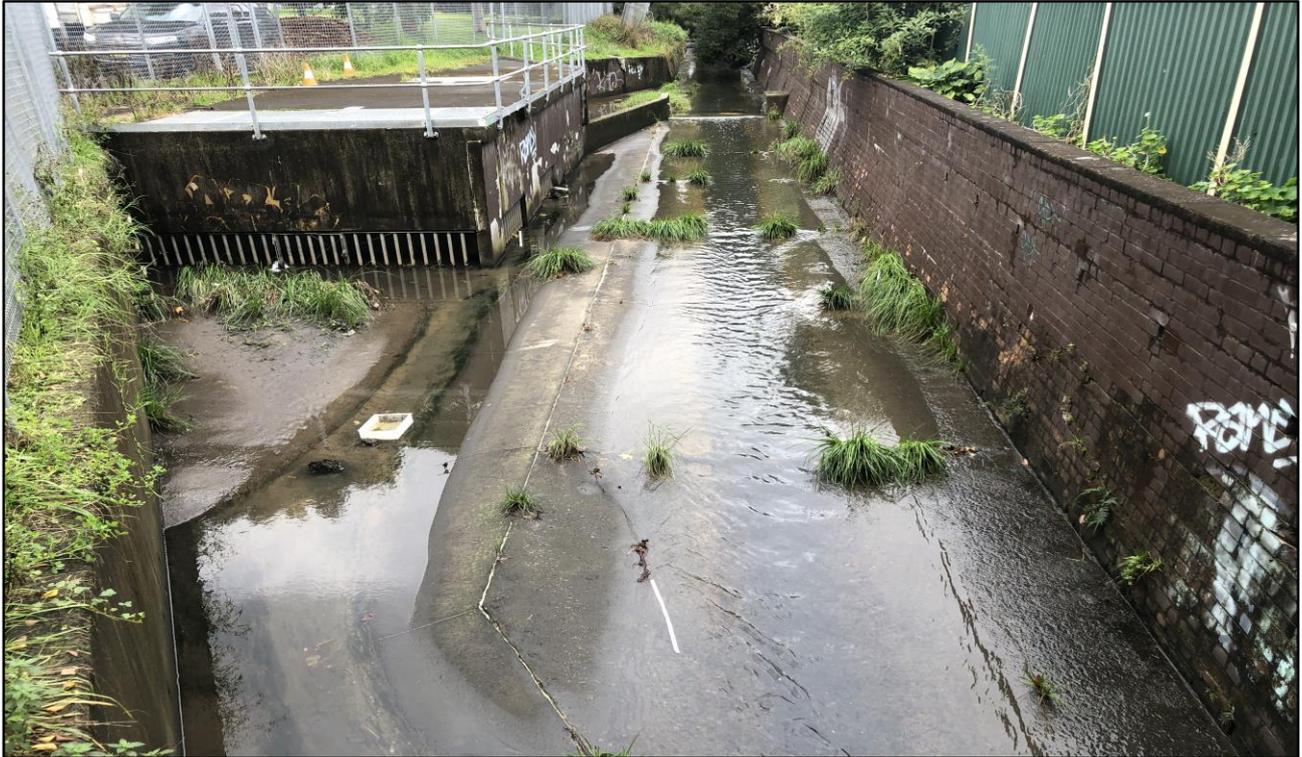
Photograph 1. Upstream sampling location WP1. Date: 24 May 2022.

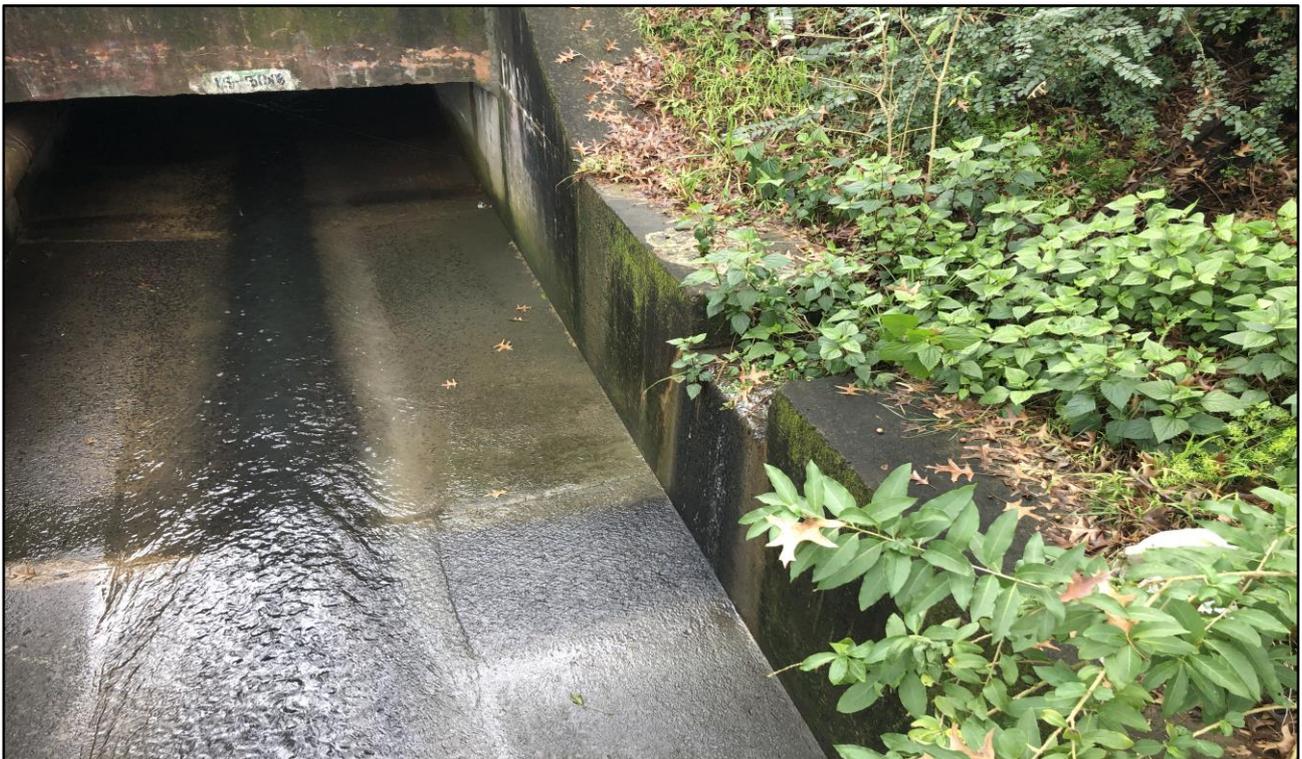
Photograph 2. Low stormwater in-flow observed from the discharge point WP1-DP1 which was located within the rail corridor and immediately downstream/north from WP1. Date: 24 May 2022.

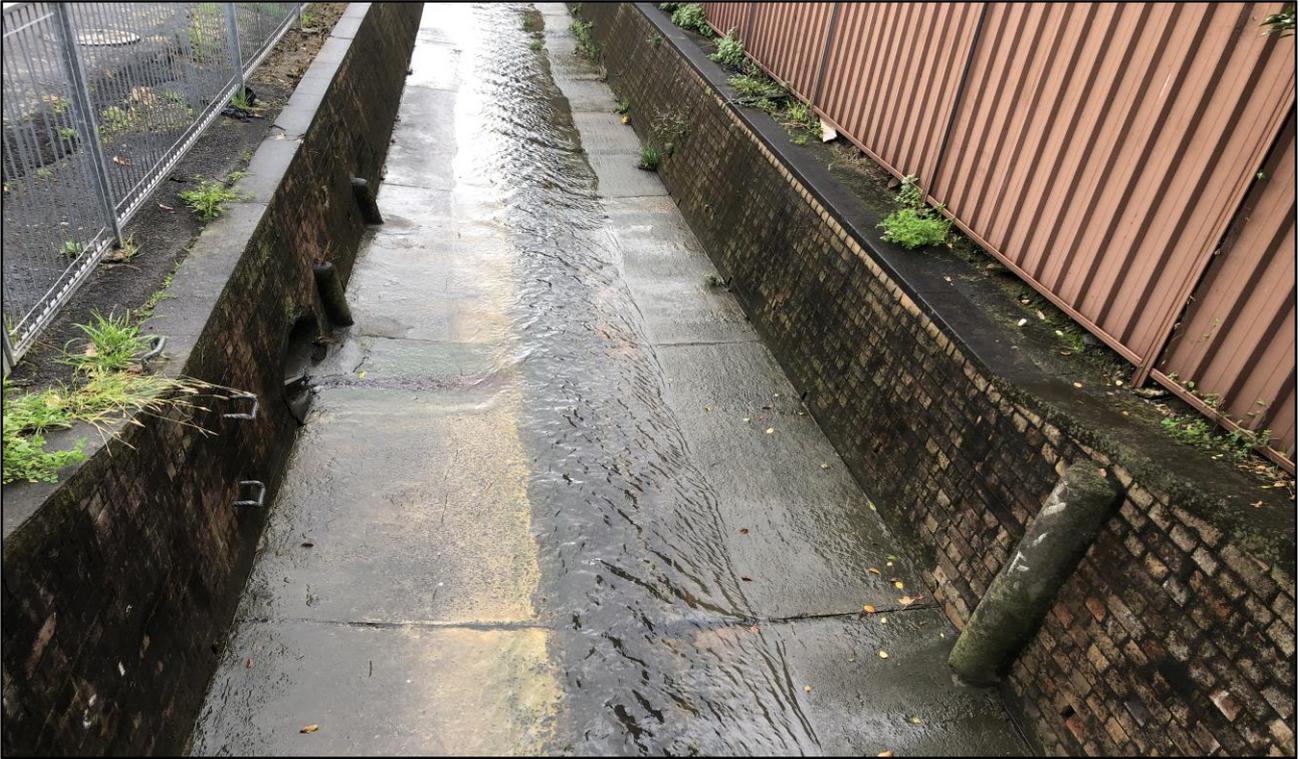
Photograph 3. Downstream sampling location WP2. Date: 24 May 2022.

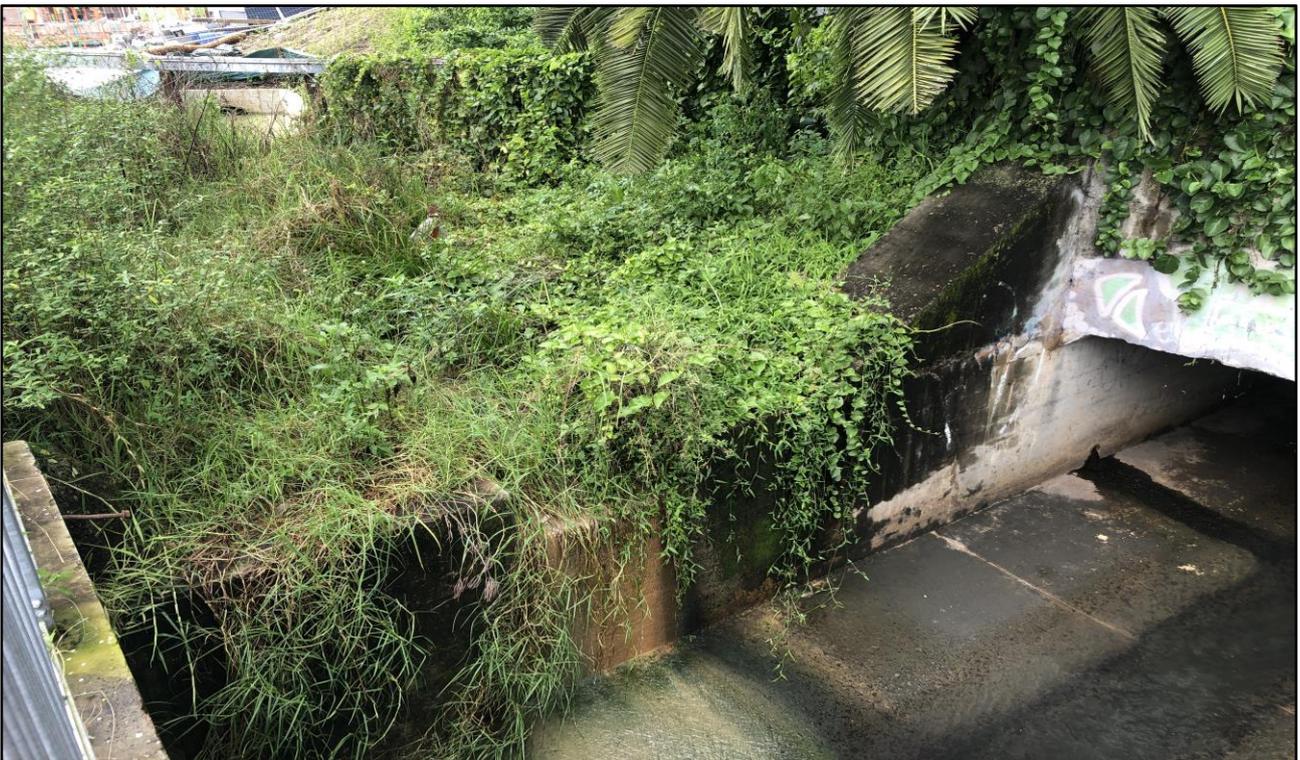
Photograph 4. Low level of flow contribution was observed from downstream eastern discharge point WP2-DP1. Date: 24 May 2022.

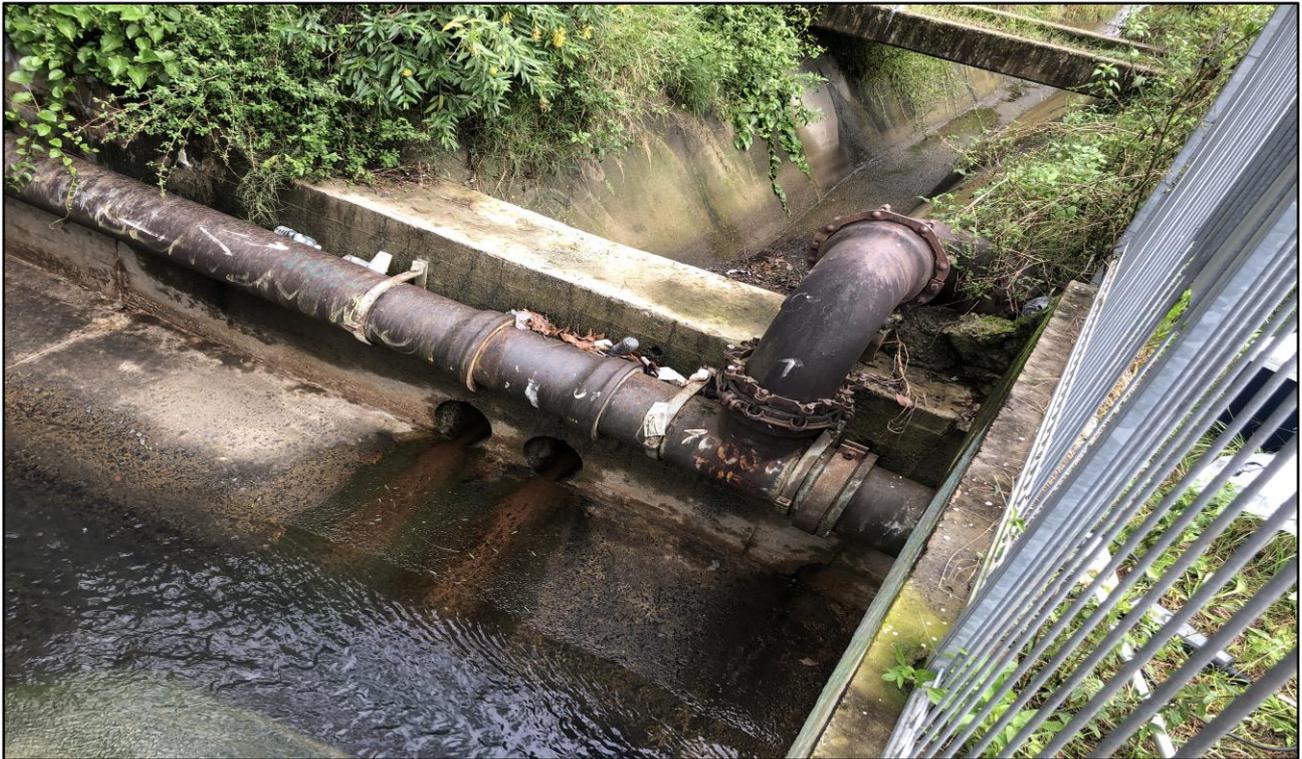
Photograph 5. No flow contribution was observed from downstream western discharge point WP2-DP2. Date: 24 May 2022.

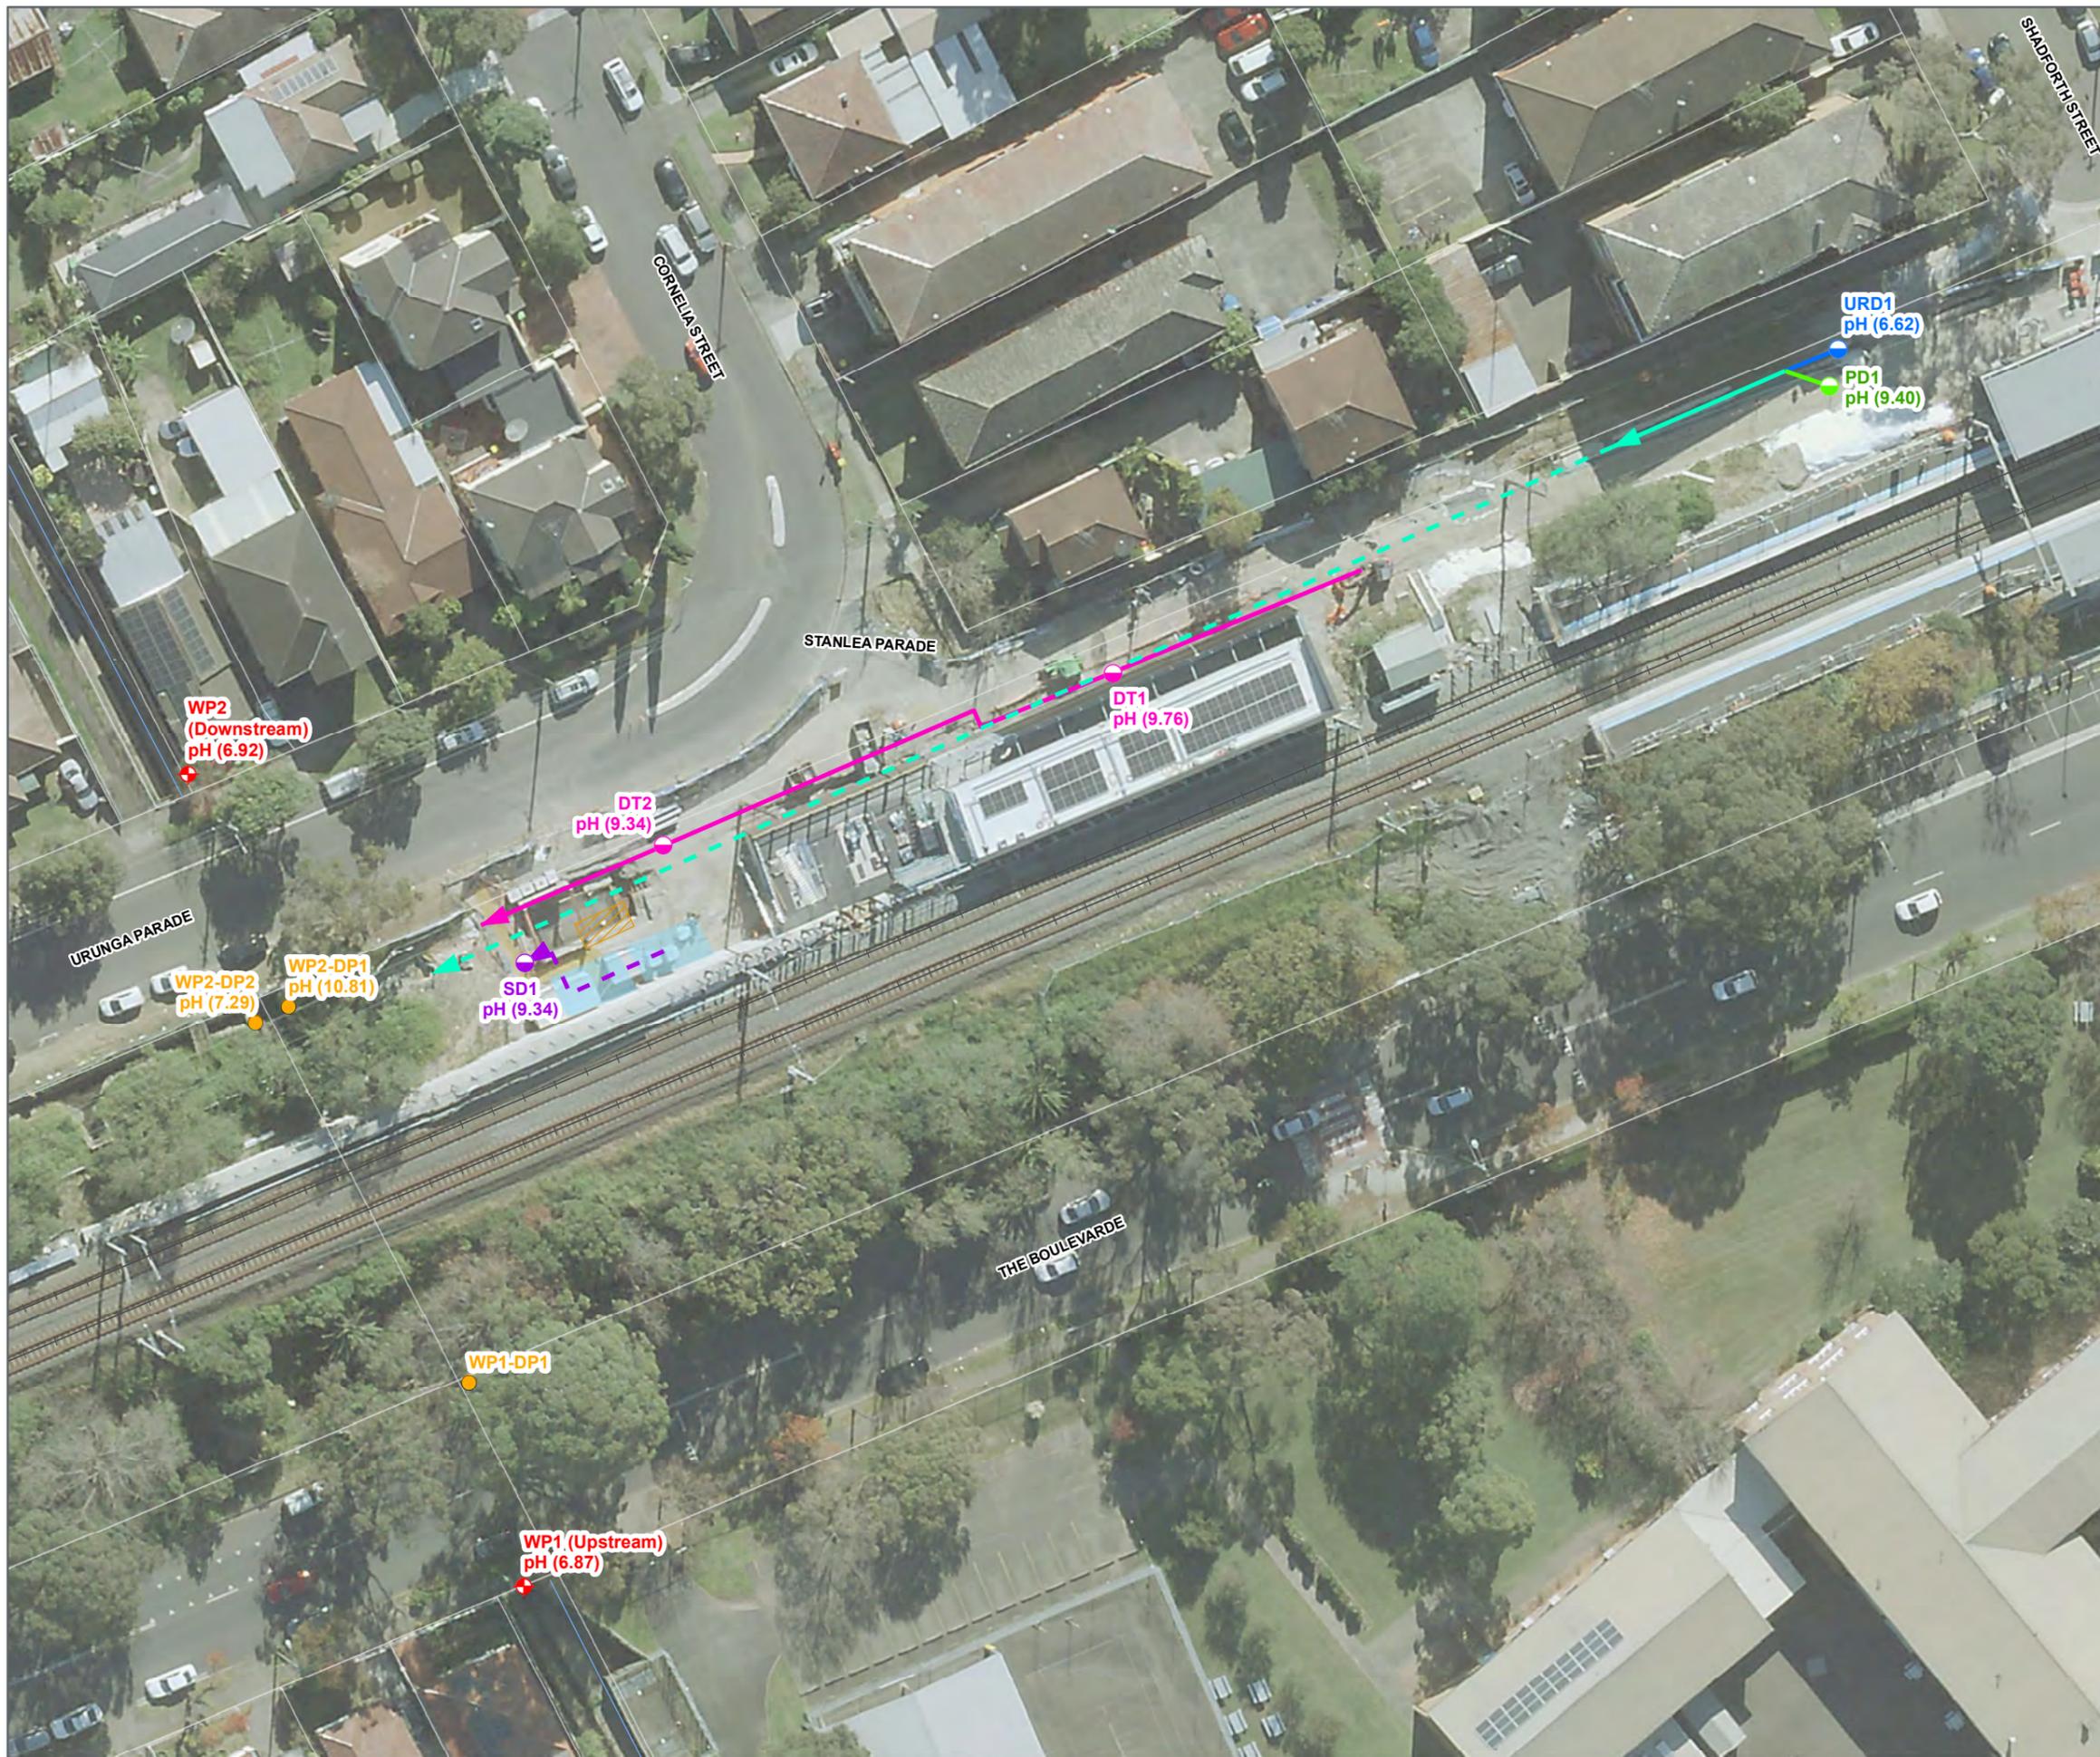
FIGURE GS001

During the inspection held on 04/07/2022 three (3) on-site and off-site flow contributions to WP2-DP1 was noted and one (1) additional flow contribution was identified. The additional contribution source was the on-site – track drainage: track drainage system collecting stormwater within the train track area and then entered into the main water channel via WP2-DP1.

Potential Flow Contributions to WP2-DP1

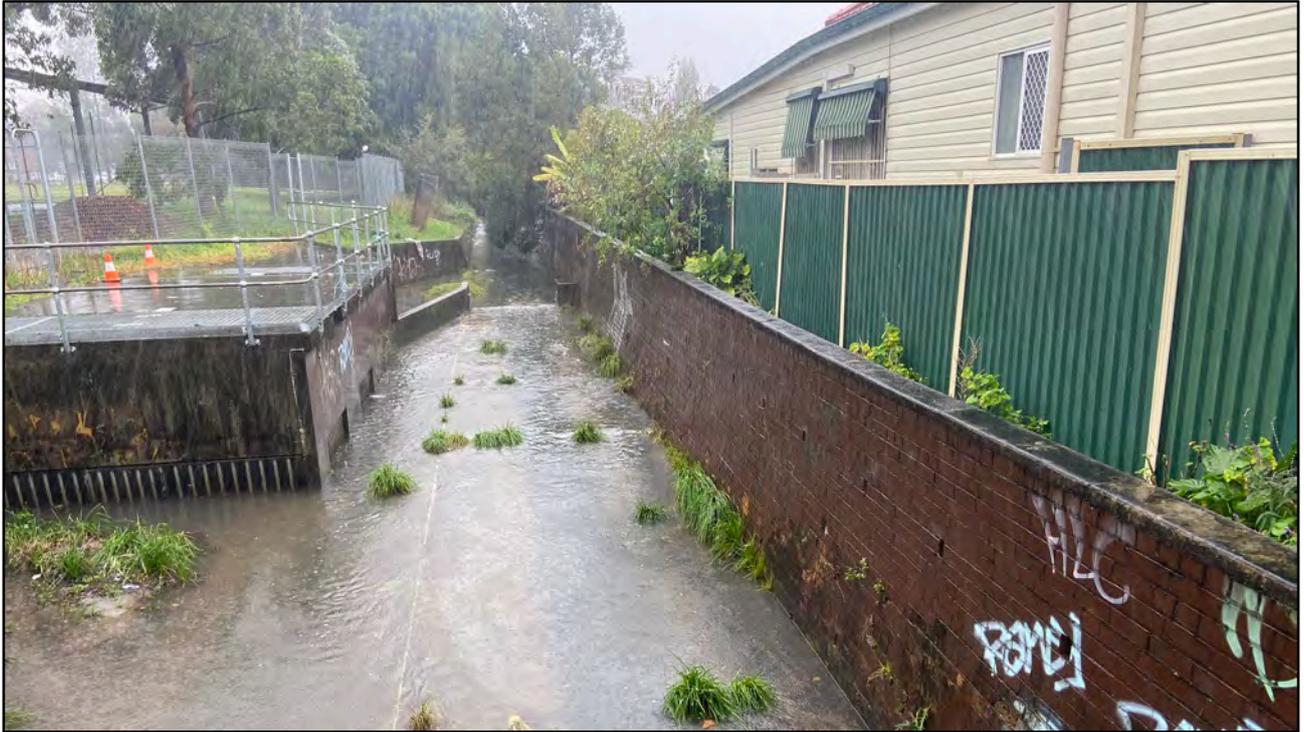
Photograph 1. Upstream sampling location WP1. Date: 4 July 2022.

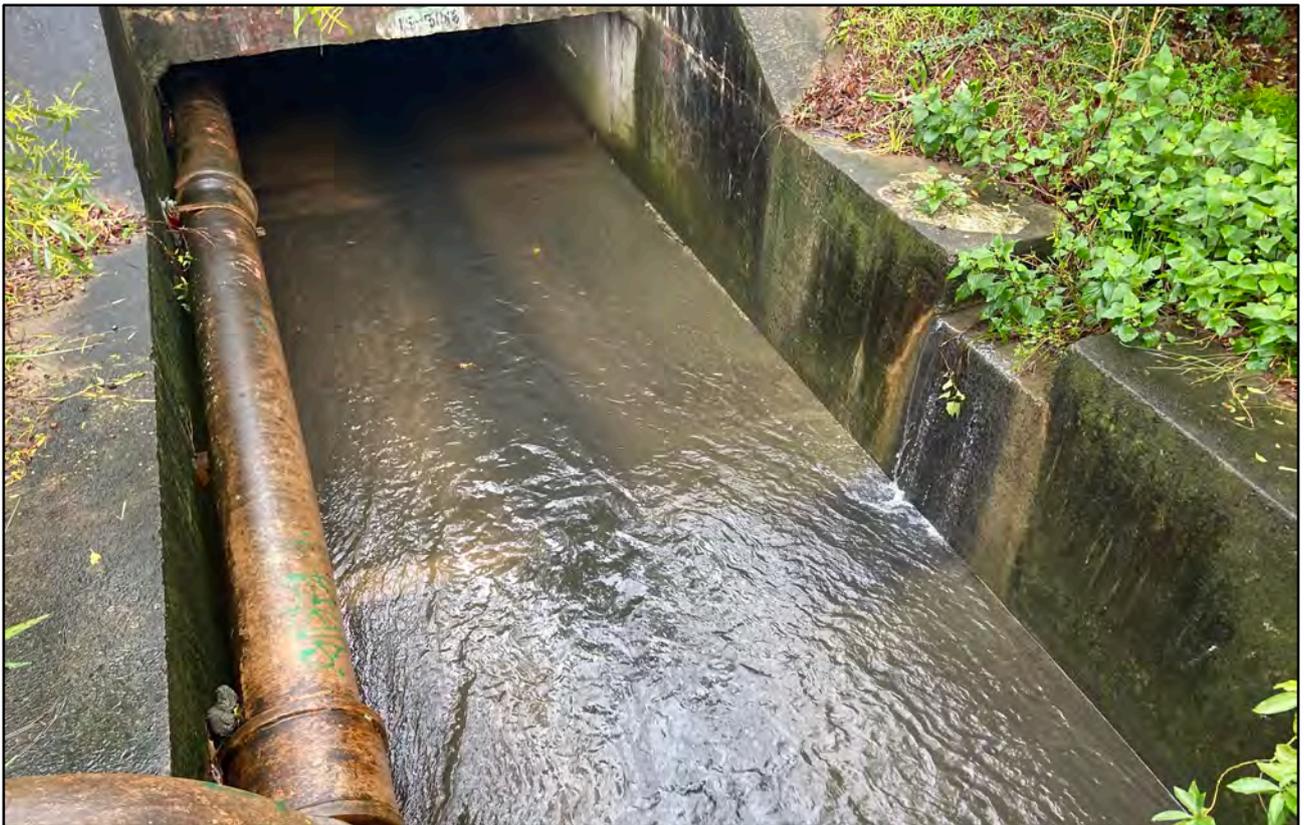
Photograph 2. Low stormwater in-flow observed from the discharge point WP1-DP1 which was located within the rail corridor and immediately downstream / north of WP1. Date: 4 July 2022.

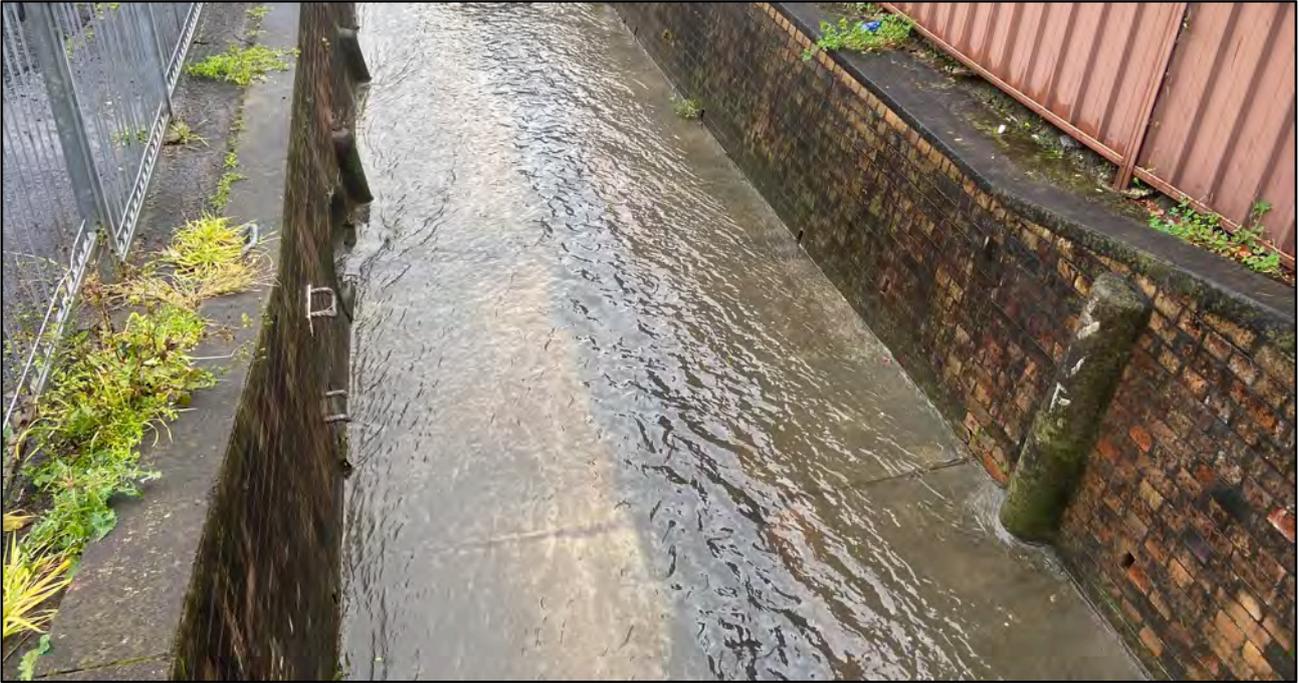
Photograph 3. Downstream sampling location WP2. Date: 4 July 2022.

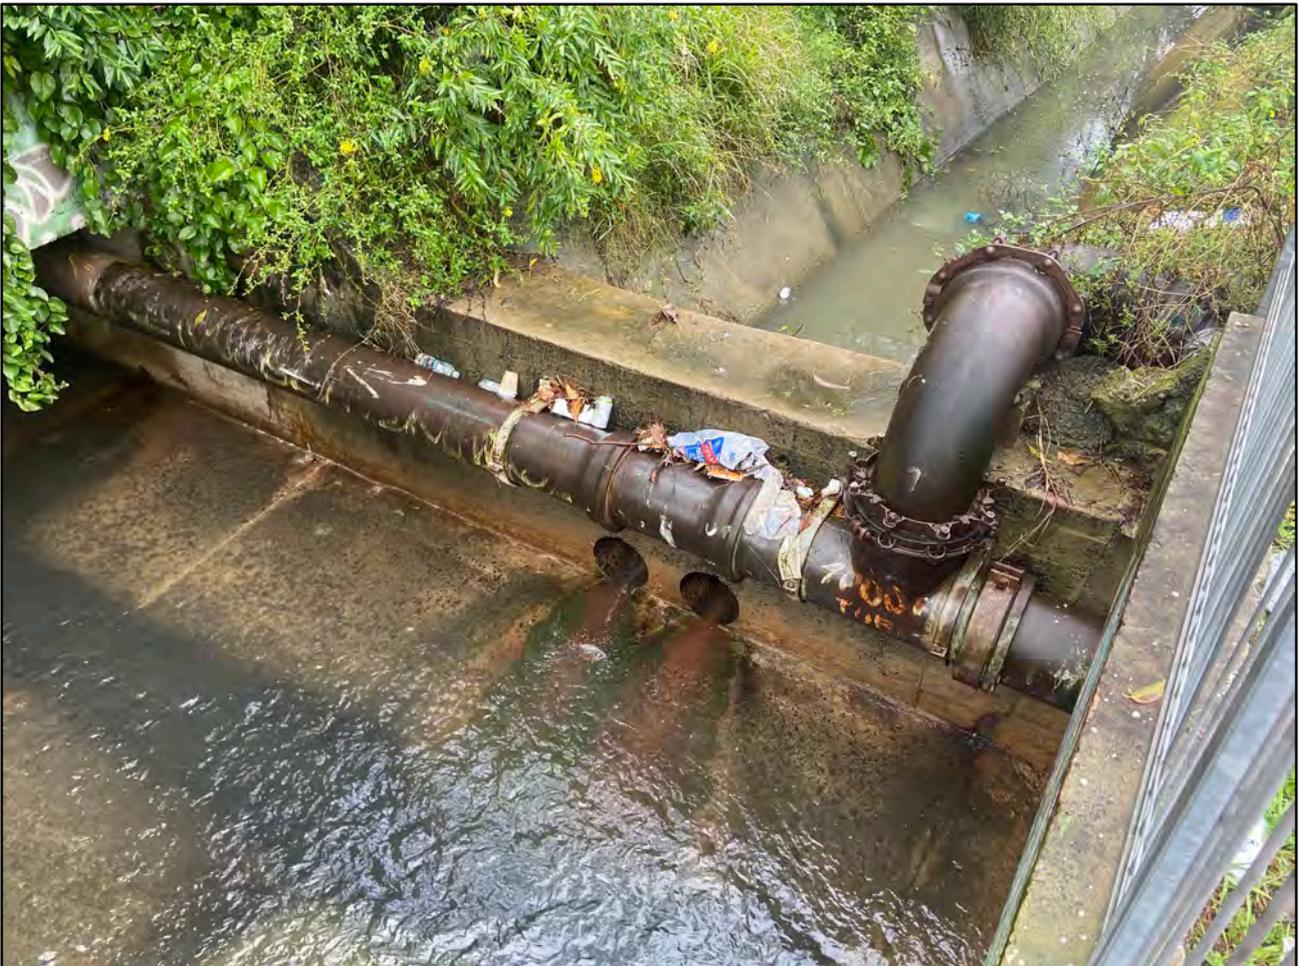
Photograph 4. Medium flow contribution was observed from downstream western discharge point WP2-DP2. Date: 4 July 2022.

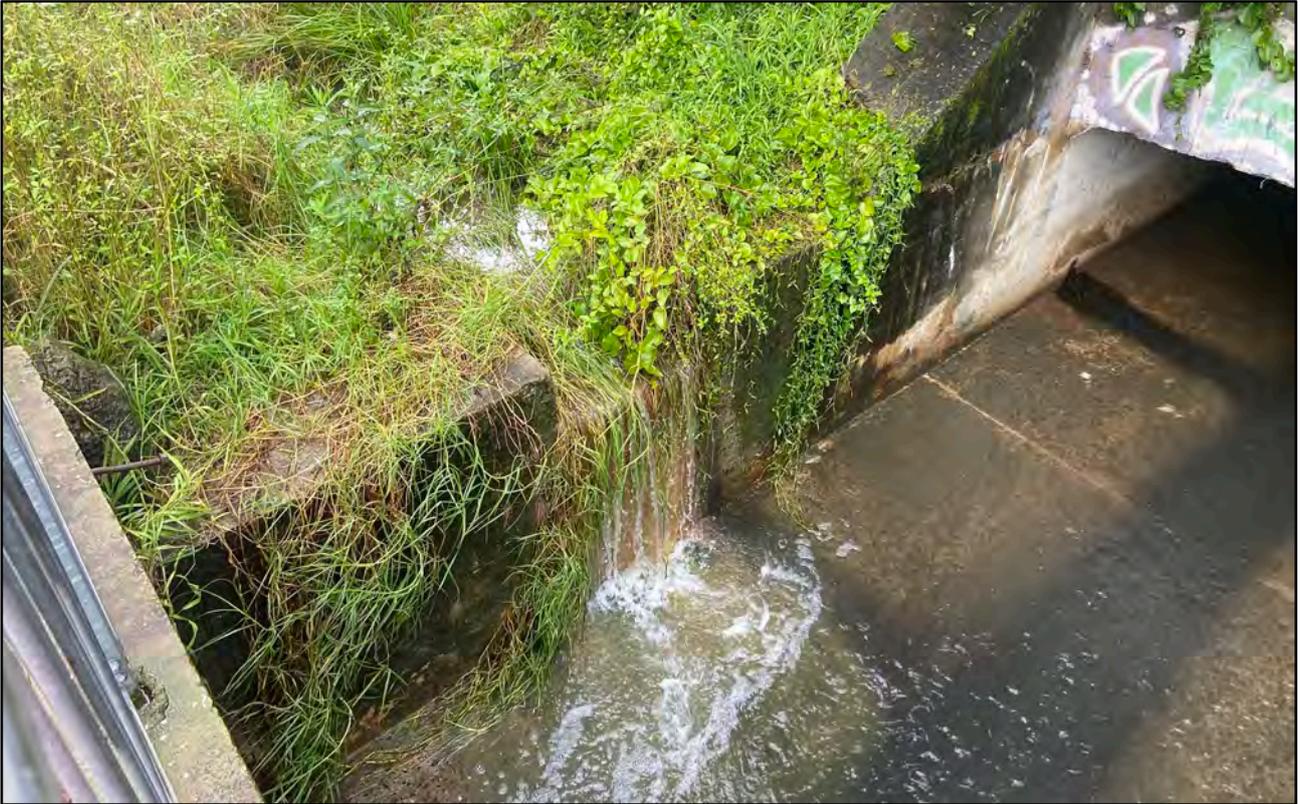
Photograph 5. High level of flow contribution was observed from downstream eastern discharge point WP2-DP1. Date: 4 July 2022.

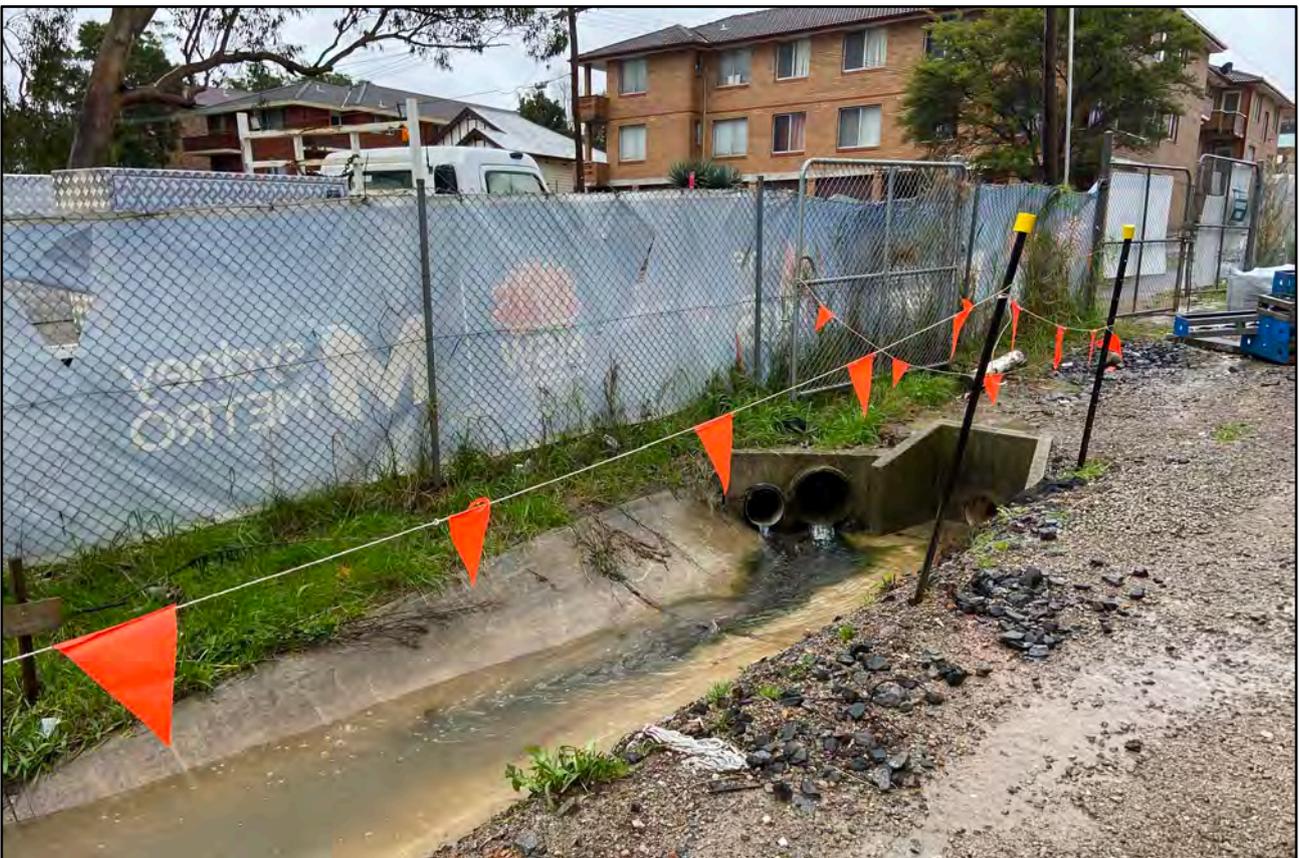
- Urban run-off drainage system: urban run-off drainage system carrying stormwater captured from the off-site area surrounding Shadforth Street was observed to join into the Platform 1 drainage system via the concrete lined swale within the Wiley Park compound. The flow was observed in a westerly direction via the concrete lined swale as well as underground drainage system passing beneath the MSB building then entered the main water channel via WP2- DP2.

Photograph 6. Identified flow contribution to WP2-DP1: urban runoff drainage – stormwater. Date: 4 July 2022.

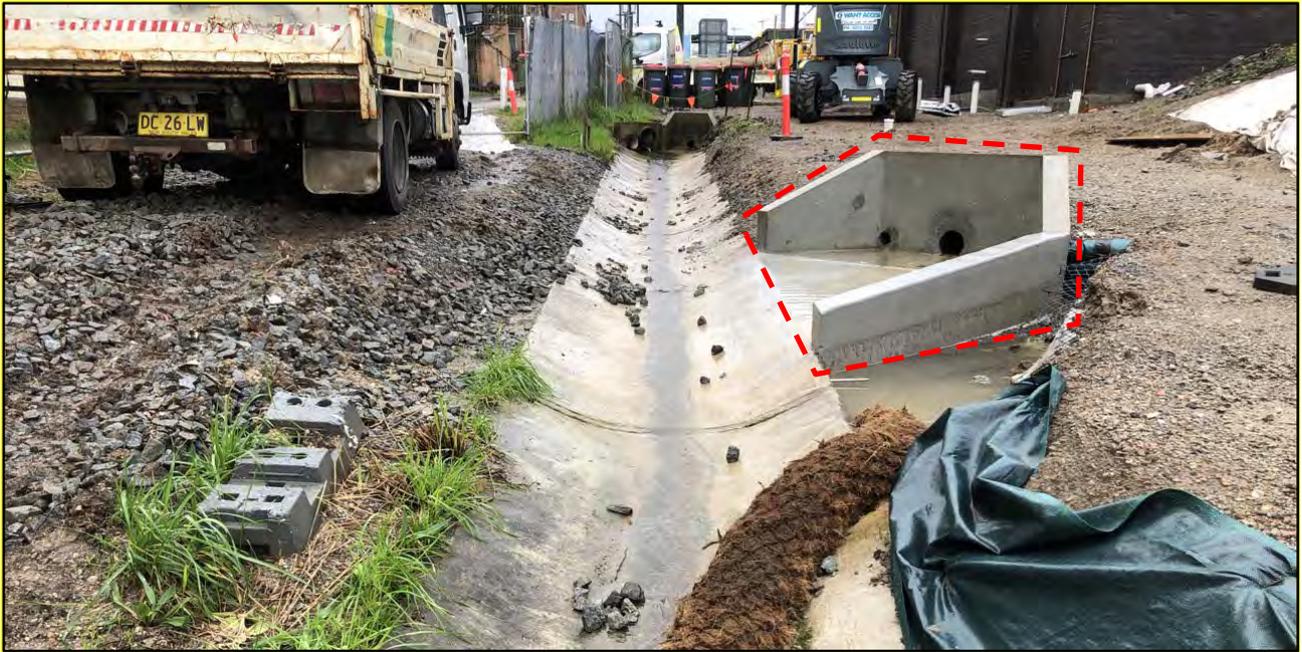
- Platform 1 drainage system: run-off collected within the aco drain at Platform 1 of Wiley Park Station was observed to flow in a westerly direction via the concrete lined swale as well as underground drainage system passing beneath the MSB building then entered the main water channel via WP2-DP2;

Photograph 7. Identified flow contribution to WP2-DP1: platform drainage – stormwater and it was mixed with urban runoff inflow once entering into the concrete lined swale. Date: 21 July 2022.

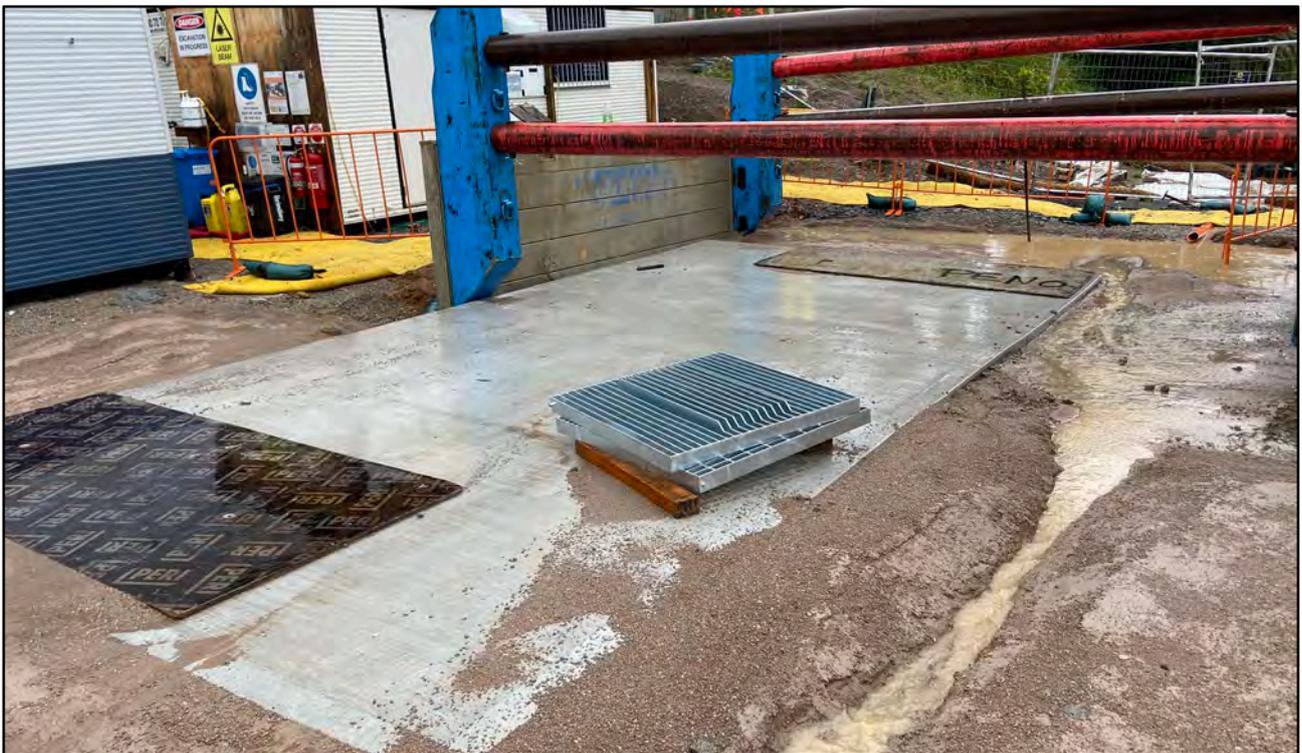
- Temporary surface water erosion and sediment control trenches: temporary surface water erosion and sediment control trenches that cut into the soil profile were observed from the north-eastern corner of the MSB building and to flow westerly and then entered the main water channel through a series of Downer EDI installed erosion and sediment controls via WP2-DP2; and

Photograph 8. Identified flow contribution to WP2-DP1: temporary surface water erosion and sediment control trenches and area surrounding constructed OSD tank. Date: 4 July 2022.

- Temporary surface water erosion and sediment control trenches: prior to rainfall events, it is recommended to install a non-permeable physical barrier (e.g. black plastic sheeting) in the drainage trench path surrounding the construction footprint of the OSD tank. This would prevent surface water from coming into direct contact with the stabilised sand / cement mixture used to backfill the area.

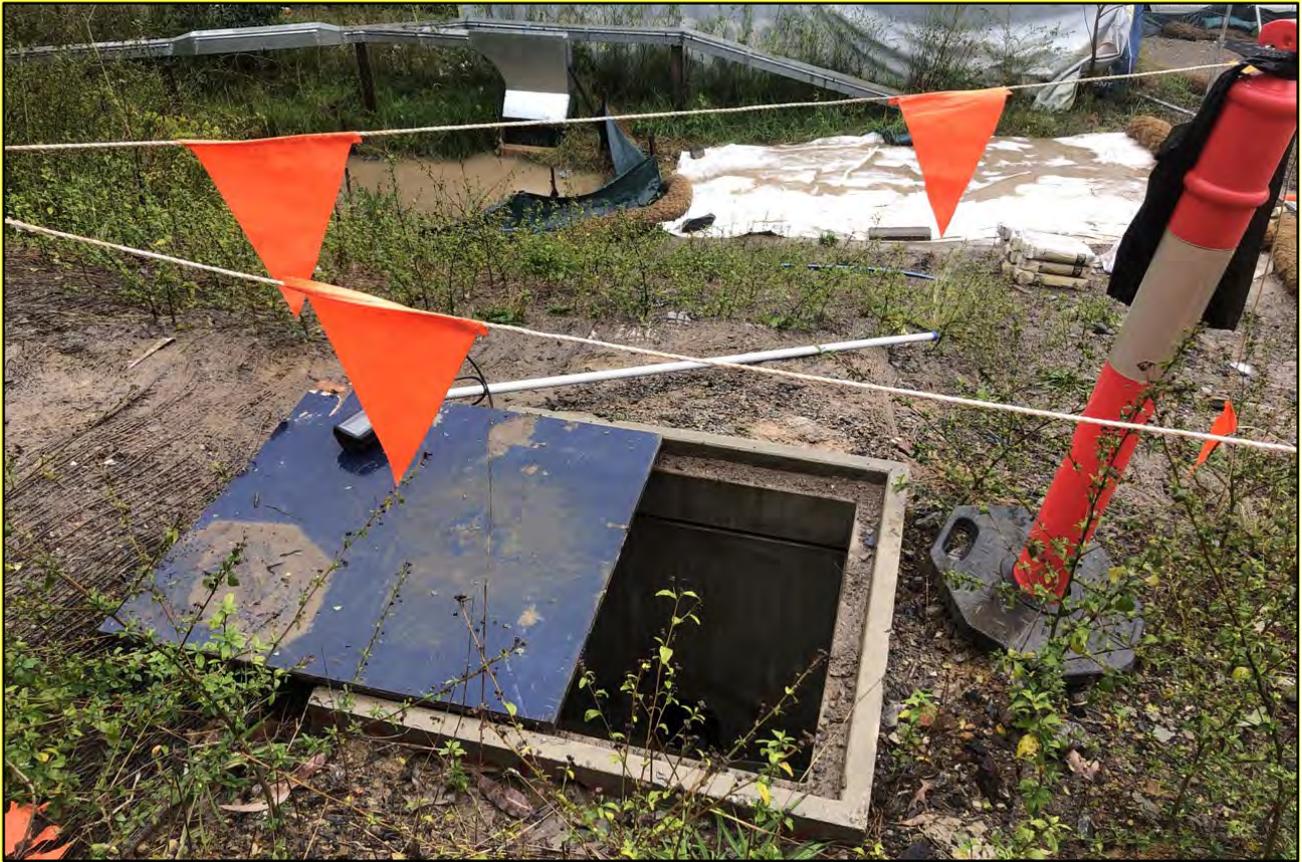
Photograph 9. Identified flow contribution to WP2-DP1: track drainage. Date: 21 July 2022.

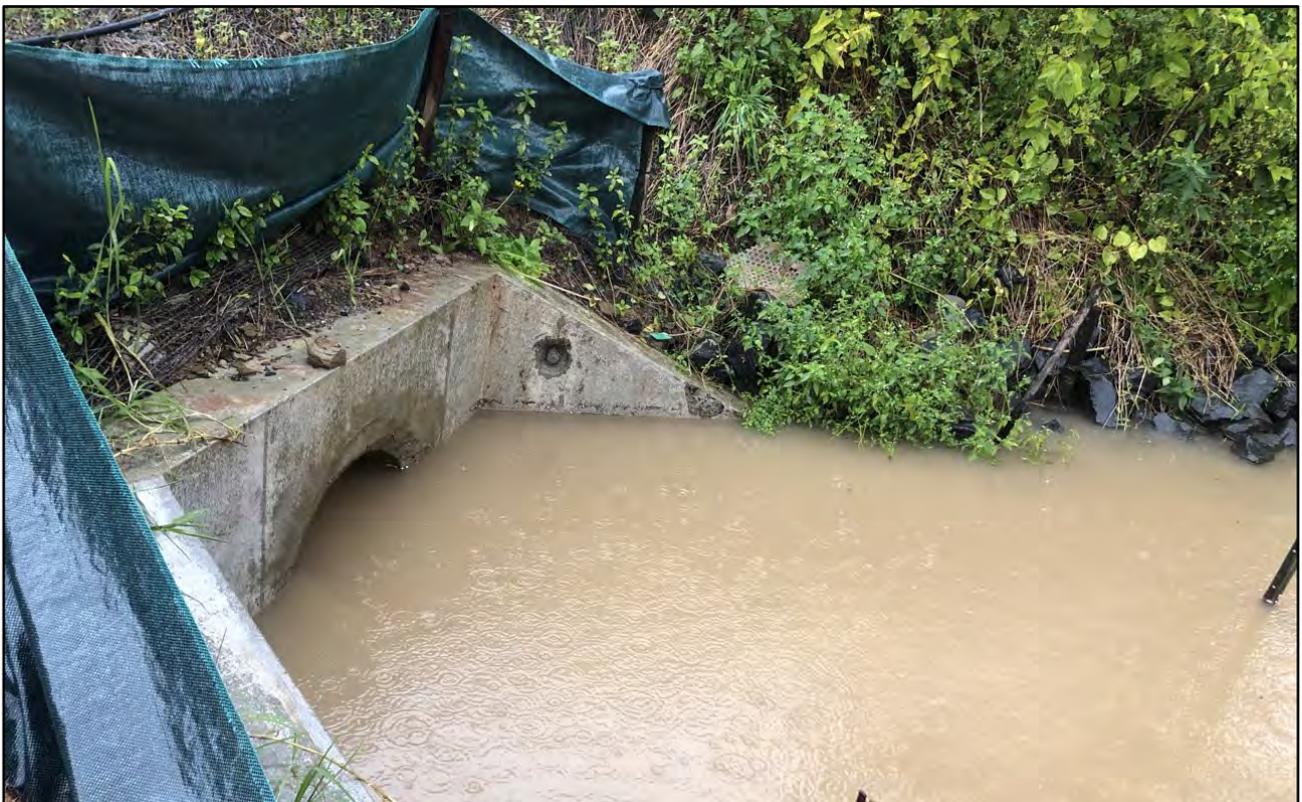
Photograph 10. Western headwall within the project footprint – mixture of all upstream flow contributions for WP2-DP1. Date: 21 July 2022.
