CONSTRUCTION MONITORING REPORT
APRIL 2022 TO November 2022
Sydney Metro City & Southwest
Package 5 & 6
Customer: Sydney Metro

Project Document Code	Latest Version Number	Latest Version Date
Package 5 - SMCSWSW5-DEW-WEC-EM-REP-001600	Rev B	25/11/2022
Package 6 - SMCSWSW6-DEW-WEC-EM-REP-001499

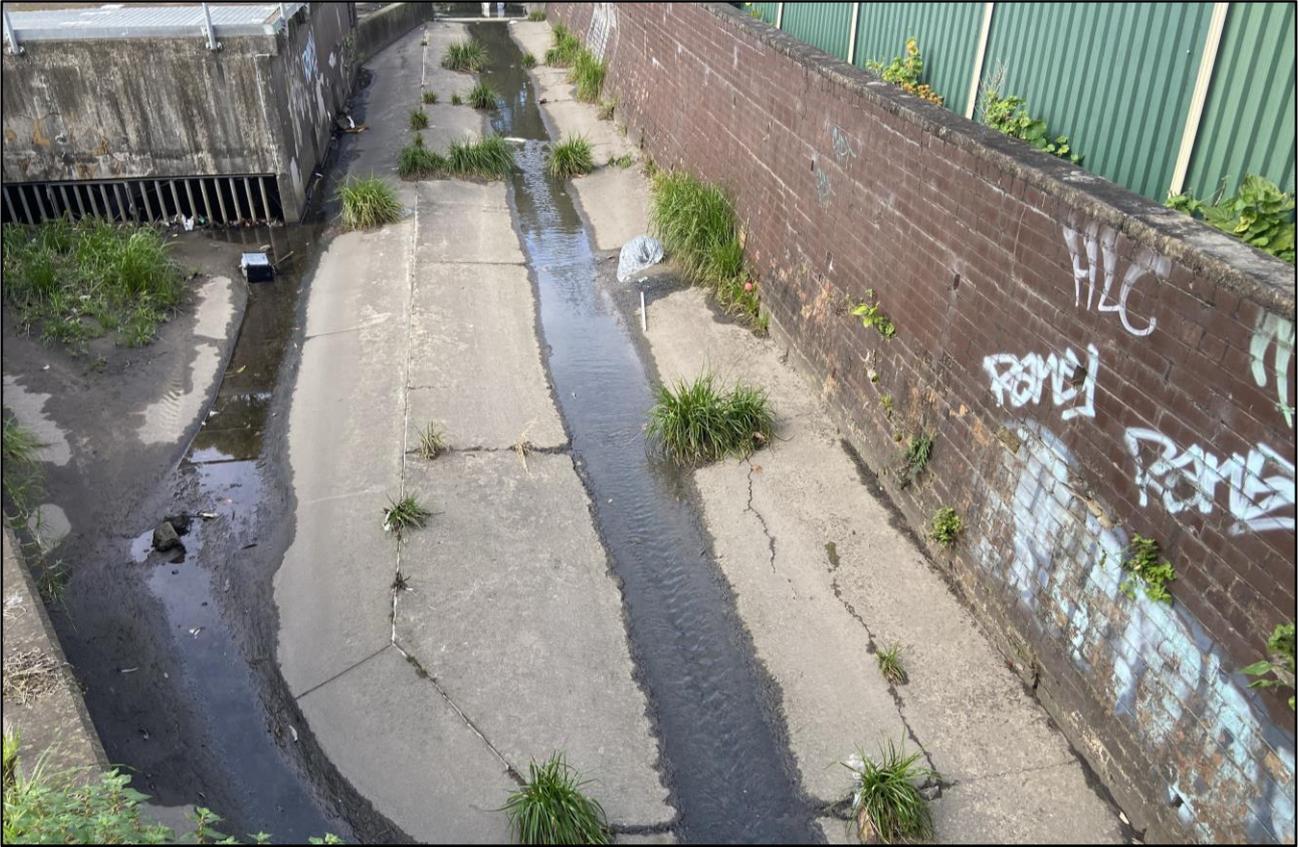
Photograph 1. Condition observed from sampling location of WP1 during the monitoring event – 25 August 2022.

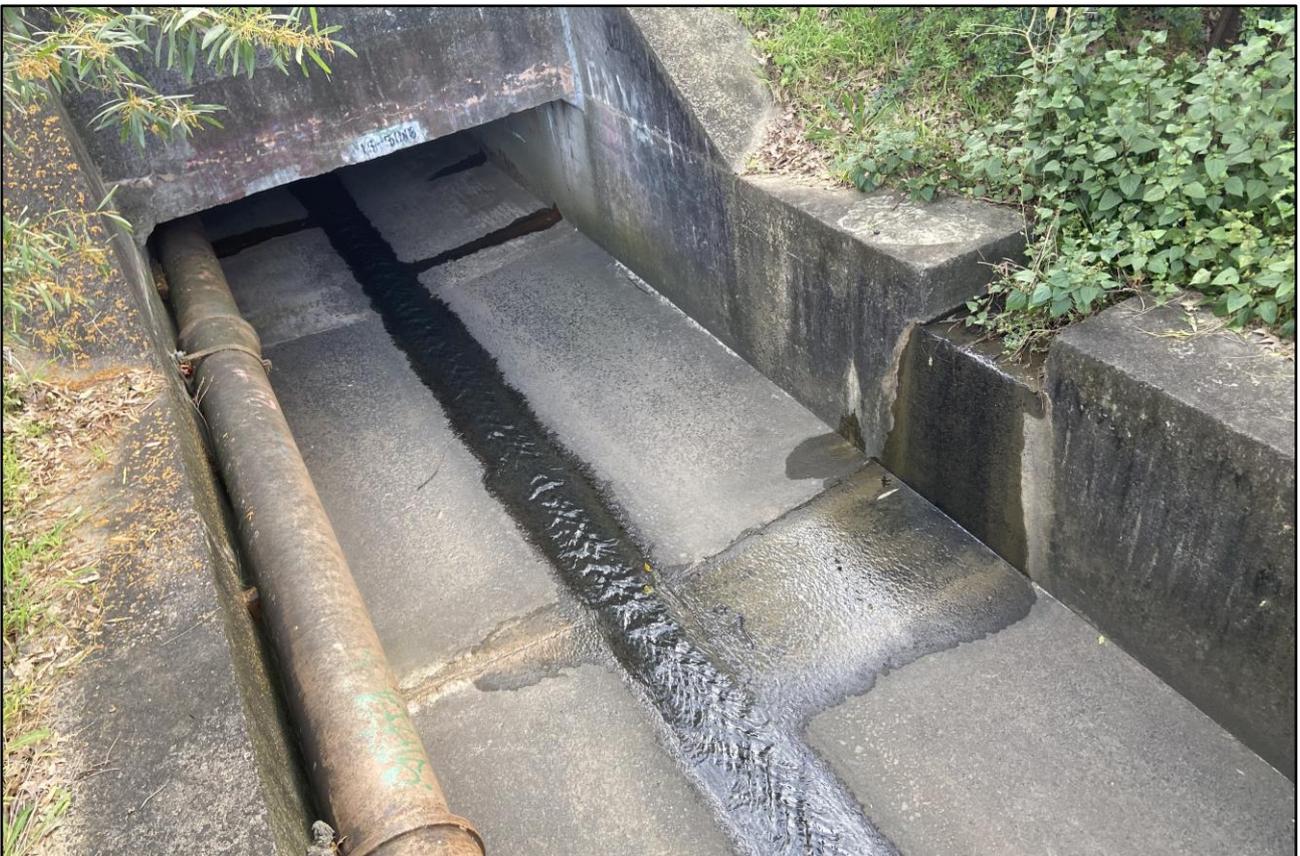
Photograph 2. Minor stormwater in-flow observed from the discharge point WP1-DP1 which was located within the rail corridor and immediately downstream / north from WP1 during the monitoring event – 25 August 2022.

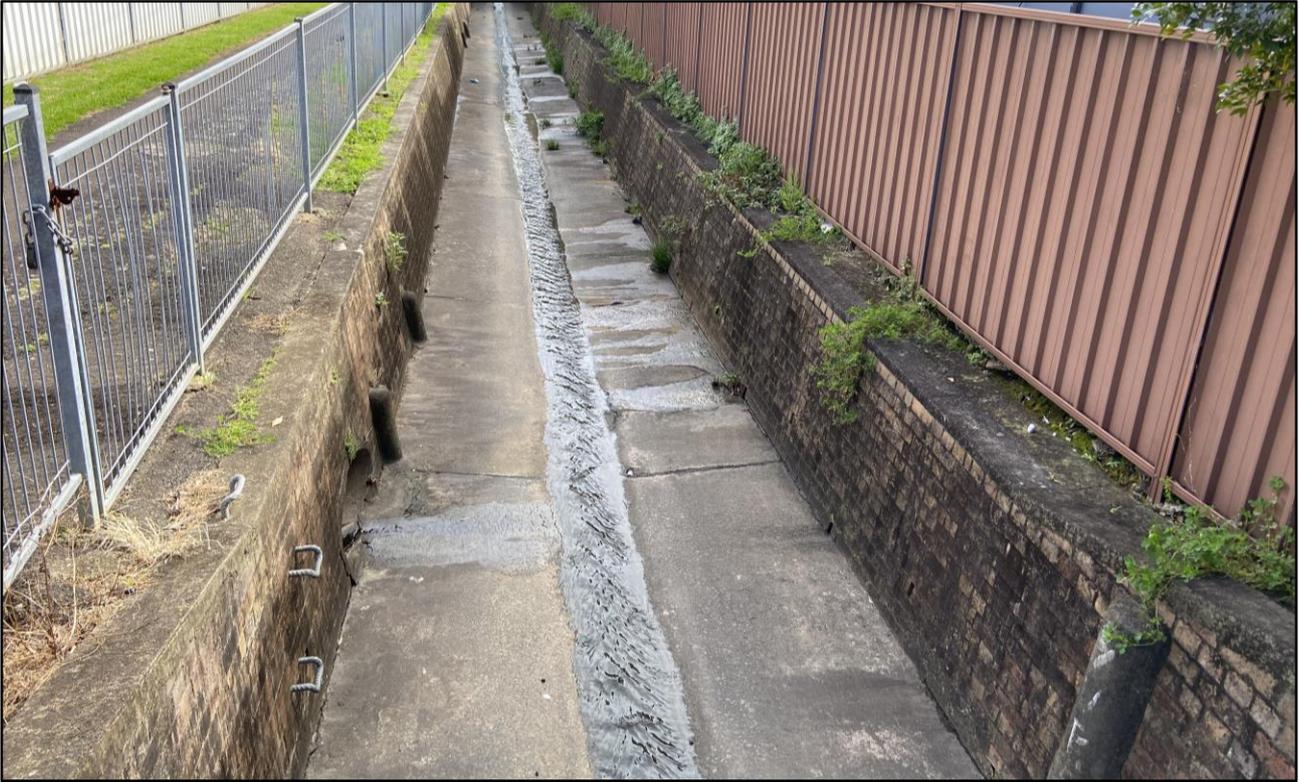
Photograph 3. Condition observed from sampling location of WP2 during the monitoring event – 25 August 2022.

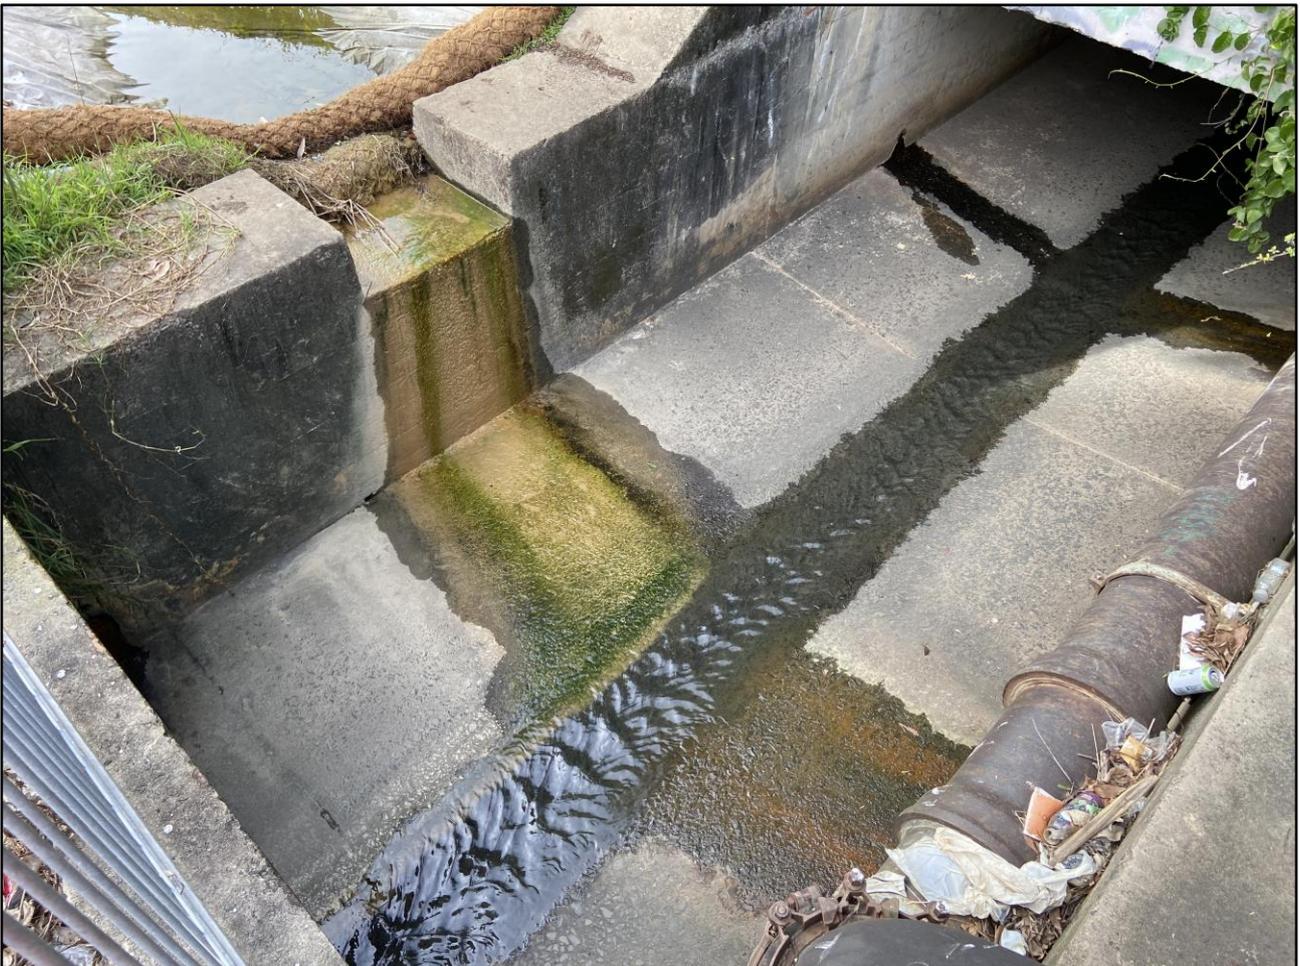
Photograph 4. Minor stormwater in-flow observed from the downstream discharge point WP2-DP1 which were located within the rail corridor and immediately upstream / south from WP2 during the monitoring event – 25 August 2022.

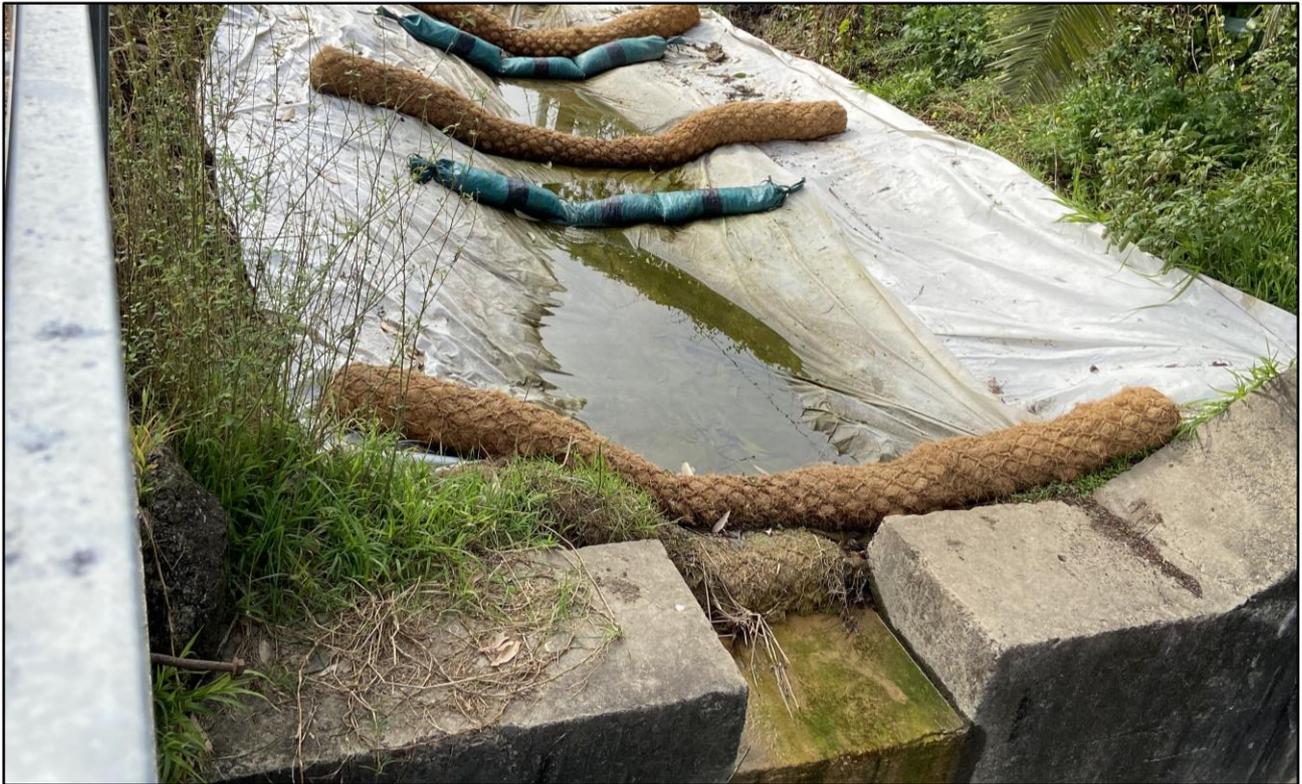
Photograph 5. Current condition and sediment / erosion control of the downstream discharge point WP2-DP1 which were located within the rail corridor and immediately upstream / south from WP2 during the monitoring event – 25 August 2022.

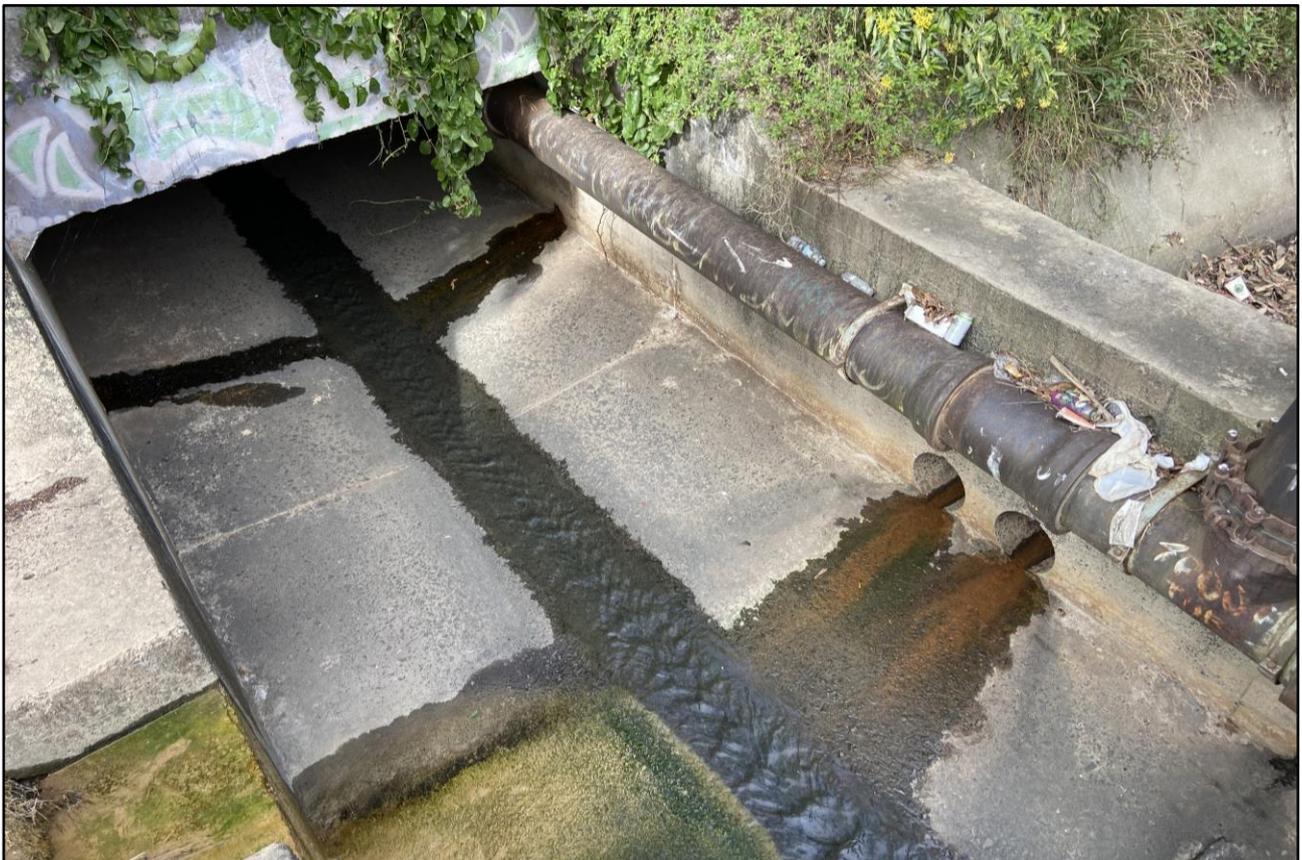
Photograph 6. No stormwater in-flow observed from the downstream discharge point WP2-DP2 which were located within the rail corridor and immediately upstream / south from WP2 during the monitoring event – 25 August 2022.

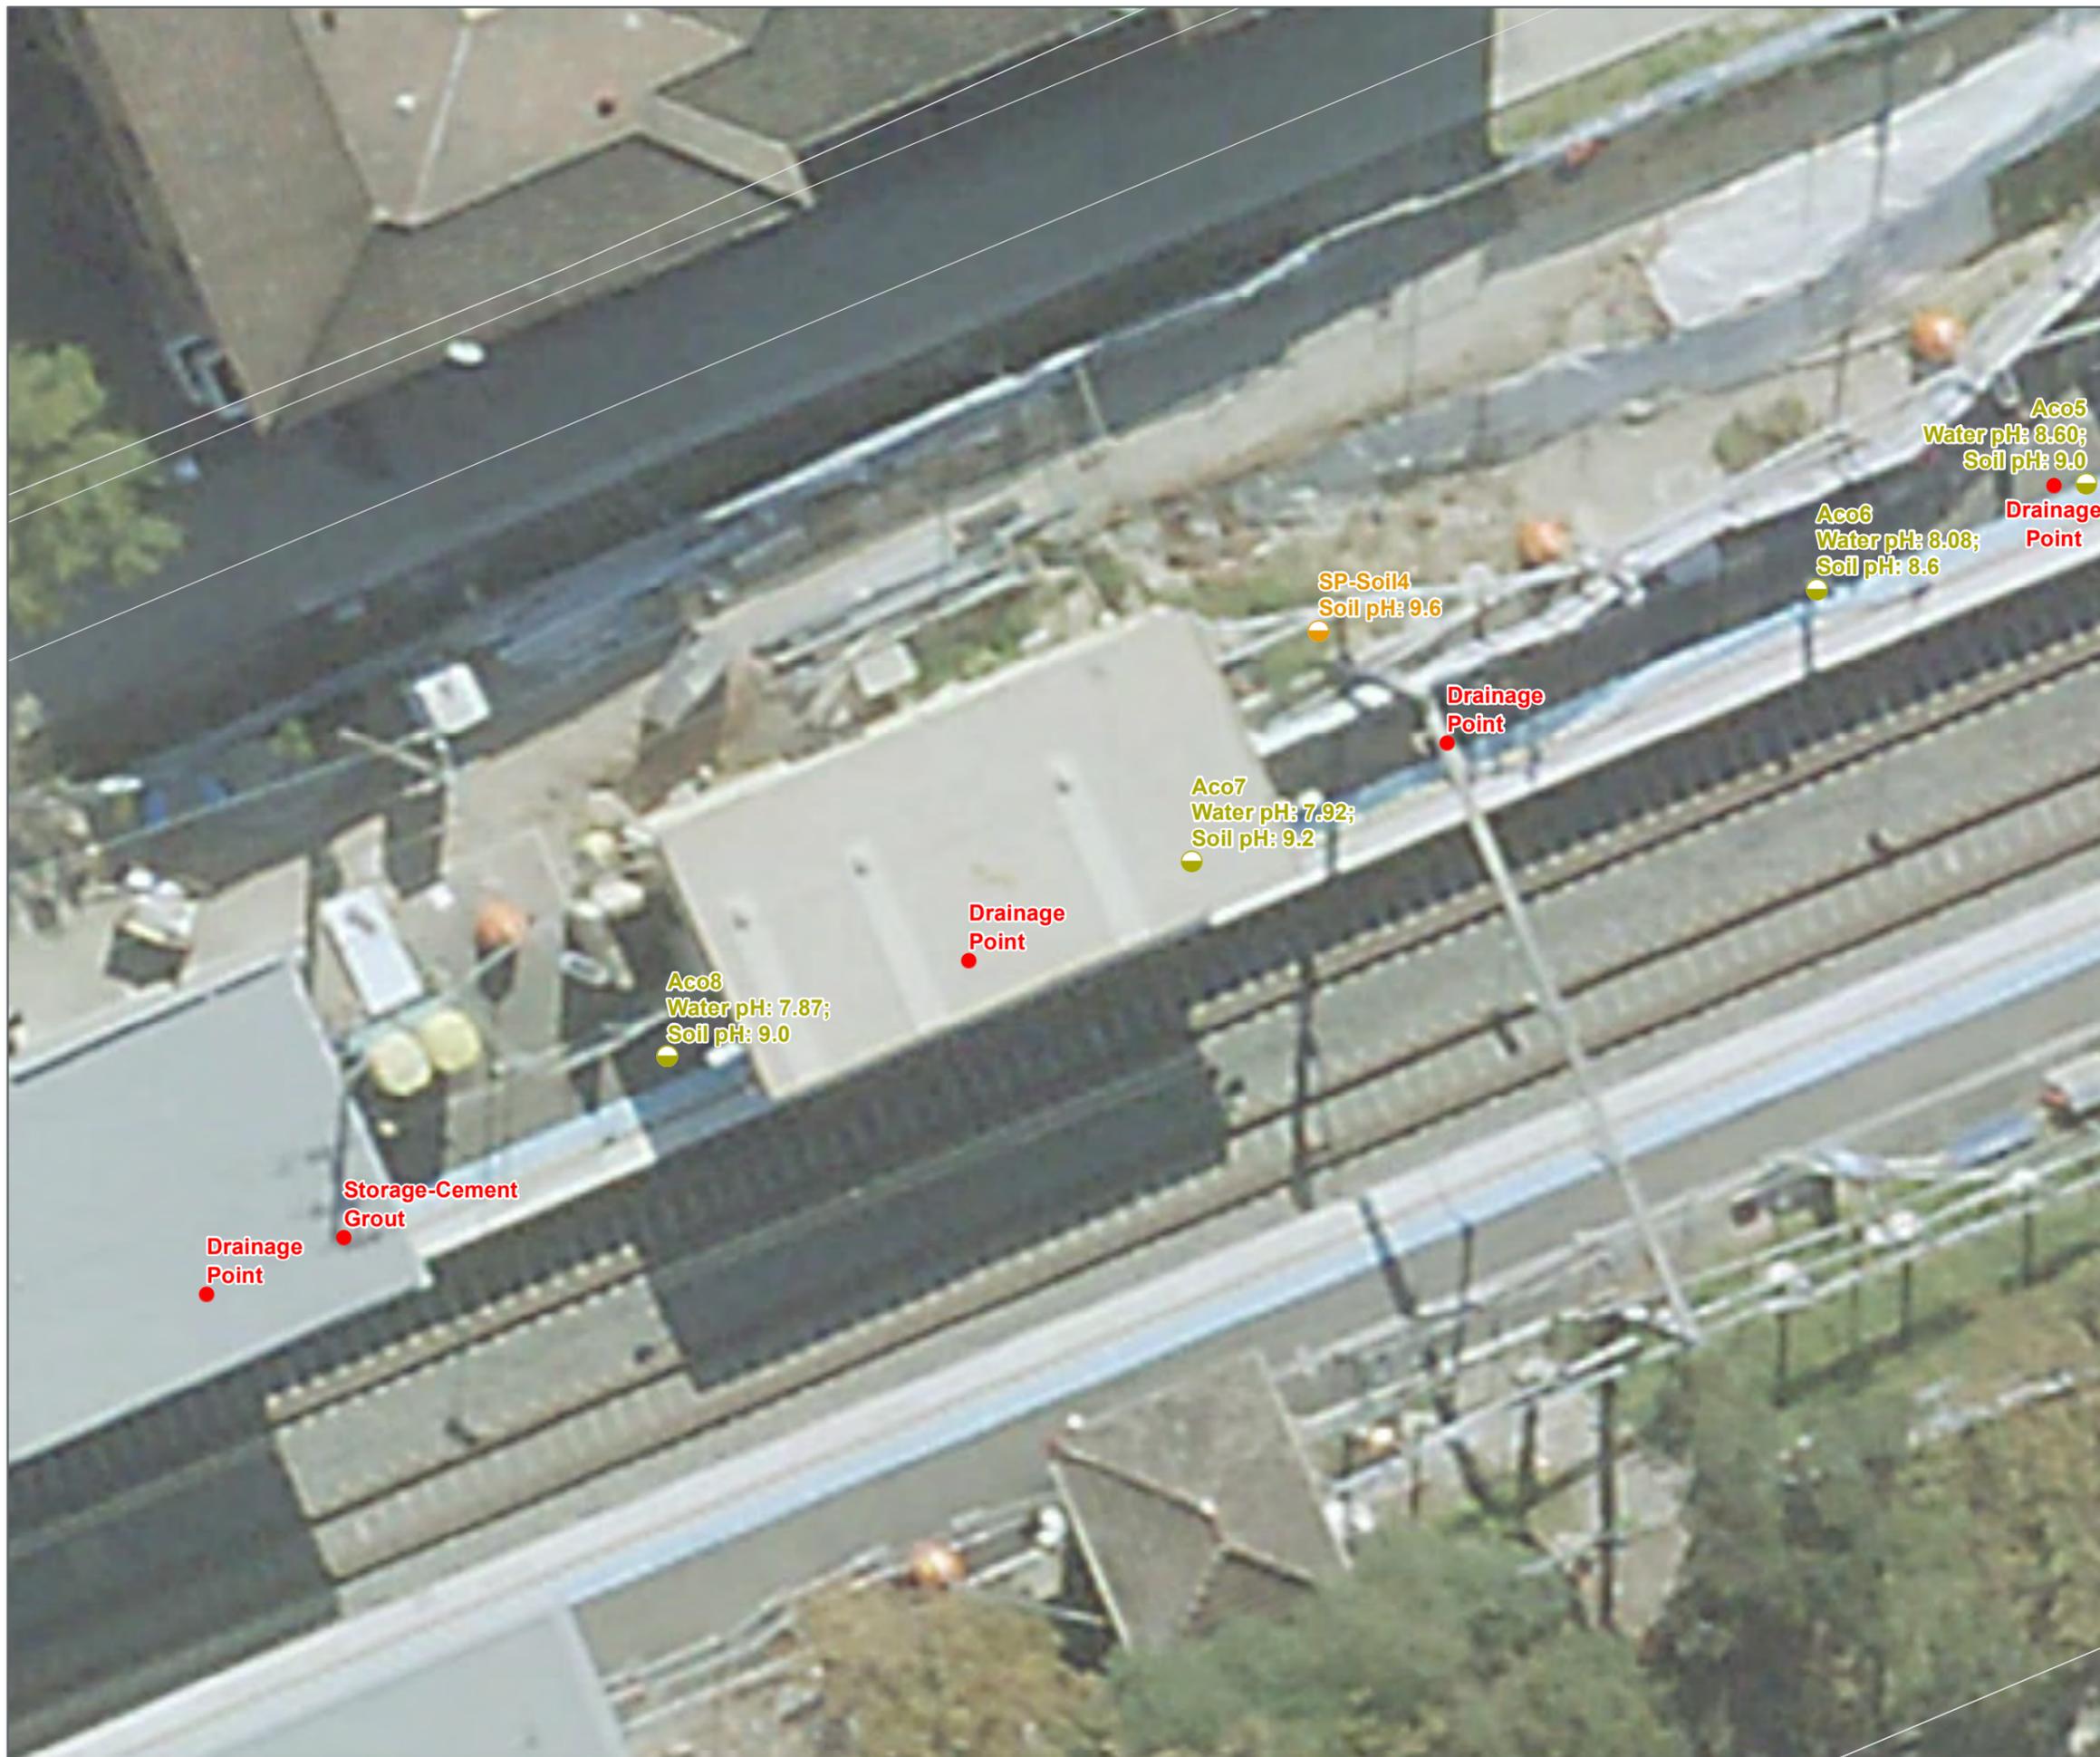
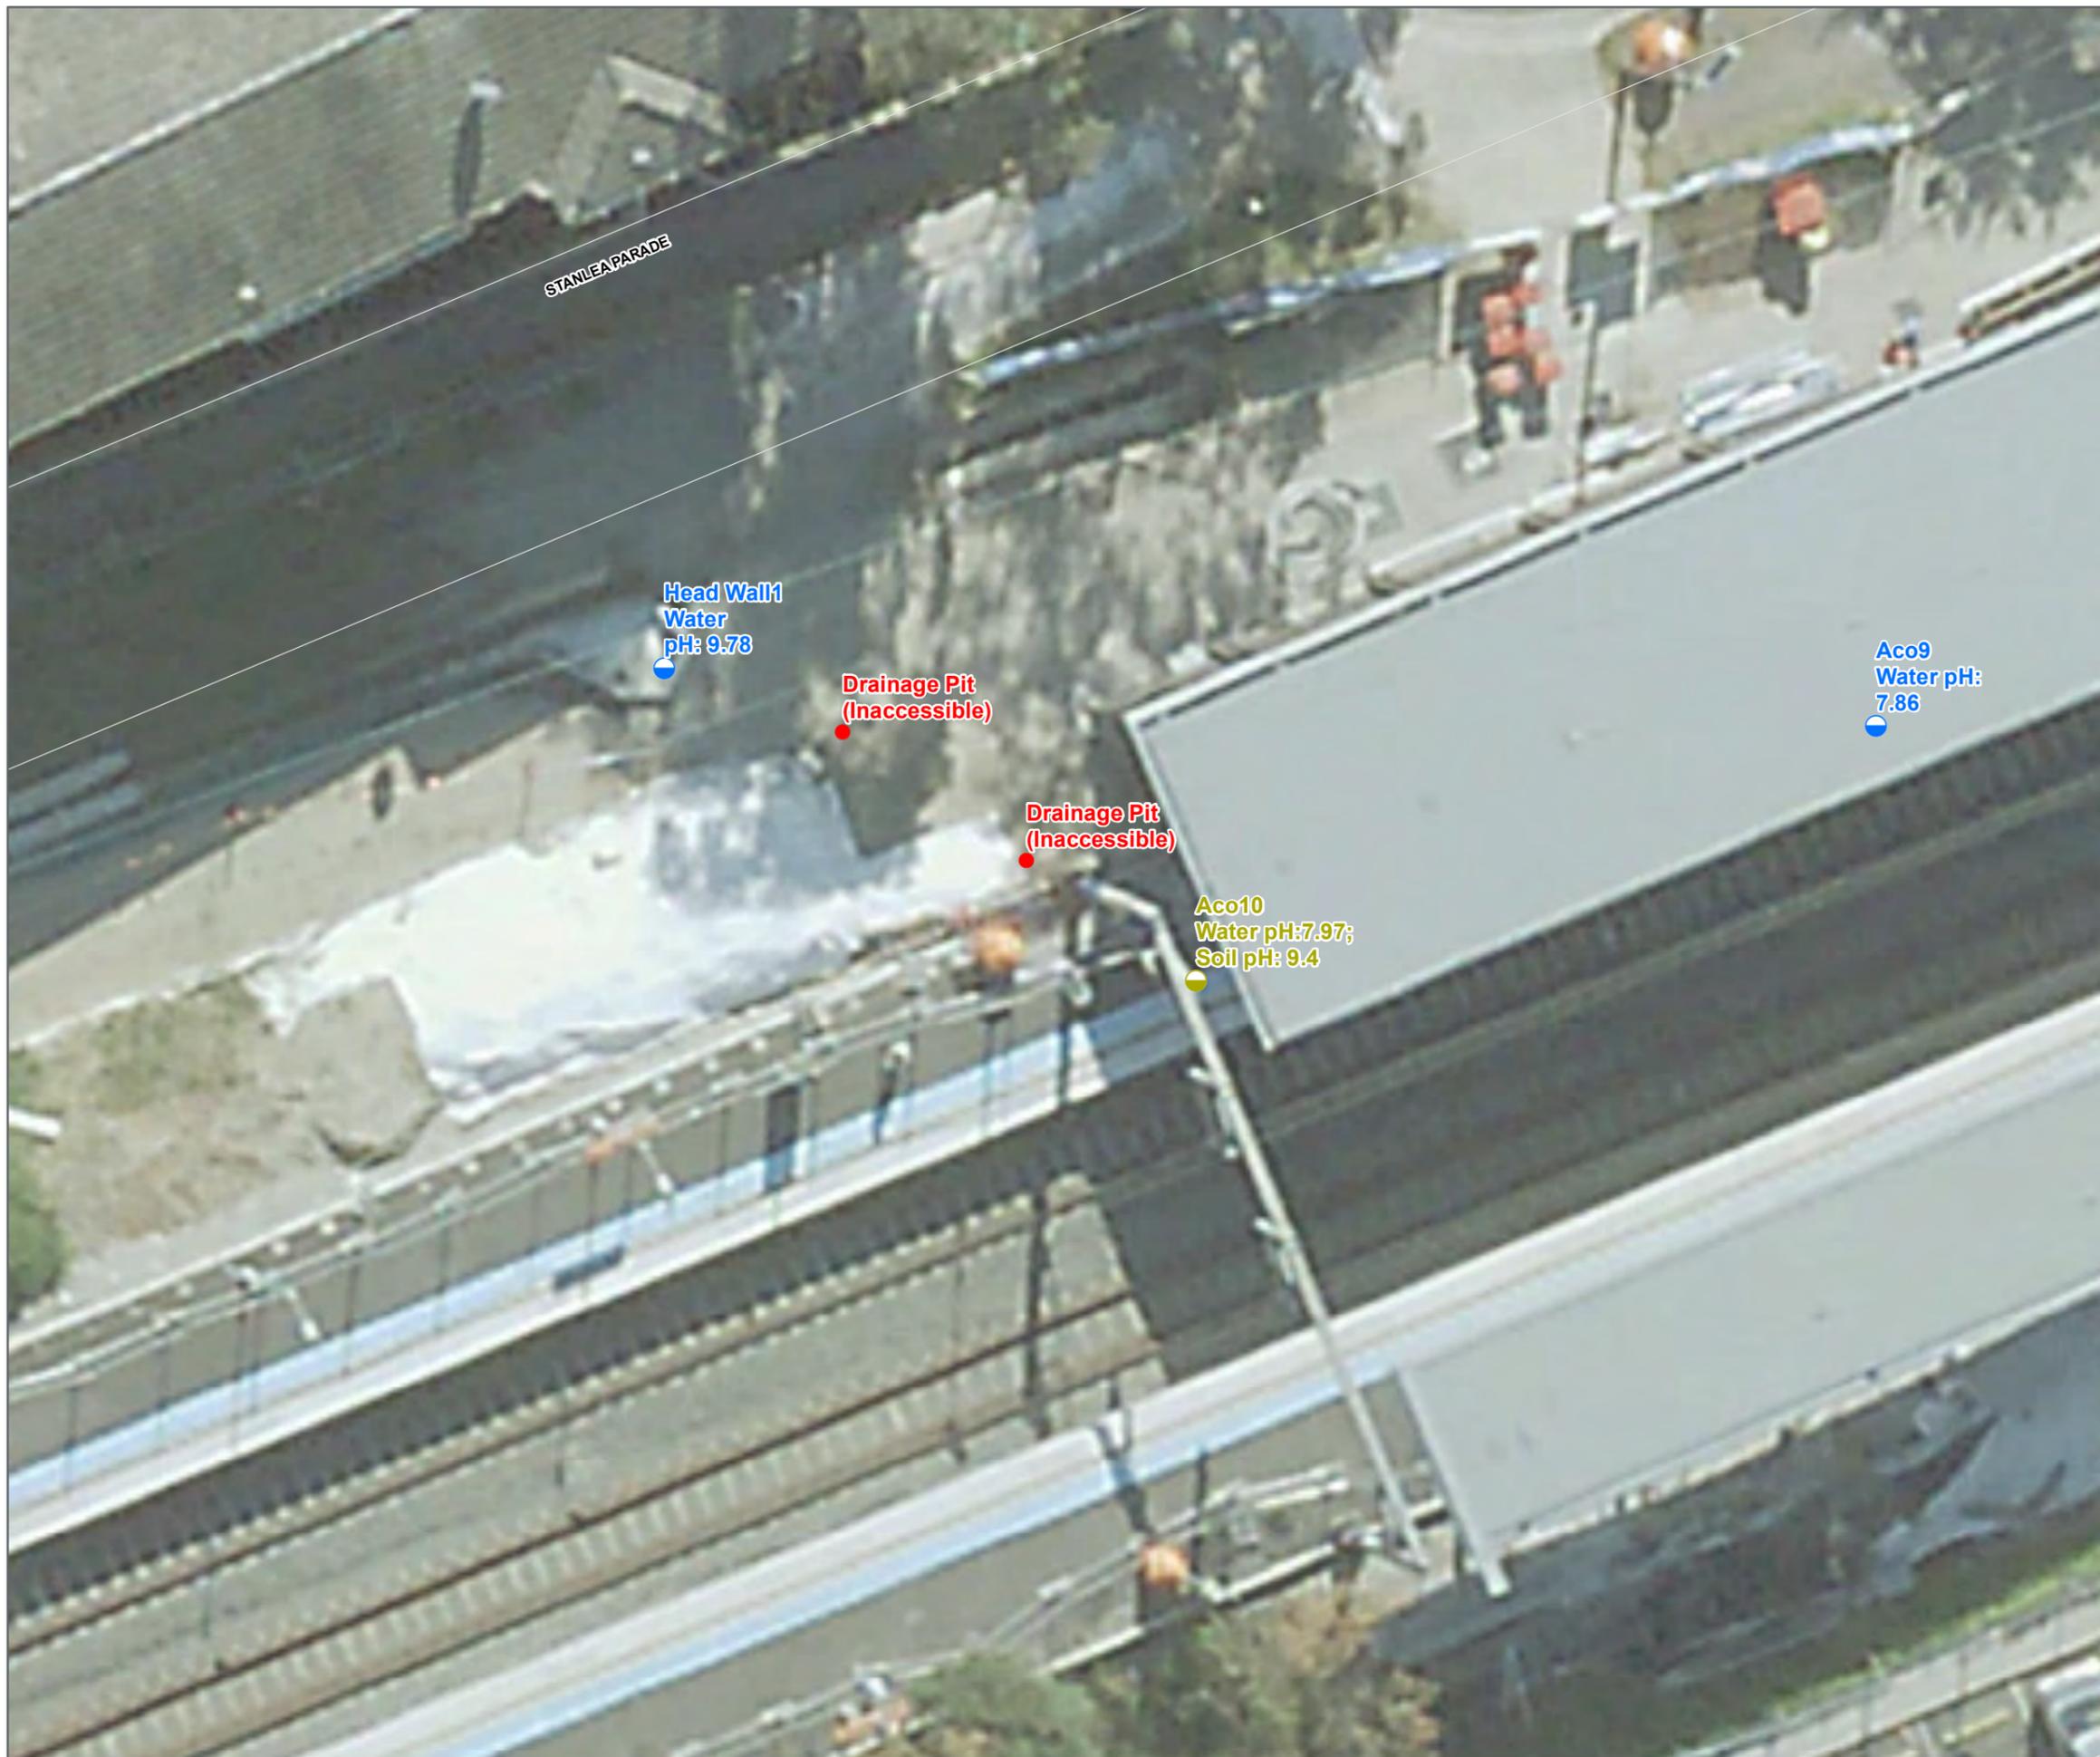
FIGURE GS-007

Table 2-2 below summarises the pH measurements undertaken. Refer to **Figure GS-007** in **Attachment A** for approximate monitoring locations. Refer to **Photograph 7** and **8** in **Attachment B** for details. Refer to **Attachment E** for a copy of the calibration certificate for the water quality meter used.

- > Several drainage points providing connection between the aco drain and drainage pipe system underneath was observed within the aco drain. This observation was consistent with the drainage drawing reviewed (SMCSWSWM-MTM-WWP-DD-DWG-233318). According to the drainage drawing provided, this drainage pipe conveys the surface water collected from the aco drain to the downstream discharge point at Headwall 1. Refer to **Photograph 10** and **11** in **Attachment B** for details. Refer to **Figure GS-007** in **Attachment A** for approximate locations observed.

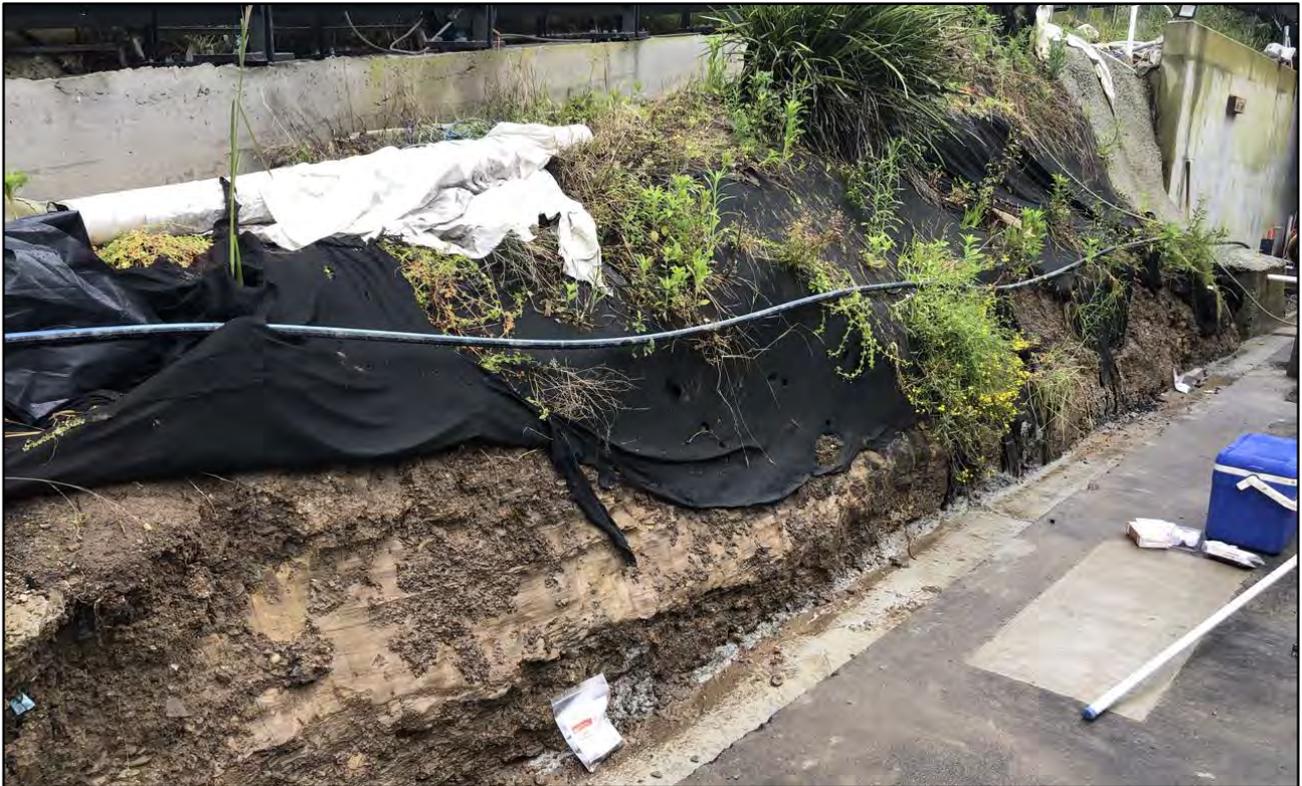
Photograph 1. Northern batter – potentially form part of the catchment area to the Platform 1 drainage system. Date: 5 October 2022.

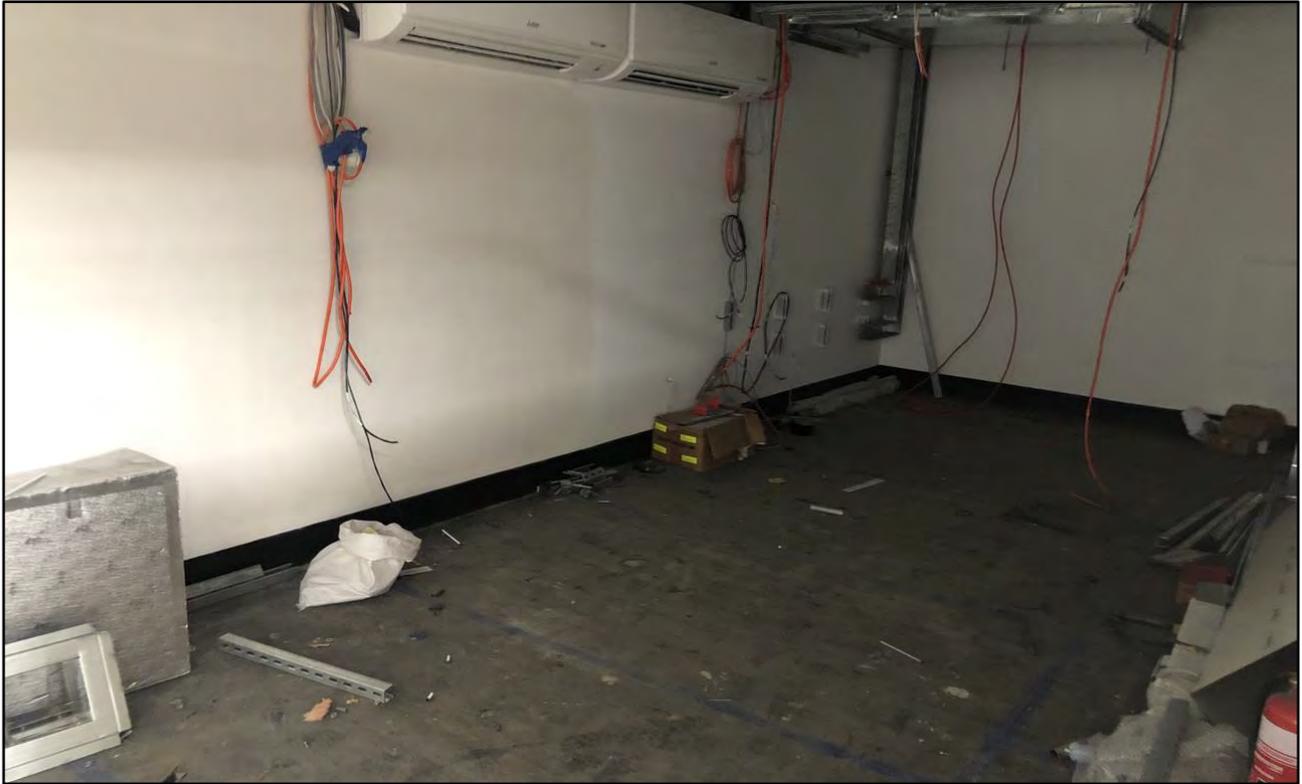
Photograph 3. South-western building within Platform 1 – currently under renovation by Downer EDI and not in use. Storage of construction materials was sighted. Date: 5 October 2022.

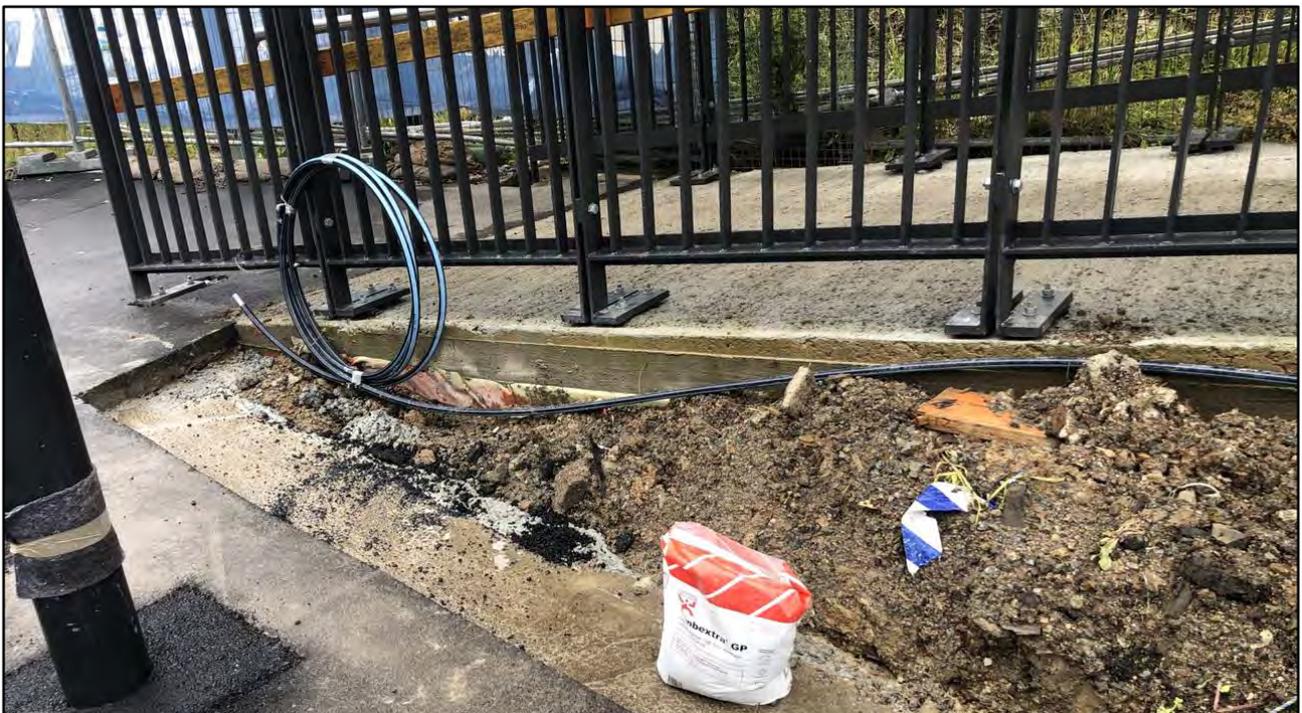
Photograph 6. Inspection of Downer EDI storage area with Platform 1 – storage of cement materials with one opened cement bag near Platform 1 aco drain was sighted at the time of inspection. Date: 5 October 2022.

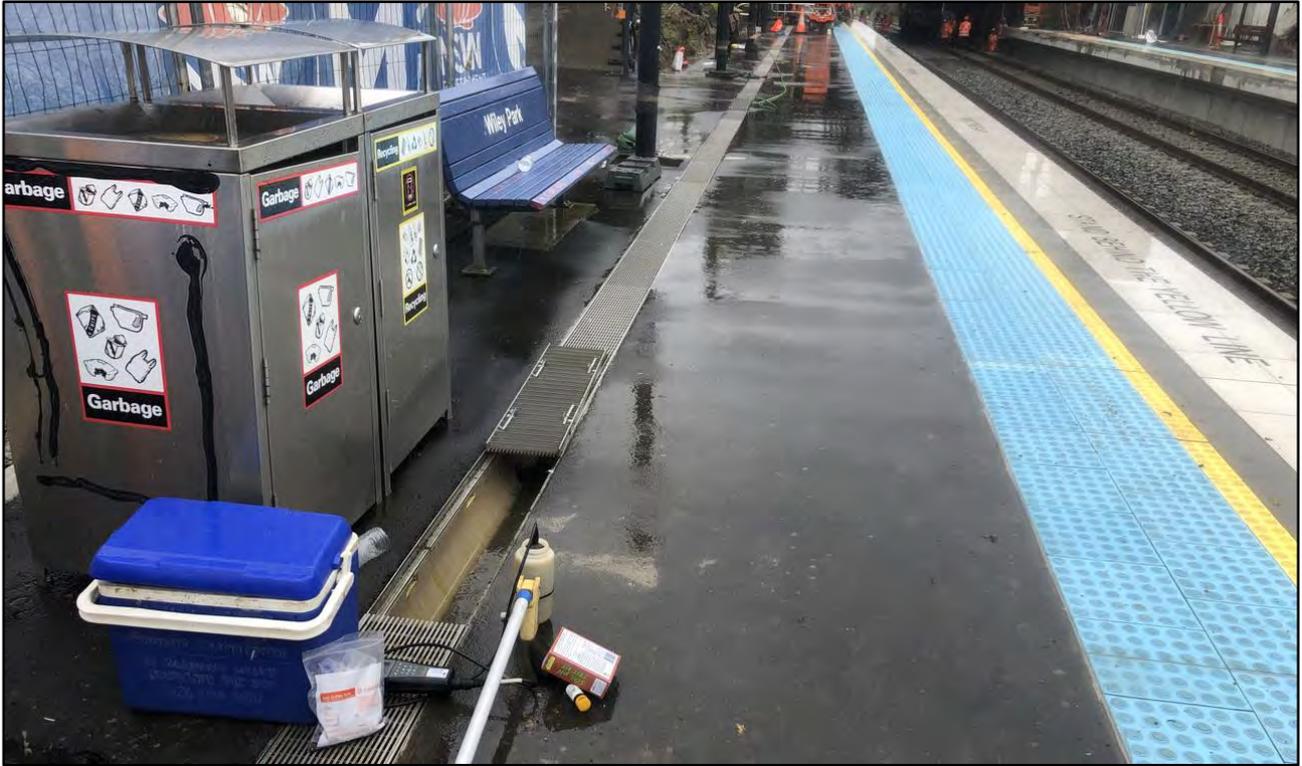
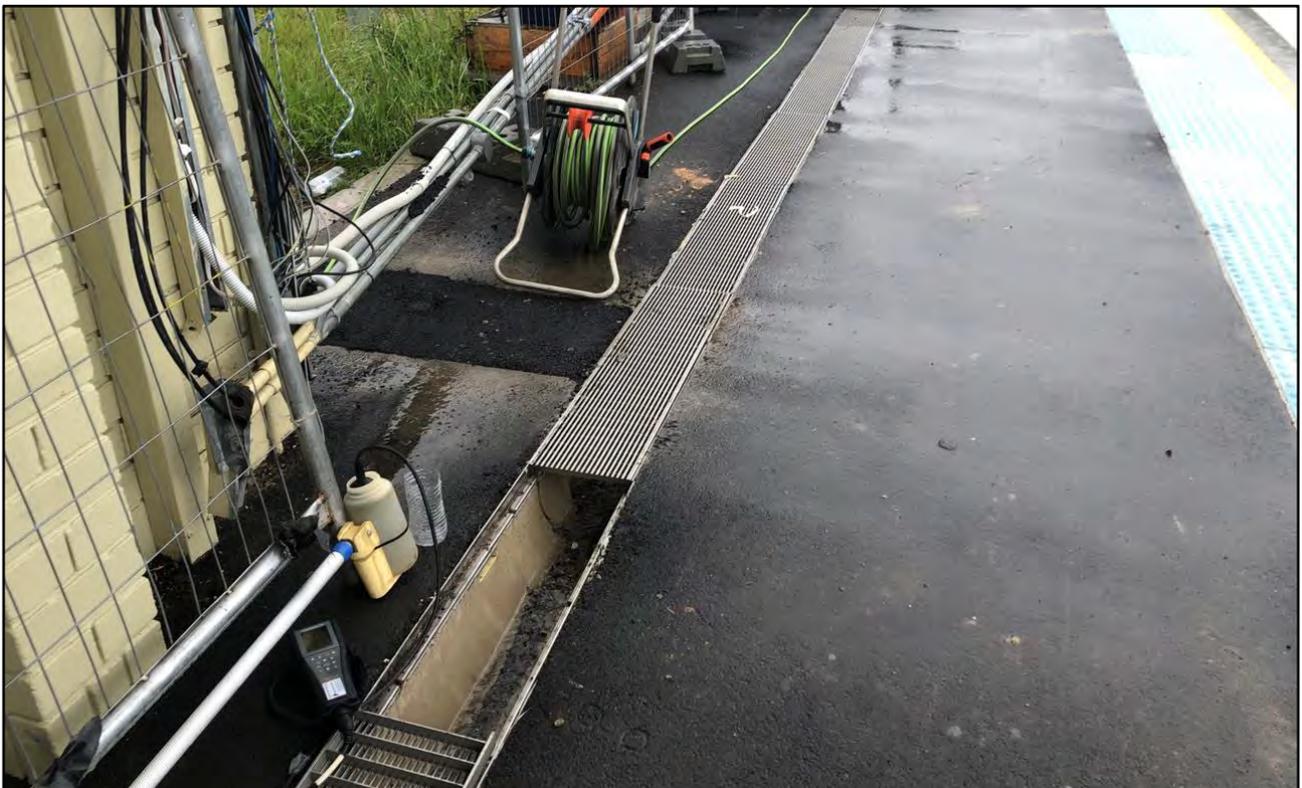
Photograph 7. Aco drain check – tap water test. Date: 5 October 2022.

Photograph 8. Aco drain check – tap water test. Date: 5 October 2022.

- Completion of a validation test: following the removal and cleaning work of the Platform 1 drainage system, a validation test is recommended to check the effectiveness of the mitigation works undertaken by applying tap water at the start / upstream of the Platform 1 drainage system and measuring pH using a calibrated water quality meter at multiple downstream locations along the aco drain and associated drainage system.

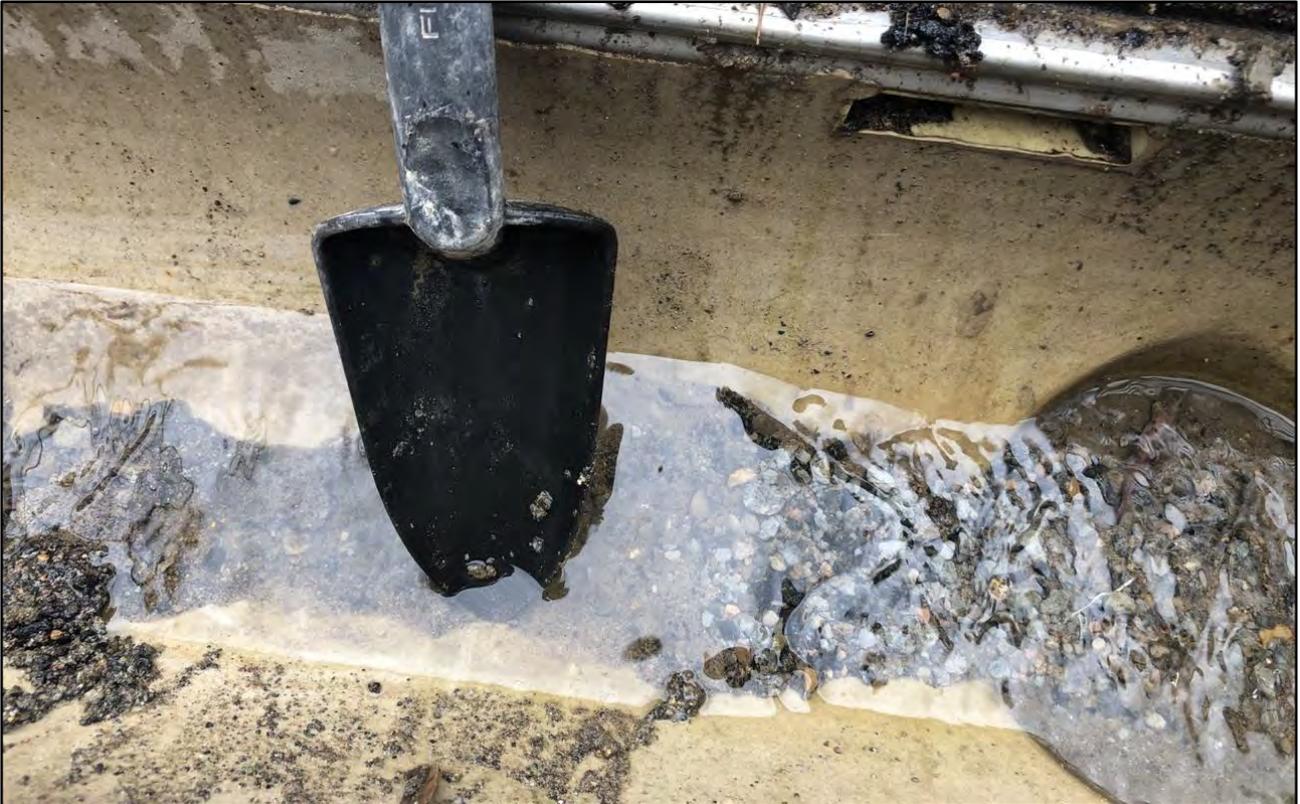
- pH measurements of the soil / sediment materials sampled from the aco drain were all alkaline, which is consistent with the soil pH measured from the surrounding soils within the areas that are considered to fall within the catchment area of the Platform 1 drainage system. Additionally, the texture and the type of soil / sediment materials within the aco drain was noted to be similar to soils located within the surrounding area.

Photograph 9. Aco drain check – soil/sediment pH measurement. Date: 5 October 2022.

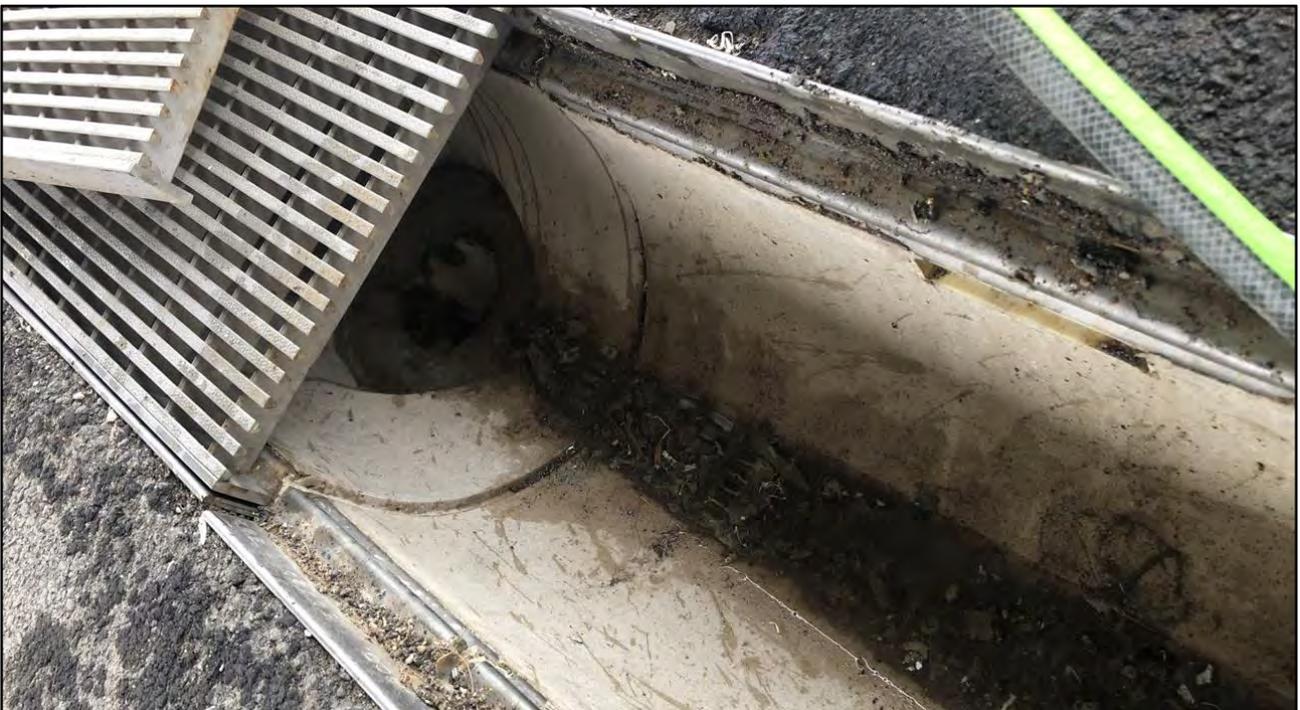
Photograph 10. Aco drain check – additional observation – drainage point. Date: 5 October 2022.

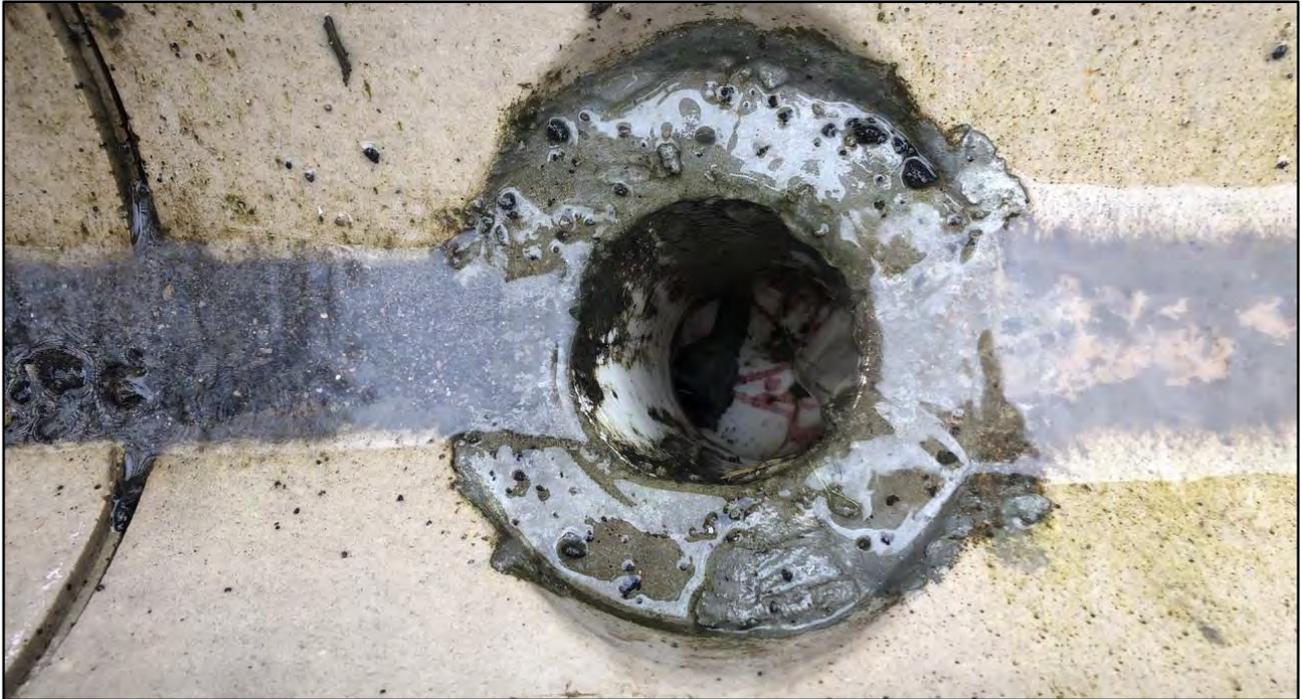
Photograph 11. Aco drain check – additional observation – drainage point. Date: 5 October 2022.
