CONSTRUCTION MONITORING REPORT
APRIL 2022 TO November 2022
Sydney Metro City & Southwest
Package 5 & 6
Customer: Sydney Metro

Project Document Code	Latest Version Number	Latest Version Date
Package 5 - SMCSWSW5-DEW-WEC-EM-REP-001600	Rev B	25/11/2022
Package 6 - SMCSWSW6-DEW-WEC-EM-REP-001499

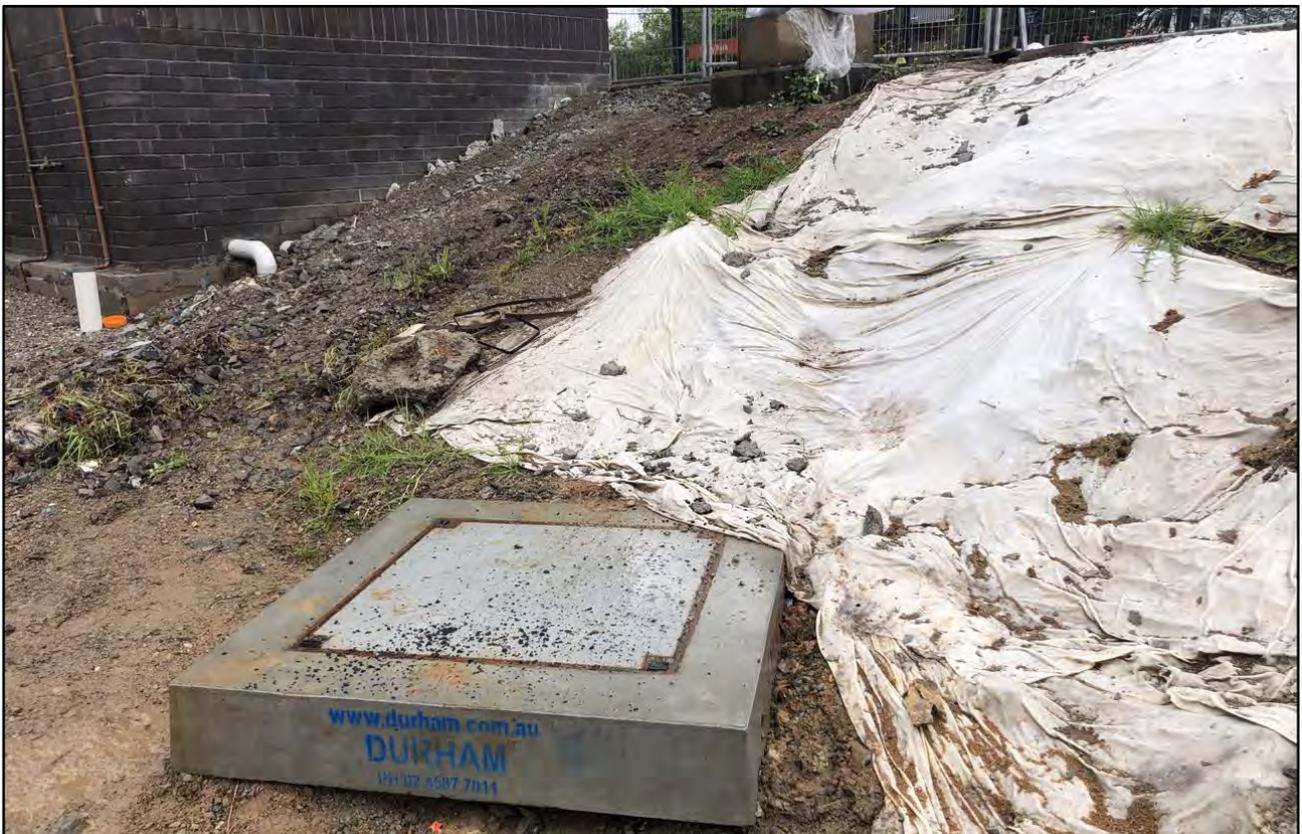
- > Two drainage pits were observed between the downstream (south-western) end of the aco drain and the downstream discharge point (i.e., Headwall 1). This observation was consistent with the drainage drawing reviewed. However, neither drainage pit was accessible for inspection. Refer to **Figure GS-007** in **Attachment A** for approximate locations observed. Refer to **Photograph 12** in **Attachment B** for details.

Photograph 12. Aco drain check – additional observation – drainage pit. Date: 5 October 2022.

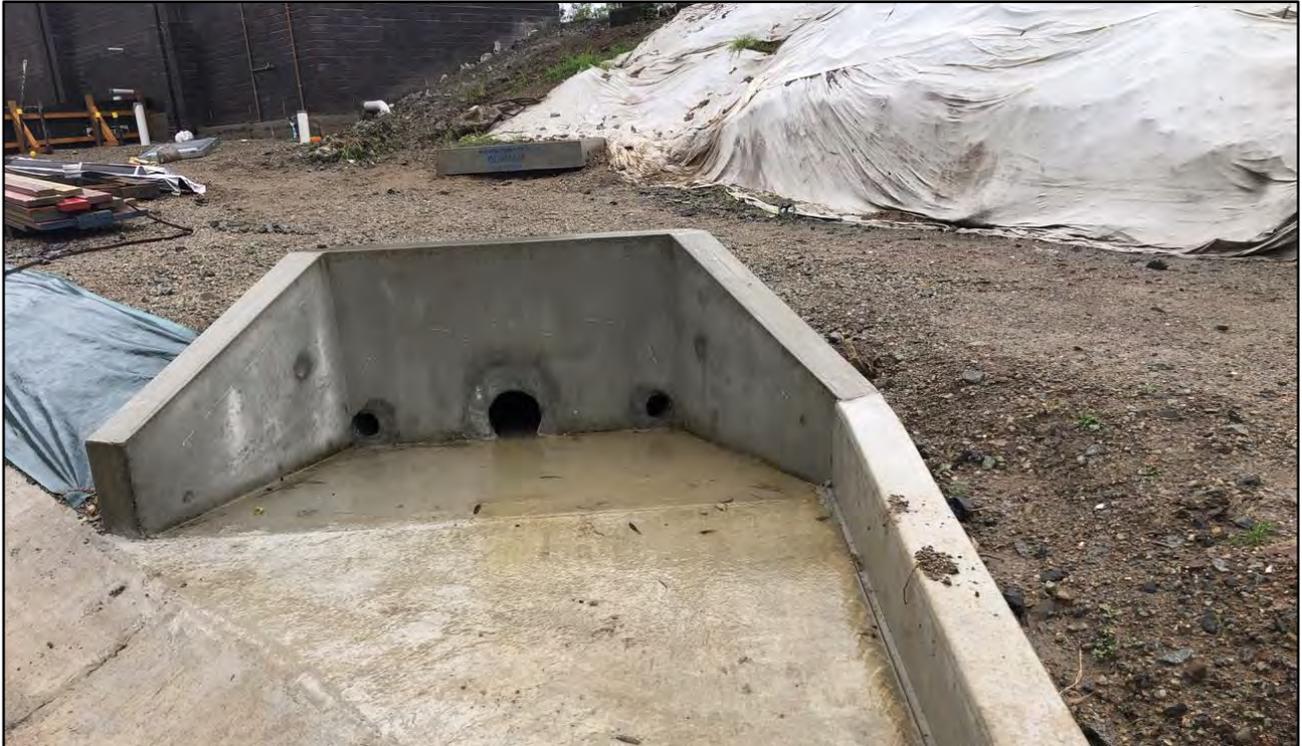
- It is noted that the pH value measured at the downstream discharge point (i.e., Head Wall 1) was 9.78 which was the highest pH value measured from all the water pH monitoring points associated with this aco drain tap water check during the investigation. This result also indicates the likelihood of the presence of alkaline materials (e.g., alkaline soil, alkaline sediment, etc.) within the underground drainage pipe and the two drainage pits.

Photograph 13. Downstream discharge point (the middle conduit of the Head Wall 1) of the surface water collected by the Platform 1 drainage system. It is noted that the two smaller diameter conduits on the sides are not connected to any drainage system and only functioned as weepholes. Date: 5 October 2022.

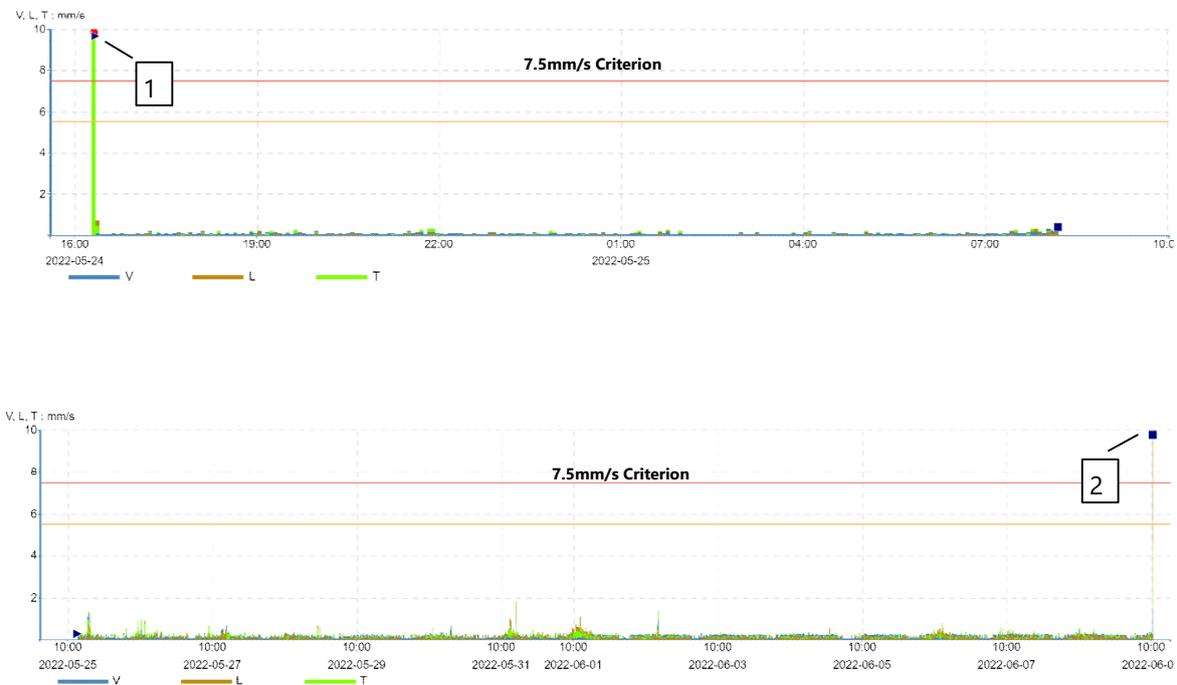
Figure 4-3: M3 vibration monitoring results between 24th May 2022 and 9th June 2022

The results of the unattended vibration monitoring for 3A Commons Street between 24th May 2022 and 9th June 2022 is shown in Figure 4-3.

The discussion of the M3 vibration monitoring results is summarised in Table 4-3.

Exceedance ID	Date and Time	Cause of exceedance
1	24.05.2022 04:39pm	At this time, the vibration monitor was being installed on the ground spike to commence the vibration monitoring. This exceedance was caused by the RT&A engineer mounting the monitor on the ground spike. No construction activities were occurring at this time.
2	09.06.2022 10:00am	At this time, the vibration monitor was removed from the ground spike to complete the vibration monitoring. The exceedance was caused by the RT&A engineer removing the monitoring from the ground spike. No construction activities were occurring at this time.

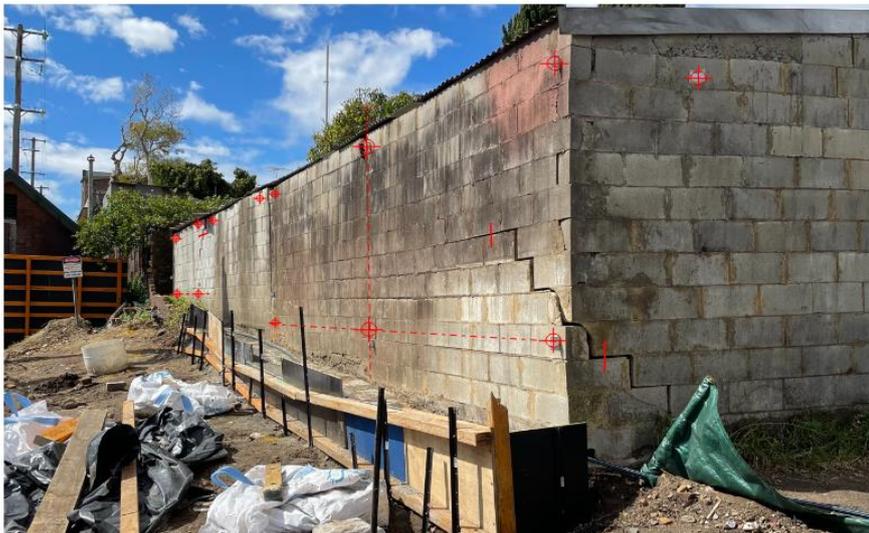
- Visually monitor the condition of the garage wall during construction activities on a daily basis
- Inspect and record results of the survey and crack gauge position on a daily basis during rock breaking activities otherwise weekly
- Should any vertical or translation movement exceed 3mm refer to Lindsay Dynan for review
- Should any crack width increase by 1mm or greater refer to Lindsay Dynan for review (Note: 1mm limit is based on a Very Slight damage category in accordance with AS 2870. Refer appendix A for further details)

— Denotes location and orientation for crack gauge (pack out and bond to blockwork) (3 locations)
