# CONSTRUCTION MONITORING REPORT

## Sydney Metro City & Southwest

### Package 5 & 6

Customer: Sydney Metro

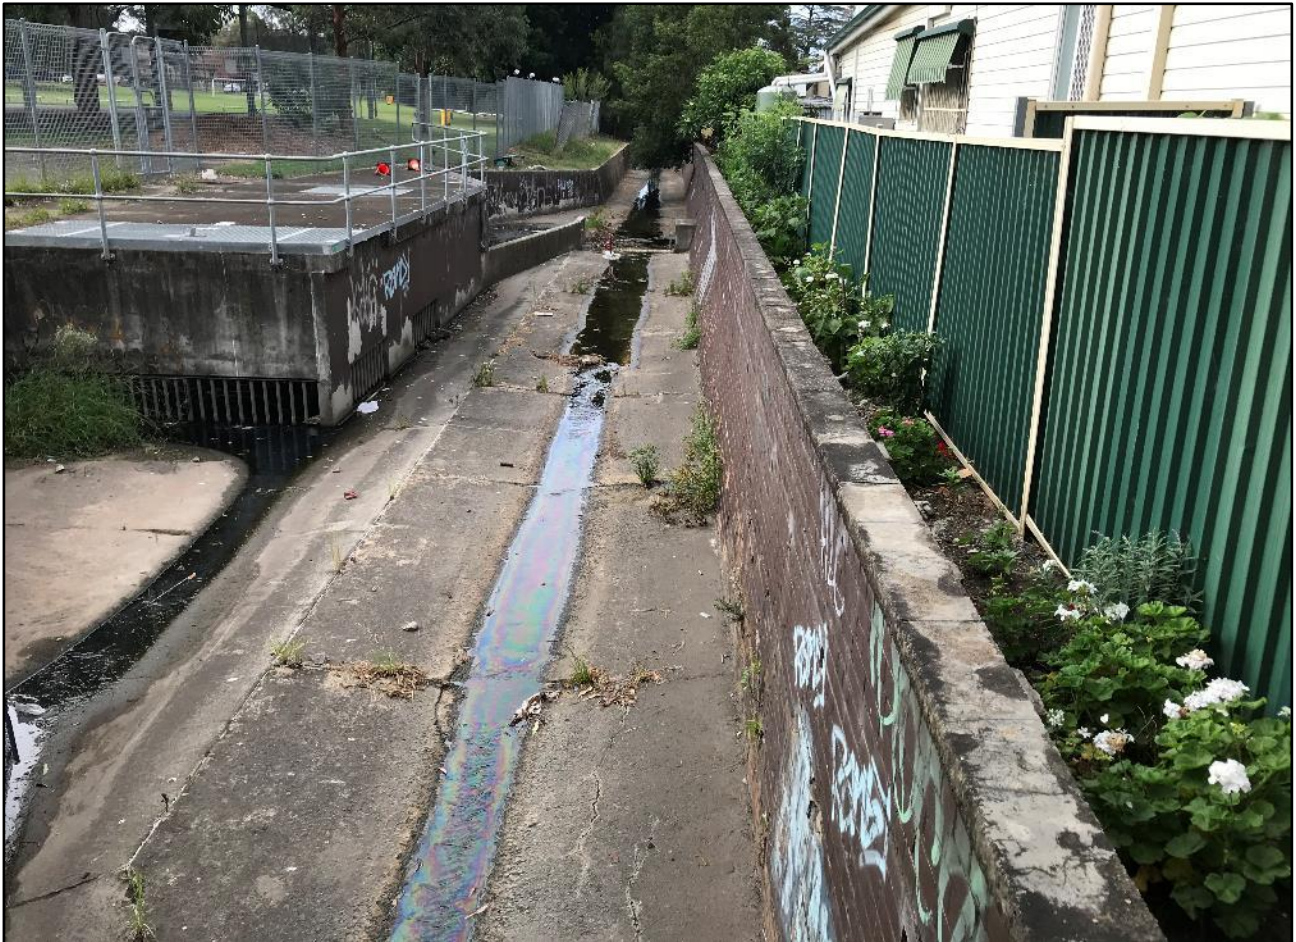
- The sampling event was undertaken in cloudy weather with 0 mm precipitation over the last 24 hours;
- WP 1 contained low flowing clear water with low turbidity. The estimated depth of the water body was 0.03 m. Visible oil sheen observed at the time of sampling work (refer Photograph 1 in Appendix B); and
- WP 2 contained low flowing clear water with low turbidity. The estimated depth of the water body was 0.03 m. Visible oil sheen observed at the time of sampling work (refer Photograph 2 in Appendix B);

**Photograph 1.** Condition observed from sampling location of WP1 during the monitoring event – 10 March.

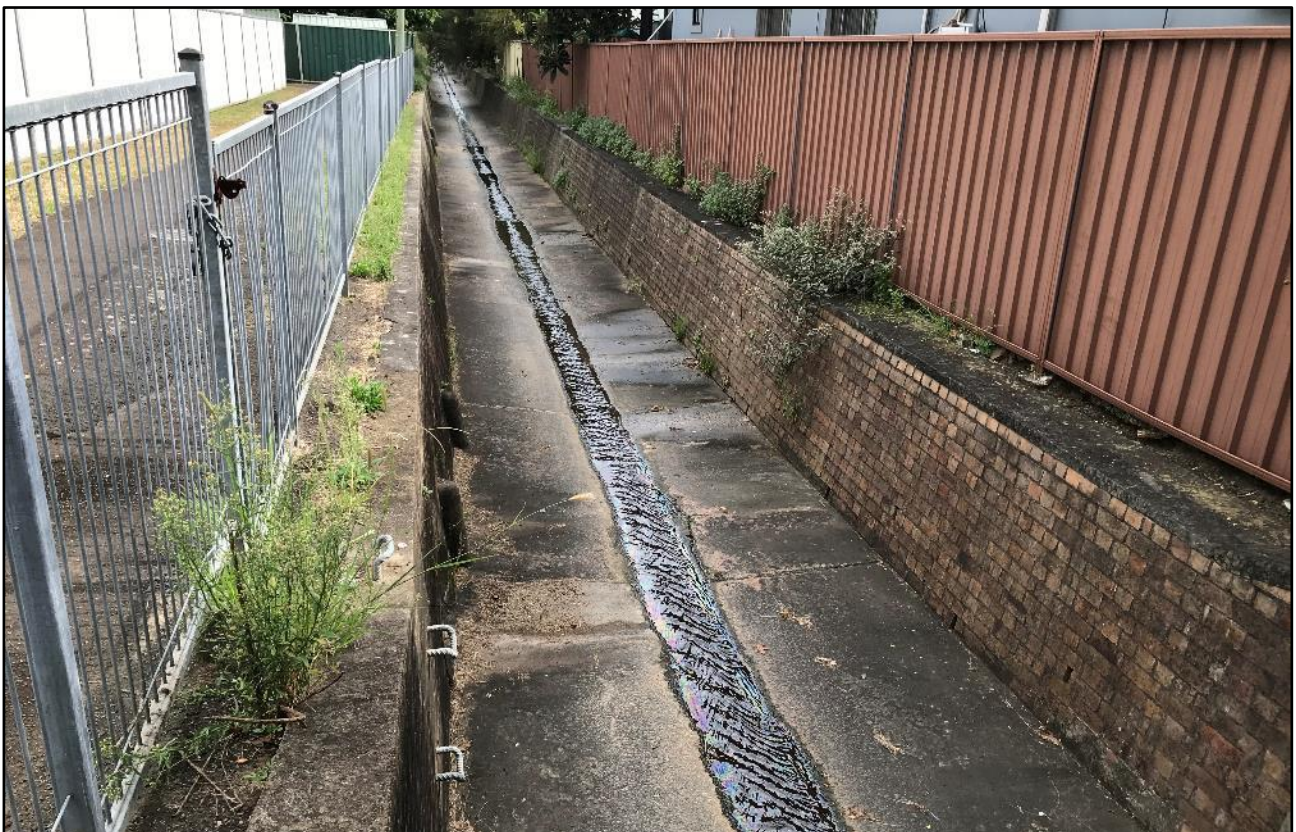
**Photograph 2.** Condition observed from sampling location of WP2 during the monitoring event – 10 March.

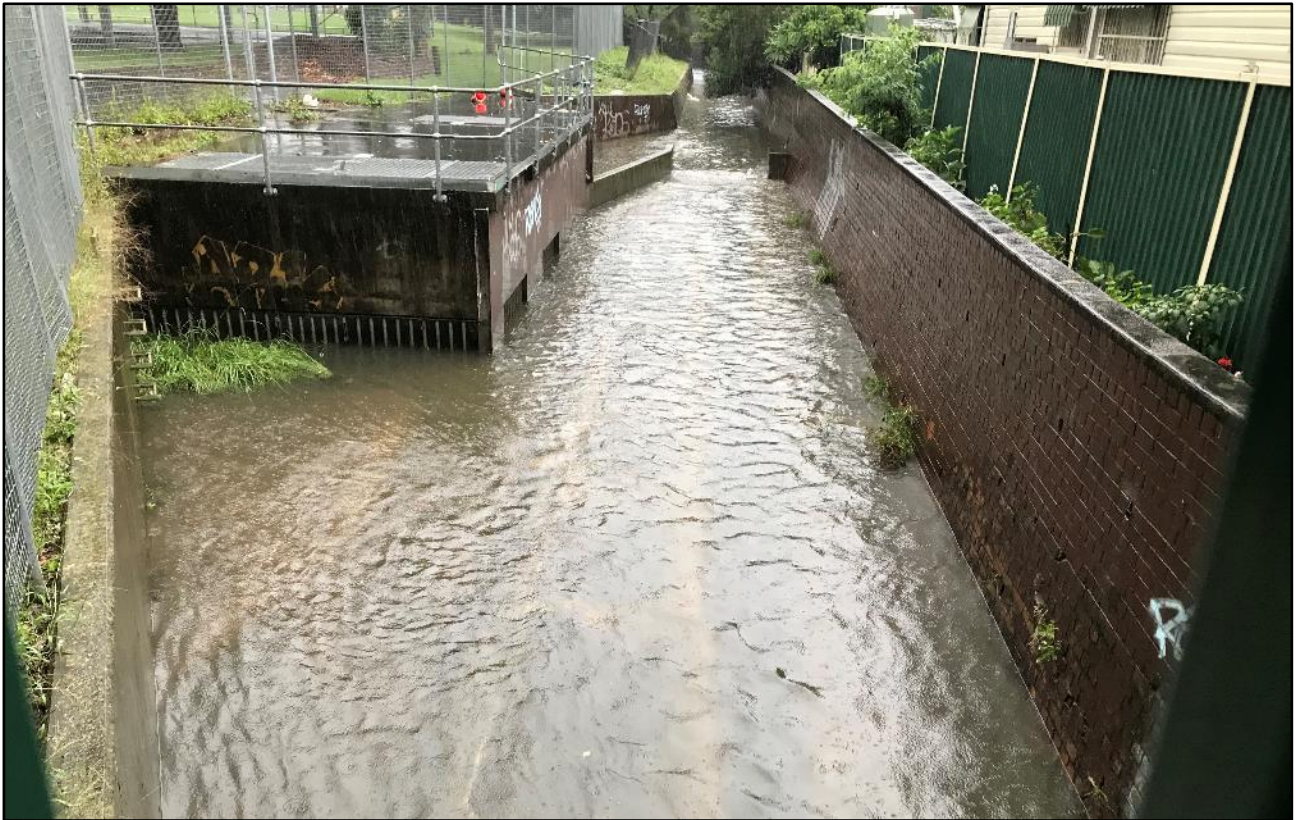
**Photograph 3.** Condition observed from sampling location of WP1 during the monitoring event – 20 March.

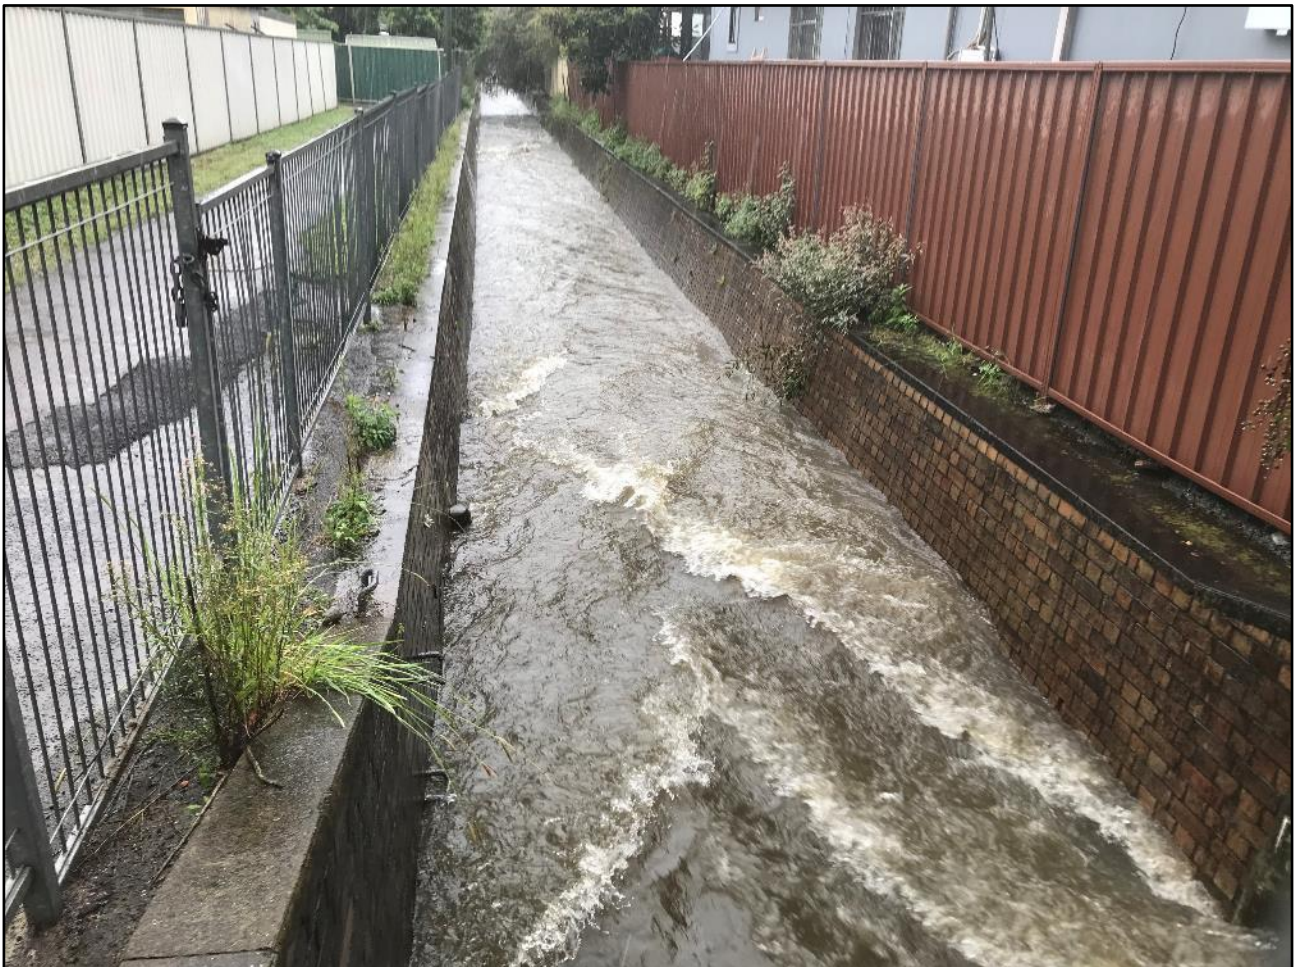
**Photograph 4.** Condition observed from sampling location of WP2 during the monitoring event – 20 March.

During the wet weather event sampled on 20 March, TSS and turbidity results were observed to be higher in the downstream WP2 sampling point. Although baseline conditions for wet weather are unknown, Cardno recommends the Environment Manager (or delegate) to re-test to confirm results and undertake an inspection of the adjacent works and propose actions where required in accordance with the SMWP.

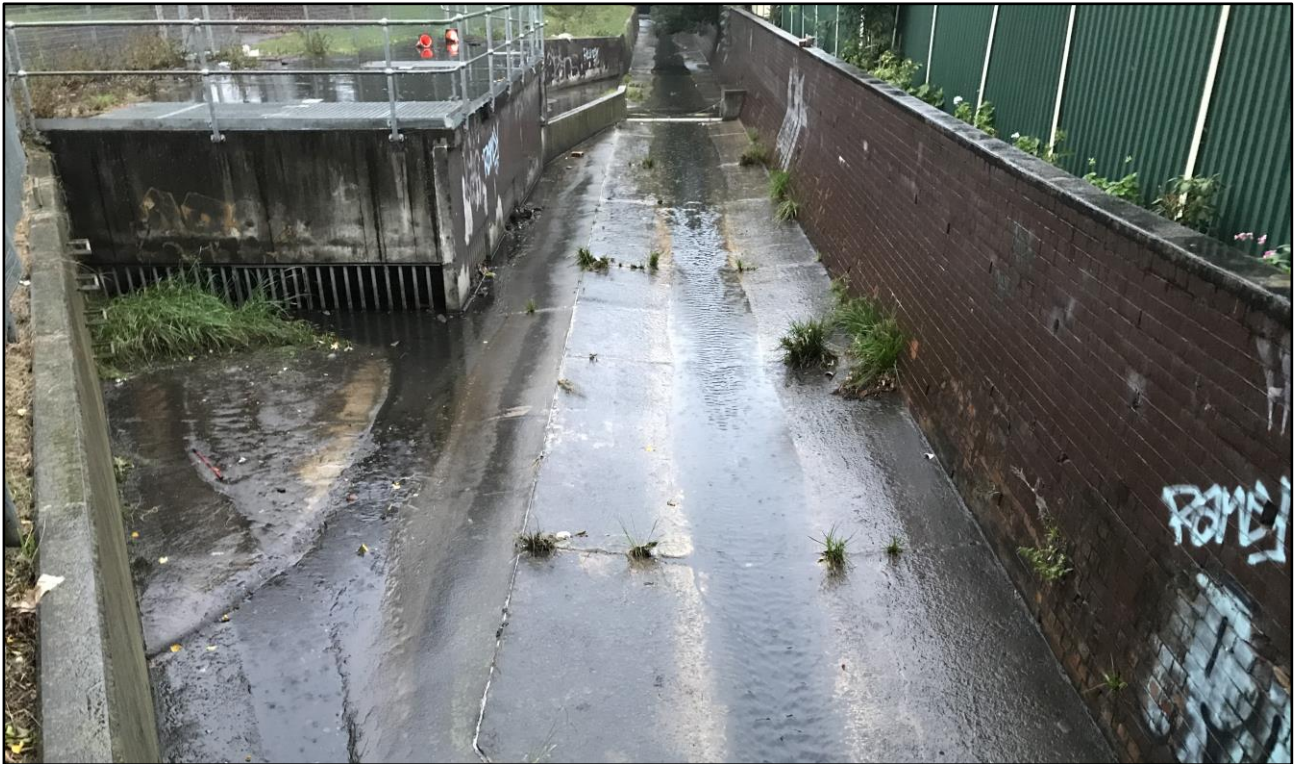
**Photograph 1.** Condition observed from sampling location of WP1 during the monitoring event – 5 May.

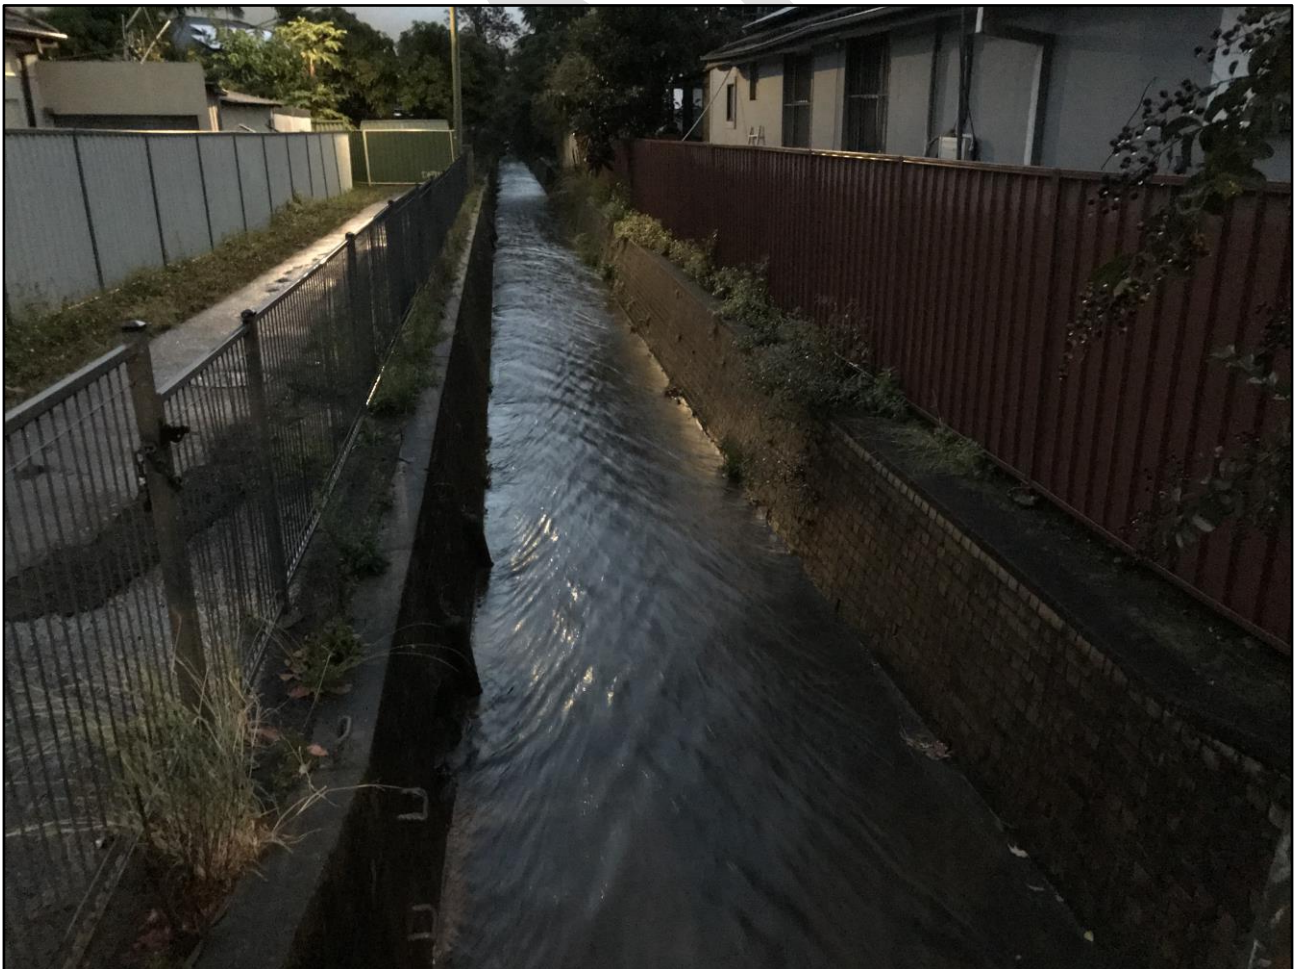
**Photograph 2.** Condition observed from sampling location of WP2 during the monitoring event – 5 May.

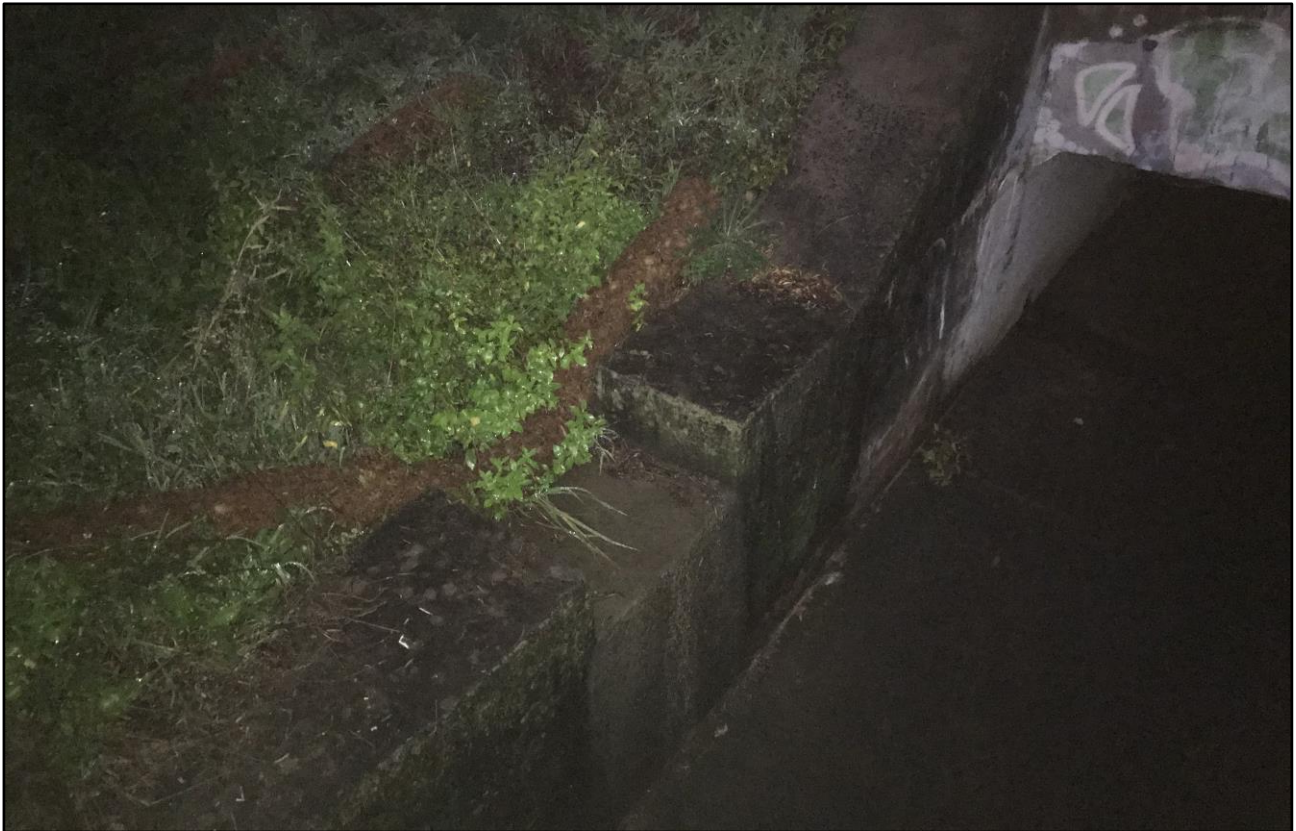
During the wet-weather sampling event the two discharge points (including the one connecting the construction site and the unnamed channel) within the rail corridor immediately upstream / south from WP2 were observed to be not flowing and not contributing to the channel. Therefore, exceedances are not related to Downer's construction activities.

**Photograph 3.** No water flow observed from the discharge (the one connecting the construction site and the unnamed channel) which is located within the rail corridor and immediately upstream / south from WP2 during the monitoring event – 5 May.

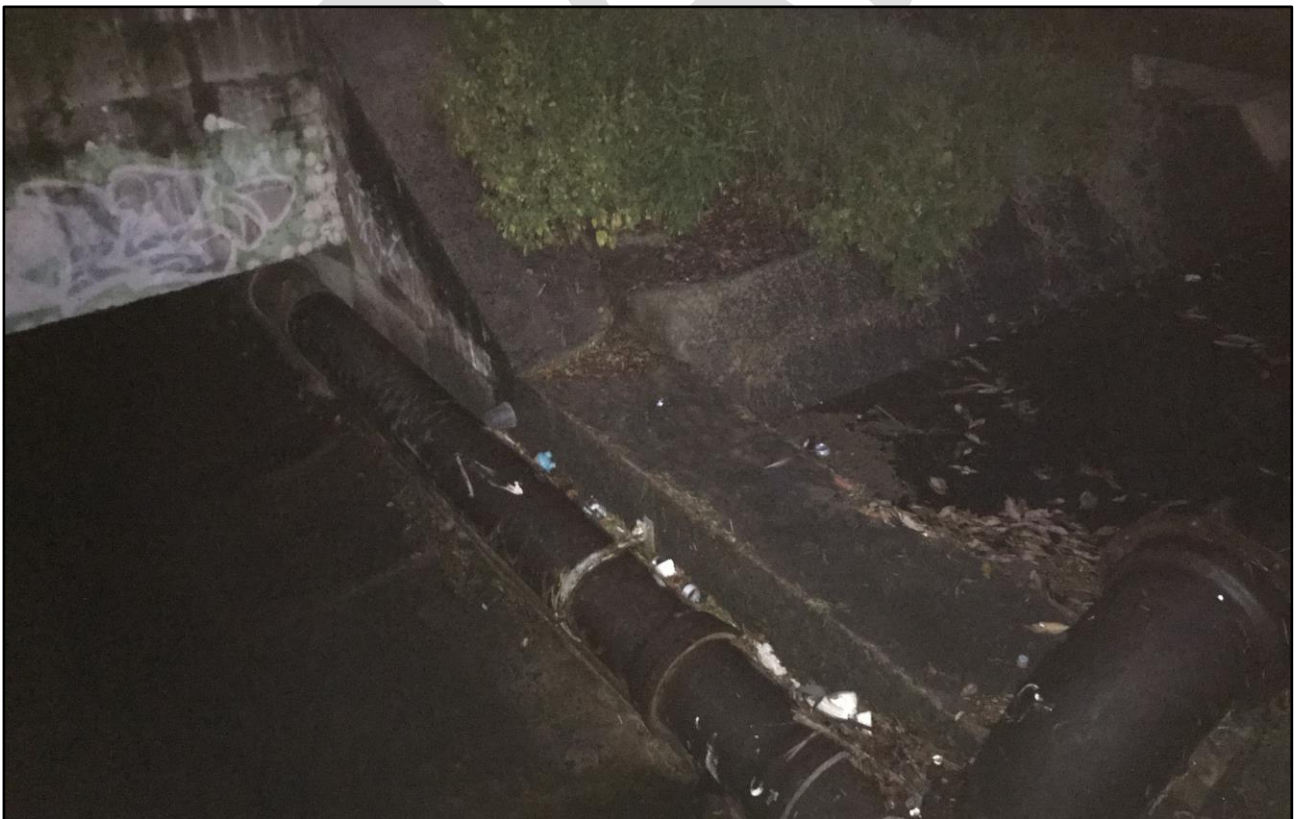
**Photograph 4.** No water flow observed from the discharge point which is located within the rail corridor and immediately upstream / south from WP2 during the monitoring event – 5 May.

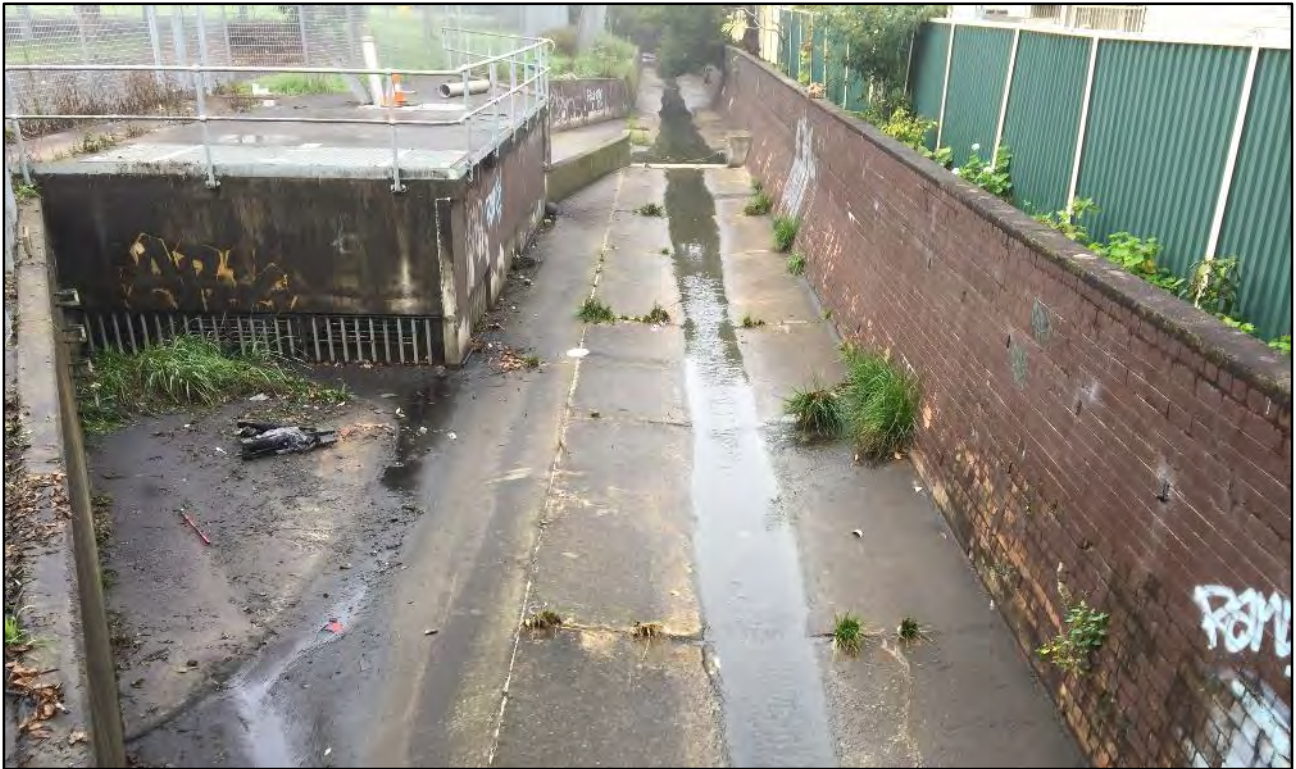
**Photograph 1.** Condition observed from sampling location of WP1 during the monitoring event – 1 July.

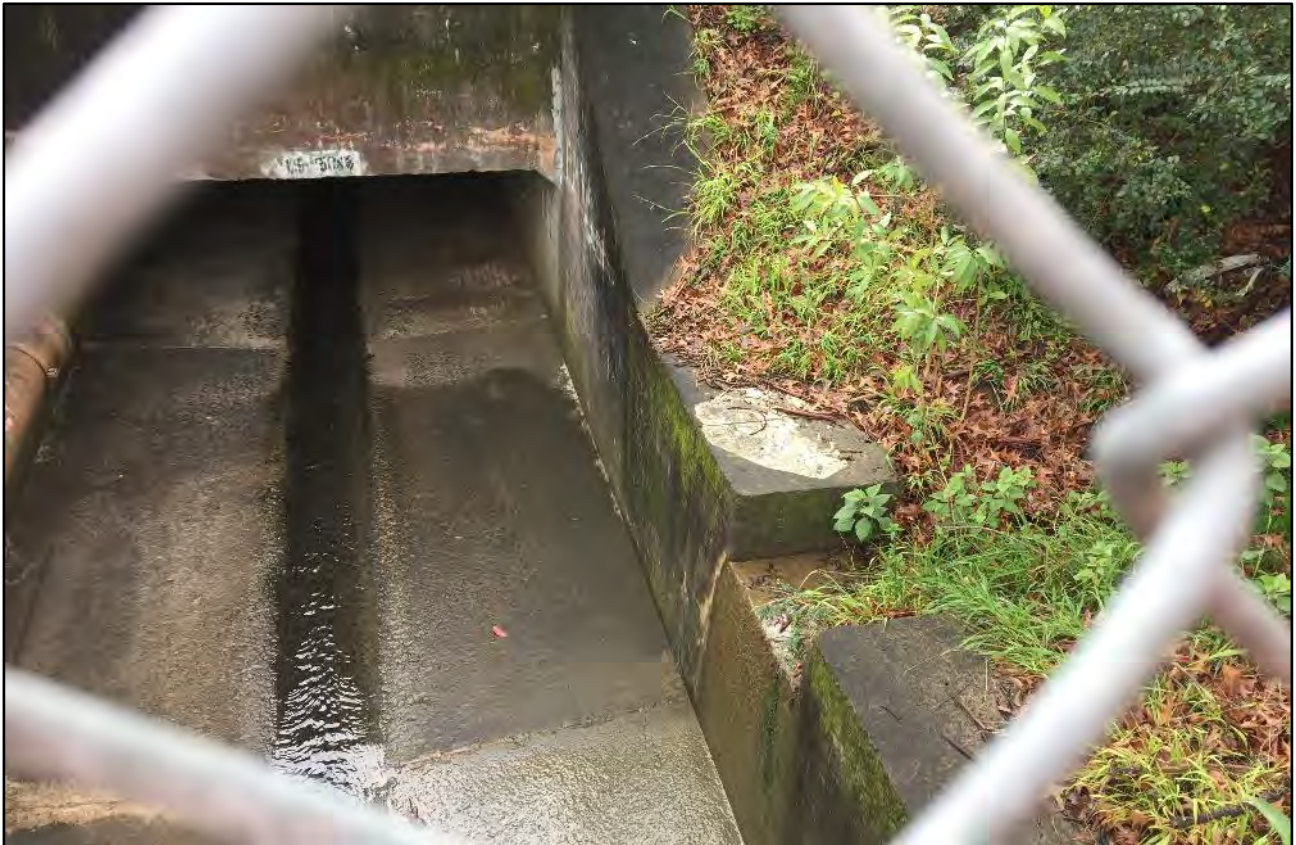
**Photograph 3.** No stormwater in-flow observed from the discharge point WP1-DP1 which is located within the rail corridor and immediately downstream / north from WP1 during the monitoring event – 1 July.

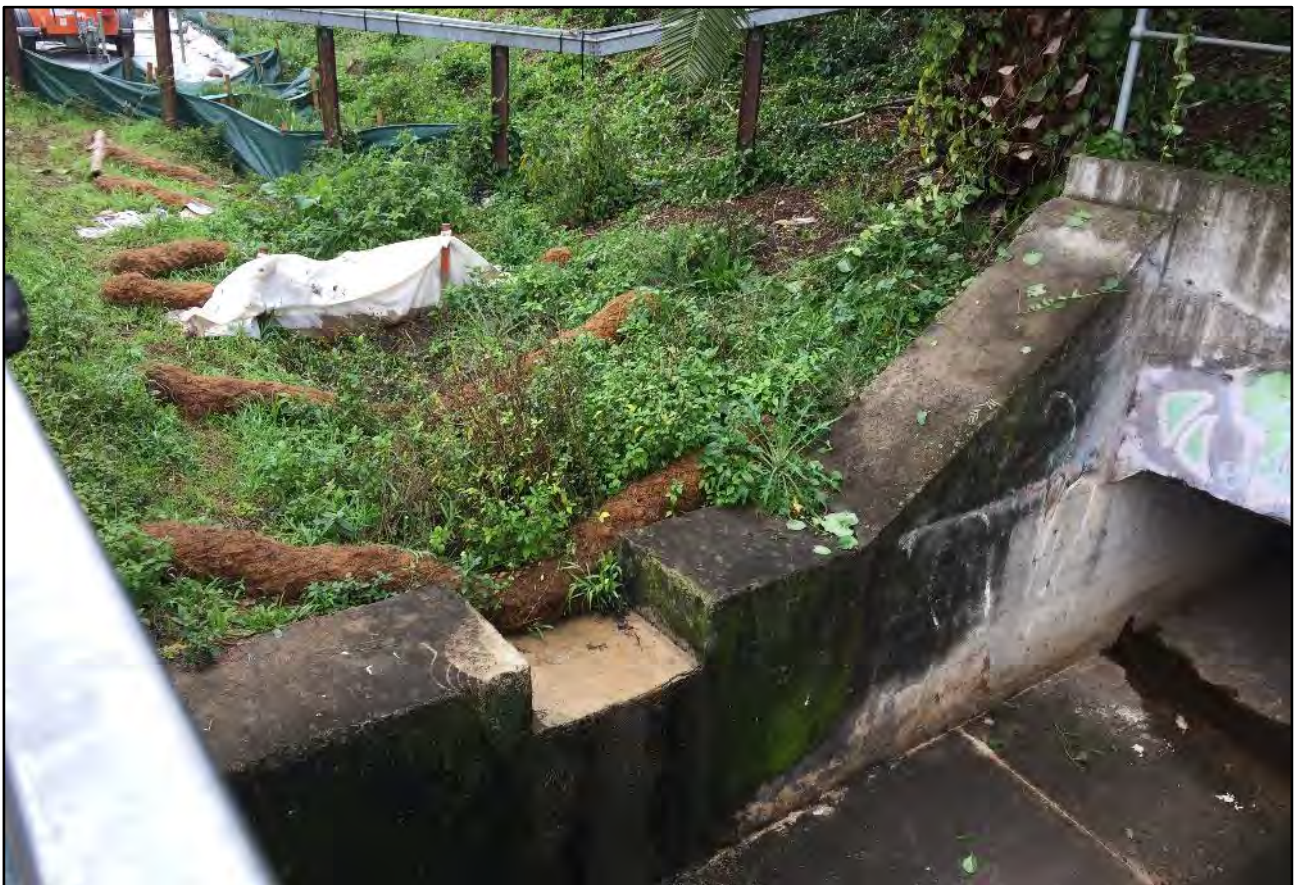
**Photograph 4.** No stormwater in-flow observed from the discharge point WP2-DP1 which is located within the rail corridor and immediately upstream / south from WP2 during the monitoring event – 1 July.

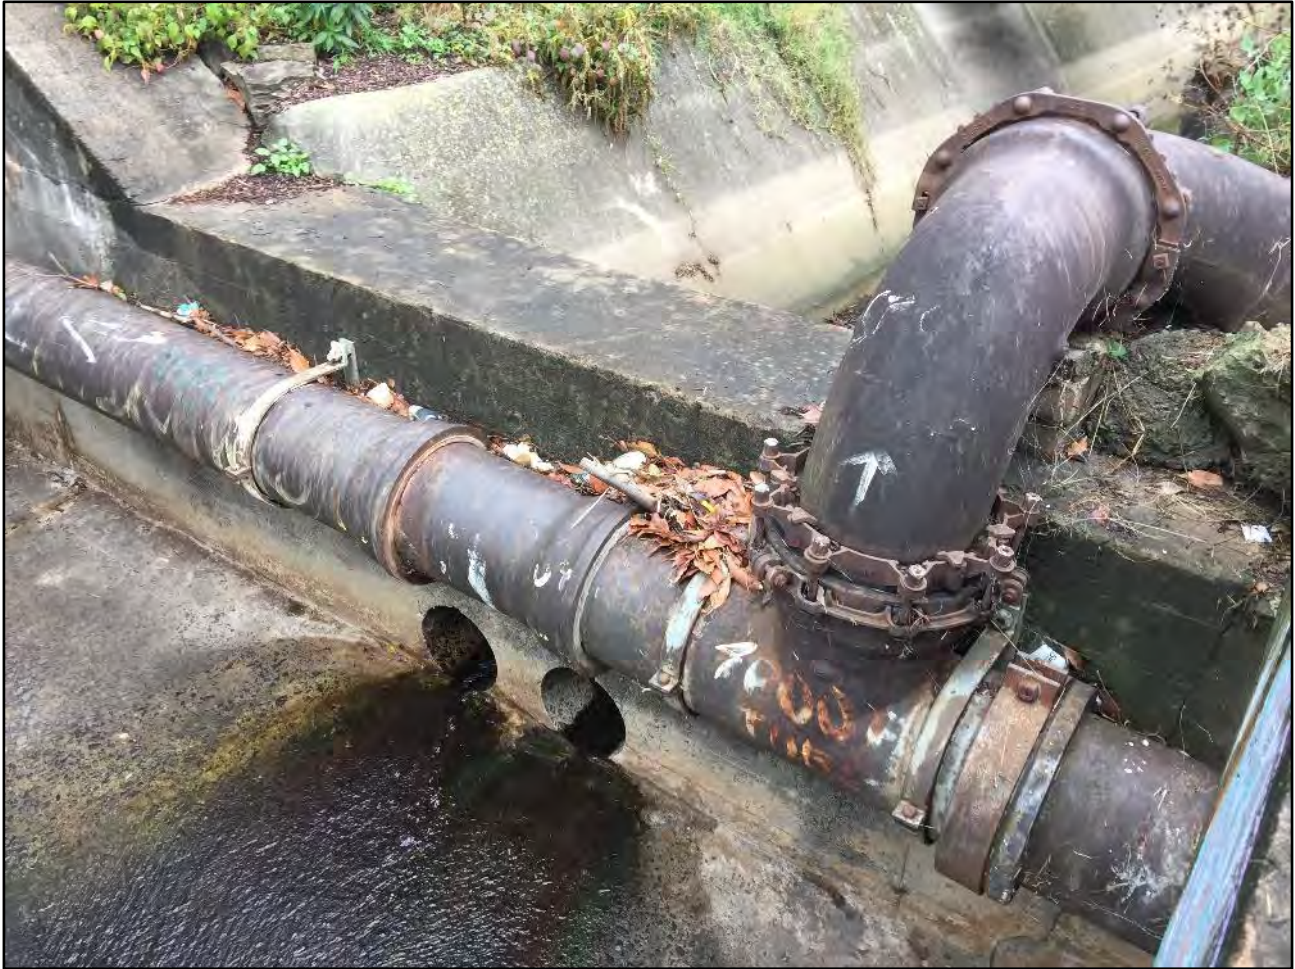
**Photograph 5.** Stormwater in-flow observed from the discharge point WP2-DP2 which is located within the rail corridor and immediately upstream / south from WP2 during the monitoring event – 1 July.

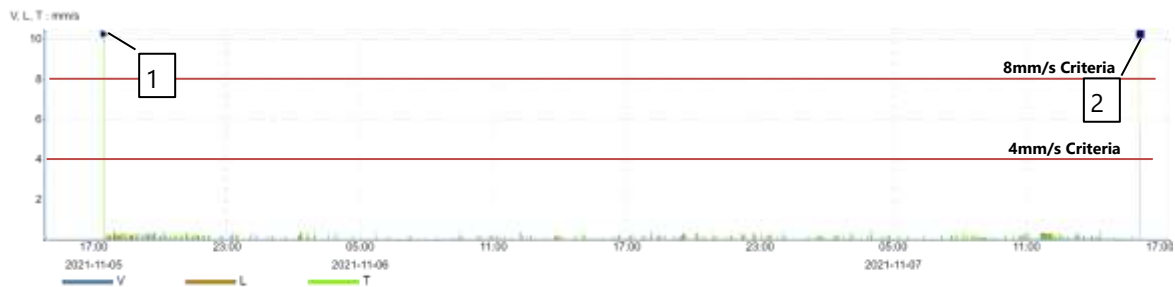
Figure 4-1: Unattended vibration monitoring location 1 results (refer to Appendix A.3)

The results of the unattended vibration measurements for the neighbouring garage structure at 3A Commons Street are presented in Figure 4-1 and Figure 4-2.

It can be seen in Figure 4-1 and Figure 4-2 that the vibration levels produced from the vibration intensive works in the vicinity of the affected garage structure is below 4 mm/s. Note that there were events that resulted in an instantaneous vibration level of above 4 mm/s which are justified in Table 4-2.
