Tree Impact Assessment Report

City and Southwest Metro Station Upgrade Works Package 5 & 6

P5 Document No. SMCSWSW5-DEW-WEC-EM-REP-000542

P6 Document No. SMCSWSW6-DEW-WEC-EM-REP-000632

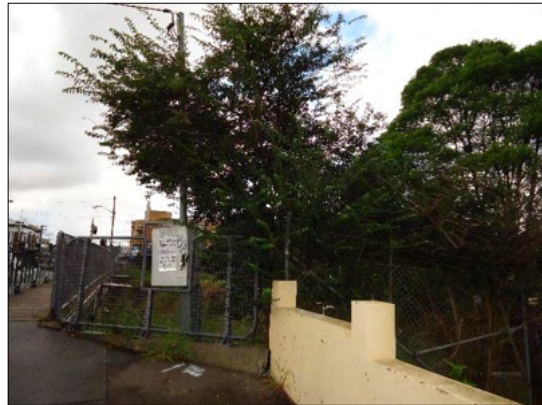
Tree 1 *Ligustrum sinensis* (Small-leafed Privet) is an identified species under the *Biosecurity Act 2015*. A general biosecurity duty exists within NSW to prevent, eliminate or minimise any biosecurity risk. The trees are not representative of a threatened or endangered species or ecological community.

Photograph 1: Tree 1 *Ligustrum sinensis* (Small-leaved Privet) to be removed for pilling works adjacent rail bridge.

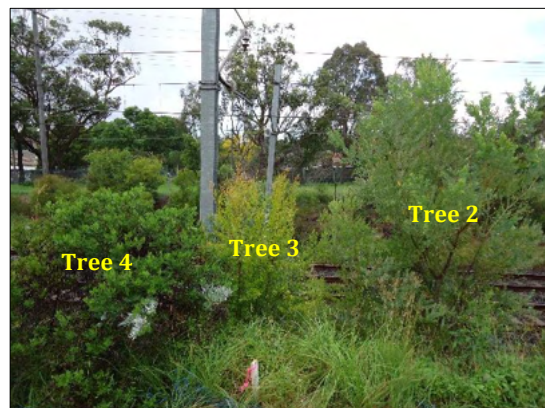
Photograph 2: Trees 2 *Acacia* sp (Wattle), 3 *Leptospermum* sp (Tee Tree) and 4 Unknown species to be removed for MSB works.

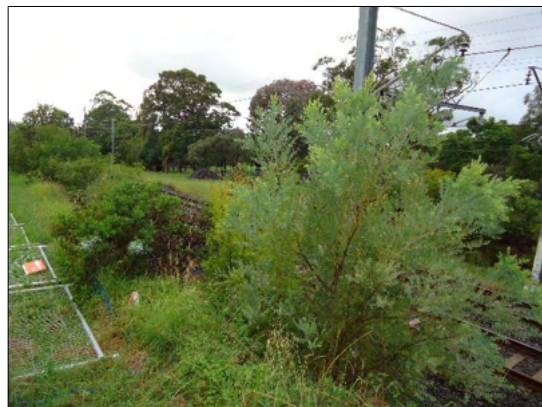
Photograph 3: Tree 5 *Acacia* sp (Wattle) to be selectively pruned for clearance along the embankment.

Tree 5 *Acacia* sp (Wattle) identified pruning involves the removal of approximately four branches up to 20mm in diameter and constitutes <10% of the total canopy volume. The pruning is not expected to have a significant impact upon the remaining stems.

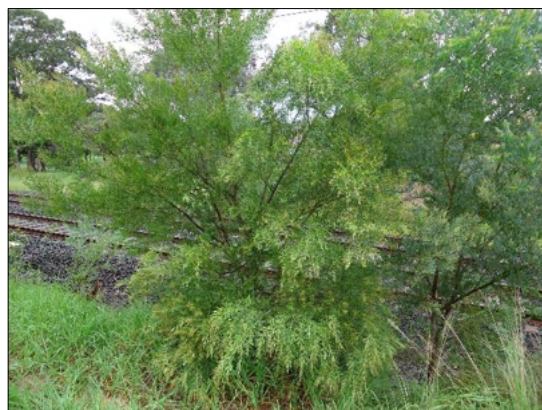
Photograph 4: Tree 6 *Acacia* sp (Wattle) to be removed for MSB works.

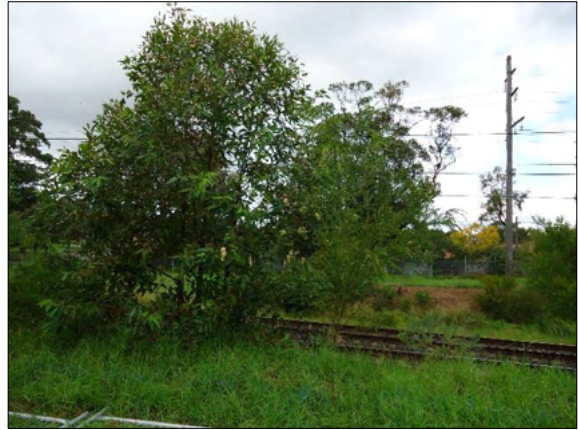
Photograph 5: Tree 7 *Eucalyptus robusta* (Swamp Mahogany) to be removed to accommodate the new GST alignment.

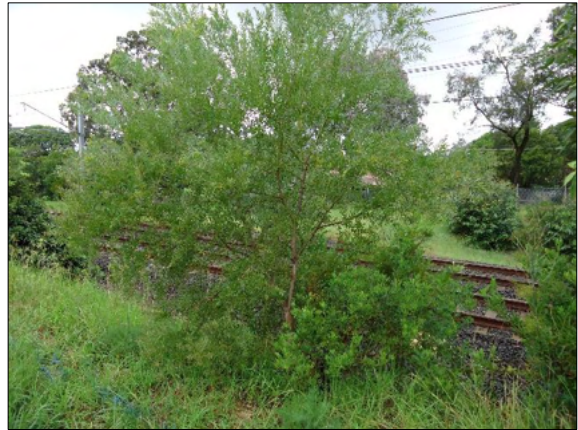
Photograph 6: Tree 8 *Acacia* sp (Wattle) to be removed for MSB works.

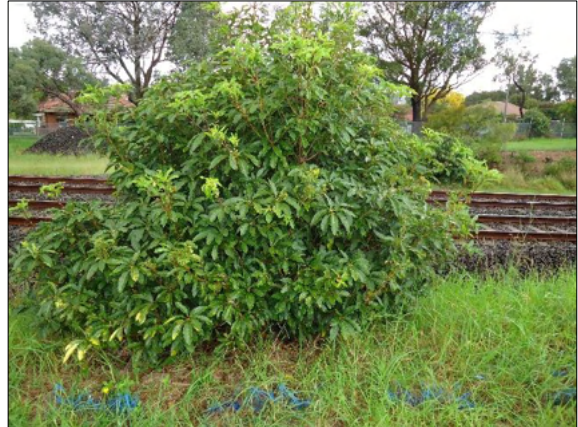
Photograph 7: Tree 9 *Pittorporum undulatum* (Sweet Pittosporum) to be removed for MSB works.

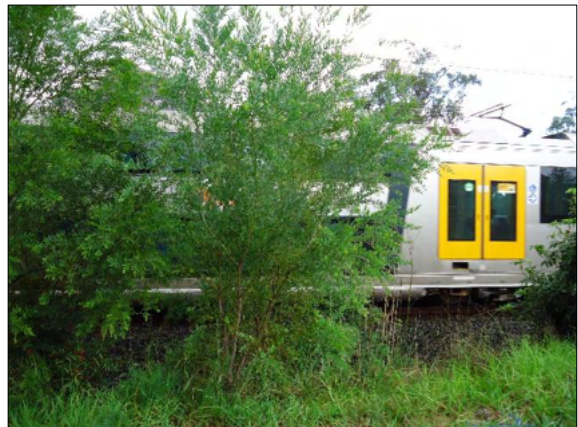
Photograph 8: Tree 10 *Acacia* sp (Wattle) to be removed for MSB works.

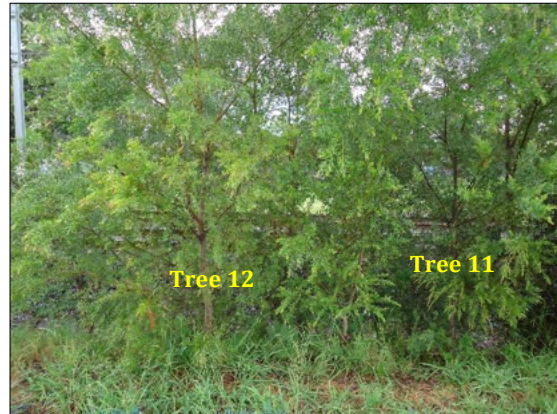
Photograph 9: Trees 11 and 12 *Acacia* sp (Wattle) to be removed for MSB works.

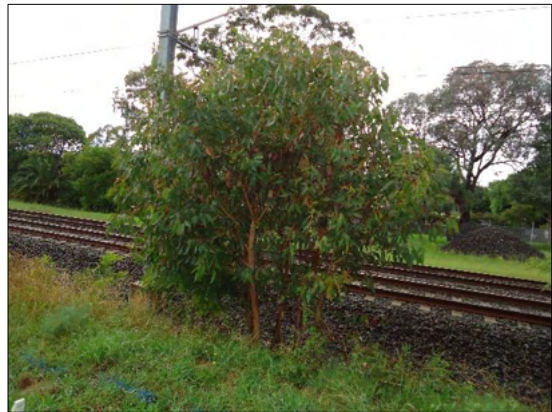
Photograph 10: Tree 13 *Eucalyptus robusta* (Swamp Mahogany) to be removed to accommodate the new sewer alignment.

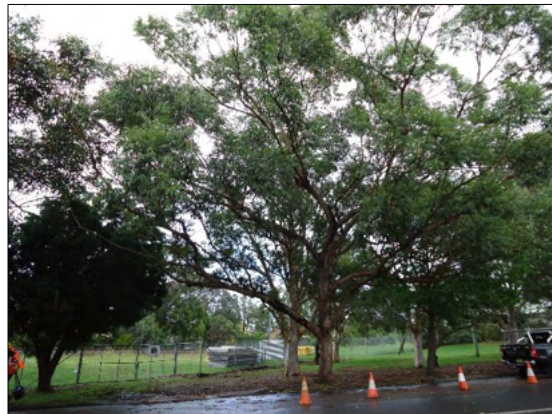
Photograph 11: Tree 14 *Eucalyptus robusta* (Swamp Mahogany) located within road reserve to be selectively pruned for site access clearances.

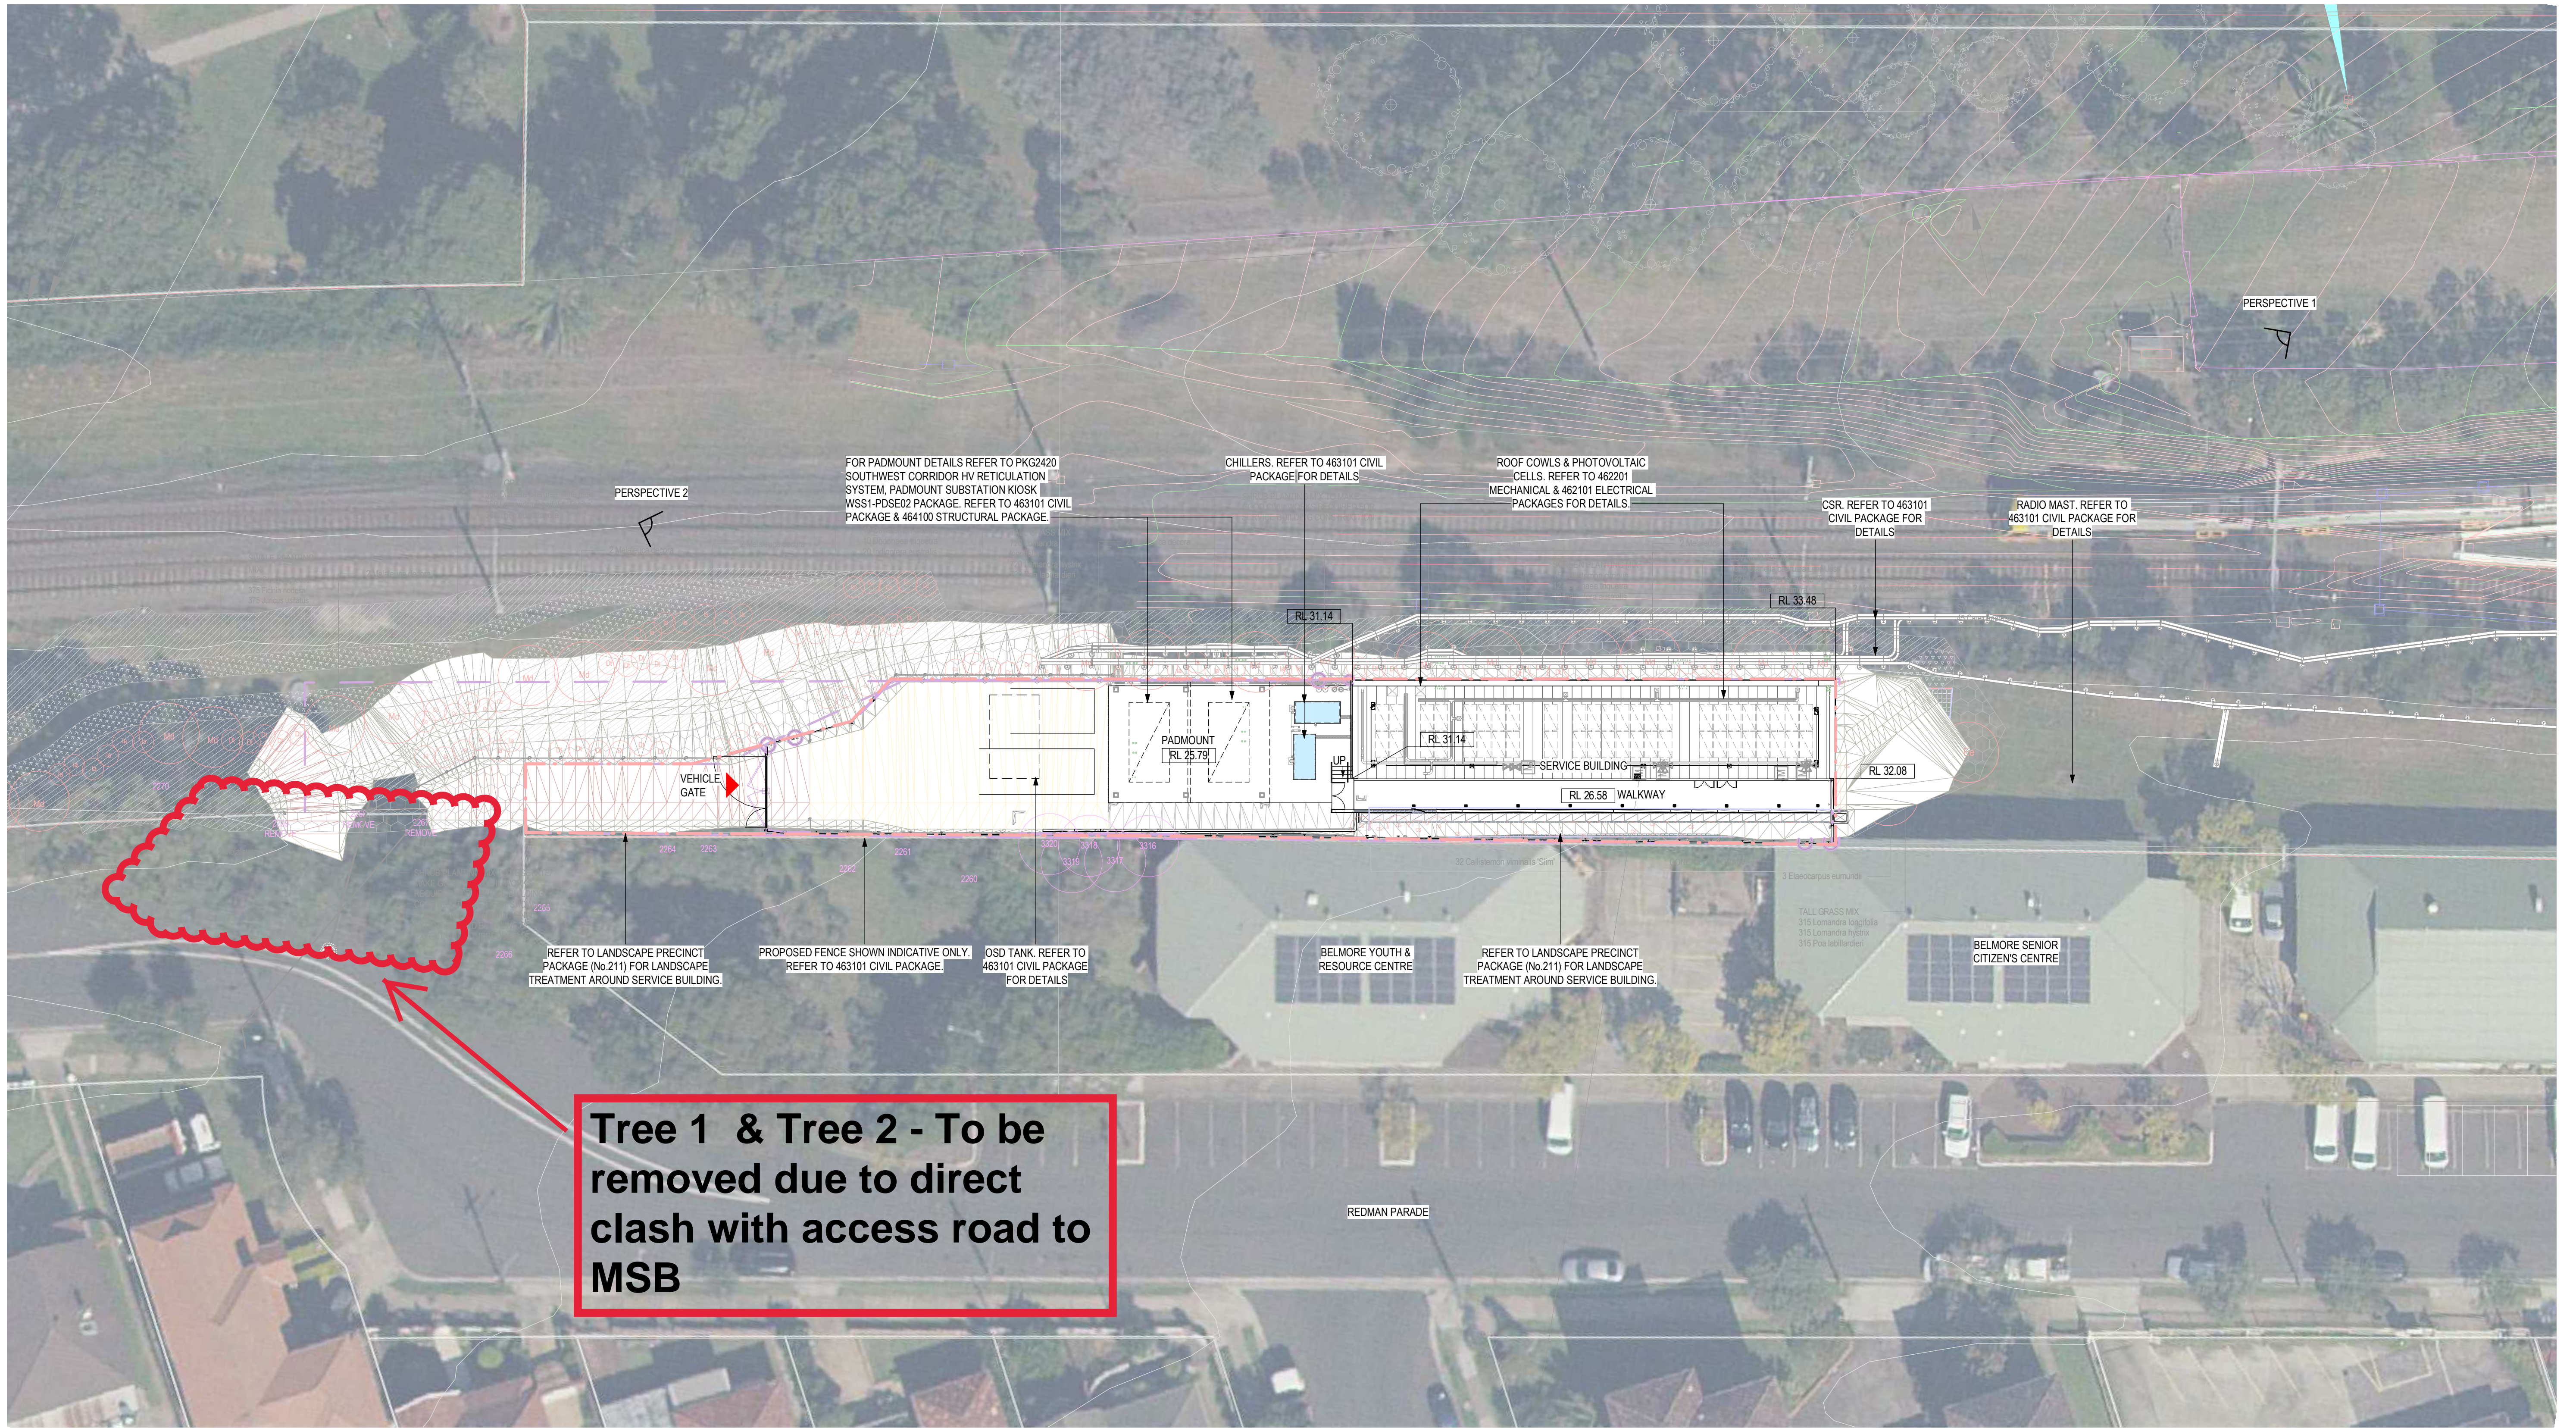
Tree 1 & Tree 2 - To be removed due to direct clash with access road to MSB

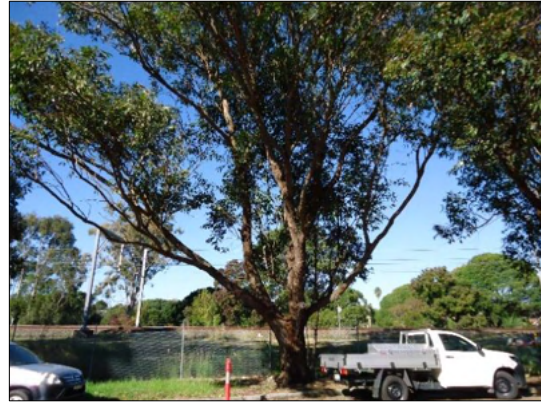
It was advised by Downer Group that two trees being a Swamp Mahogany, tree 1, and a Brown Pine, tree 2, are to be removed. Both trees were considered to be in good health and have medium useful life expectancies of 15 to 40 years. These trees are located within the road reserve area adjacent to the rail corridor and form part of the existing streetscape. Their removal, in particular the Swamp Mahogany is likely to be visually significant. The Swamp Mahogany and Brown Pine are not representative of an endangered or threatened species or ecological community. Photographs 1 and 2 show these trees.

Photograph 1: Tree 1 *Eucalyptus robusta* (Swamp Mahogany) to be removed due to direct clash with permanent design access road to MSB.

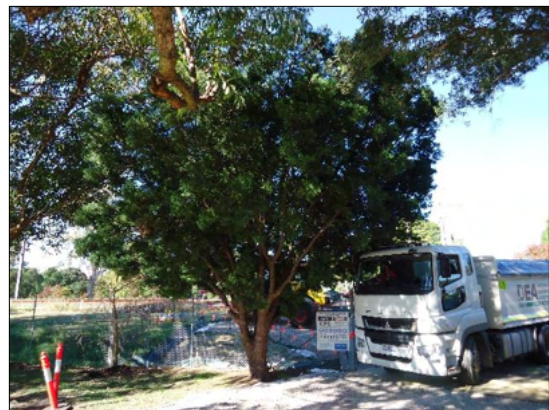
Photograph 2: Tree 2 *Podocarpus elatus* (Brown Pine) to be removed due to direct clash with permanent design access road to MSB.

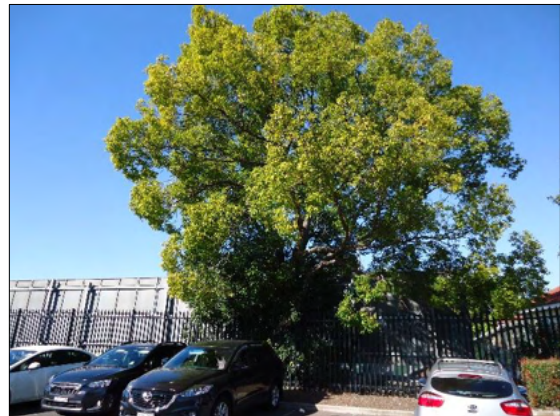
The new GST is aligned past tree 3, Camphor Laurel and shall require the removal of the suckers and epicormics from around the base of its trunk. Any excavation within 6m of the trunk (refer to **Appendix 1** Tree Assessment Schedule for TPZ offset) to install the troughing posts is to be undertaken using methods that do not damage tree roots. There is to be enough flexibility in the GST's design and alignment to reposition posts if roots greater than 30mm in diameter are exposed within the excavations. Although commonly regarded as a weed species this specimen is protected under local tree preservation controls due to its height. Photographs 3 and 4 show the tree and suckering around the base of the trunk to be removed.

Photograph 3: Tree 3 *Cinnamomum camphora* (Camphor Laurel) within northern side of rail corridor.

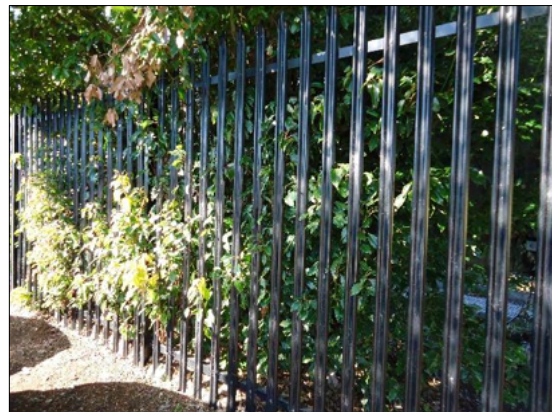
Photograph 5: Tree 4 *Callistemon slaignus* (Weeping Bottlebrush) to be selectively pruned to clear site sheds.

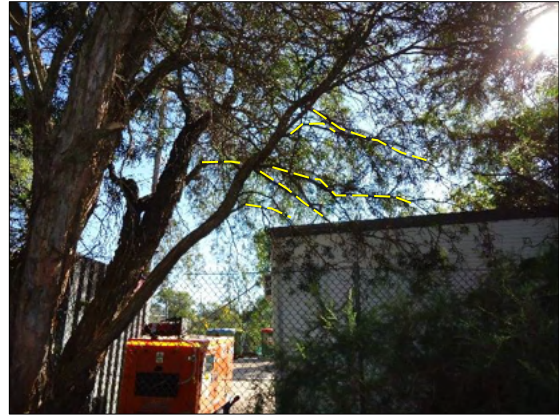
Photograph 6: Tree 5 *Leptospermum petersonii* (Lemon-scented Tee Tree) to be selectively pruned to clear site sheds.

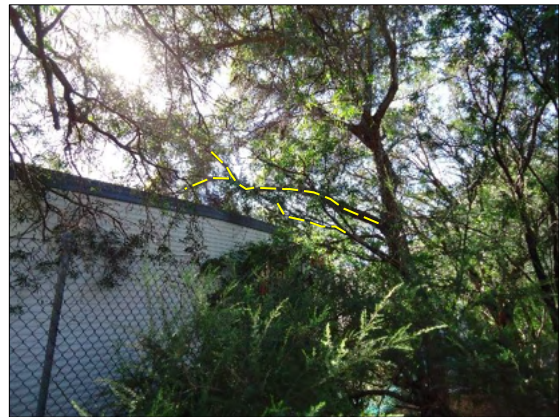
Photograph 7: Tree 6 *Leptospermum petersonii* (Lemon-scented Tee Tree) to be selectively pruned to clear site sheds.

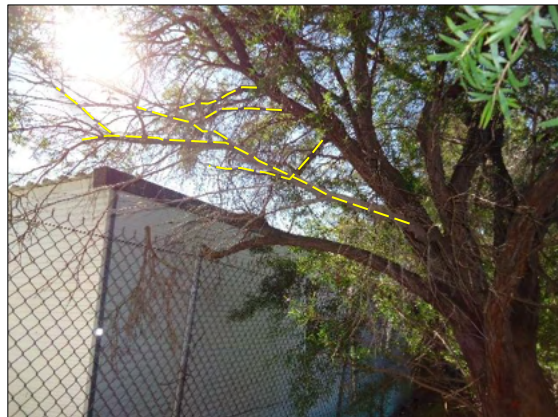
Photograph 8: Tree 7 *Leptospermum petersonii* (Lemon-scented Tee Tree) to be selectively pruned to clear site sheds. Additional pruning shall be required to provide clearances to new over head cabling.

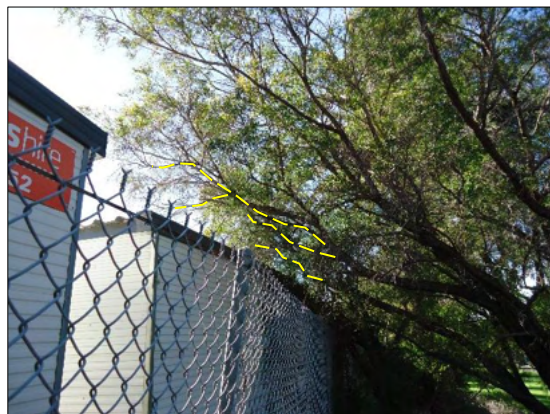
Photograph 9: Tree 8 *Leptospermum petersonii* (Lemon-scented Tee Tree) to be selectively pruned to clear site sheds.

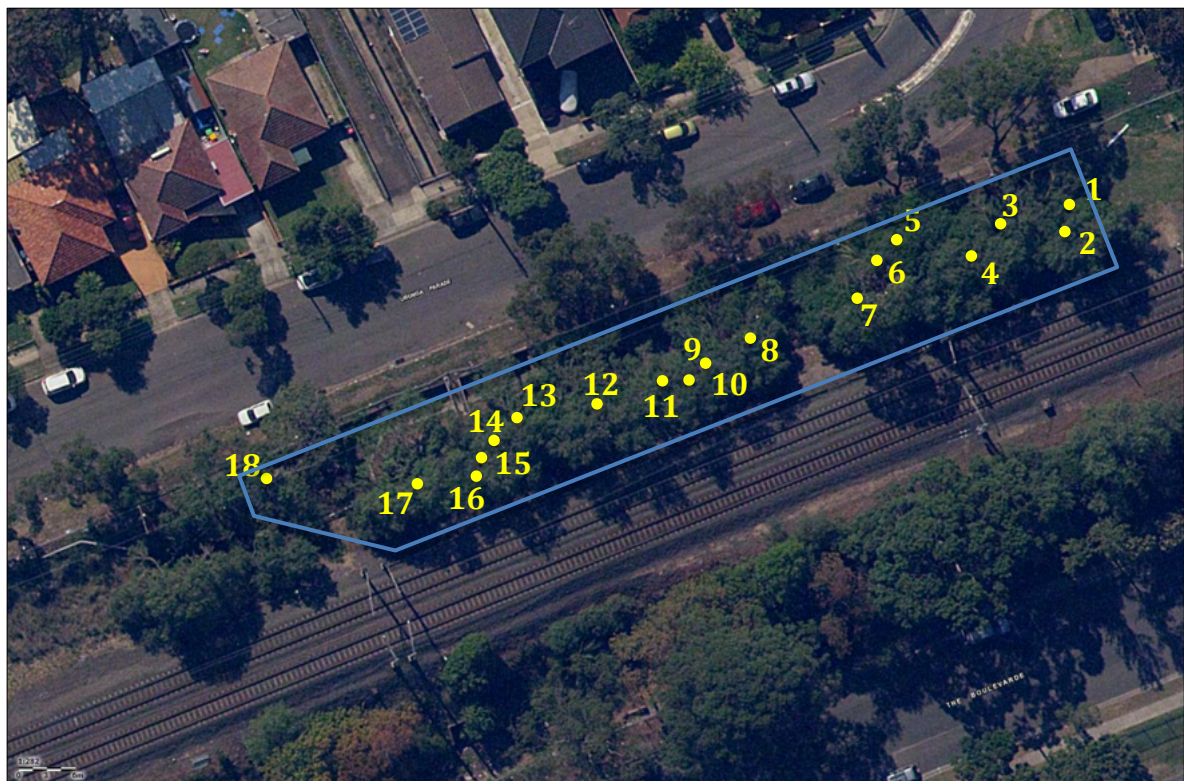
The additional tree removals where there is a direct design clash and 100% encroachment into the TPZ and SRZ consist of seventeen *Schinus molle* (Peppercorn Tree), one *Eucalyptus scoparia* (Wallangarra White Gum) which constitute the significant trees within the site. Understory plants totaling sixty-two individual specimens were also identified. All trees are located along the rail embankment adjacent Urunga Parade. Image 1 shows the area of assessment and approximate locations of significant trees (trees 1-18). The Peppercorn trees are typically arranged in a line suggesting a landscape planting. The Wallangarra White Gum is likely to be a self-seeded specimen.

Image 1: Aerial image showing the proposed vegetation clearance area (blue outline) and approximate locations of significant trees (1 to 18).

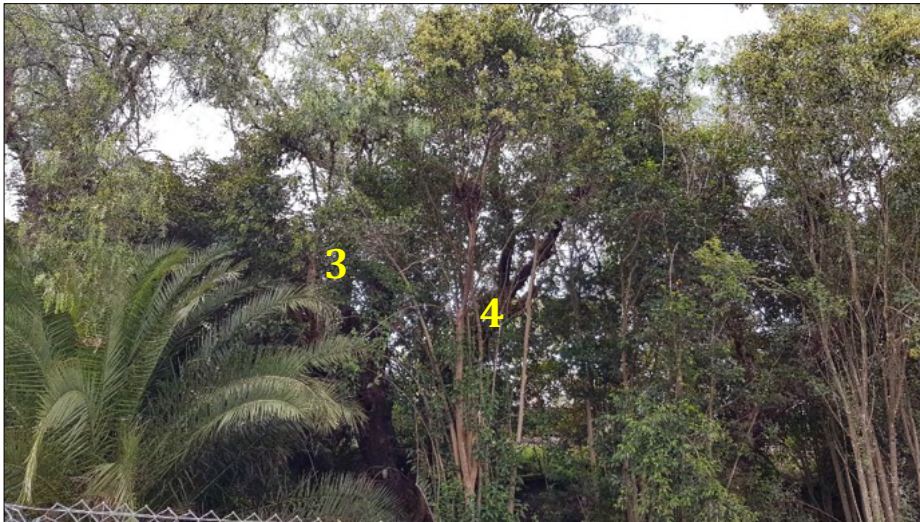
Photograph 2: Trees 3 and 4 *Schinus molle* (Peppercorn Tree) to be removed.

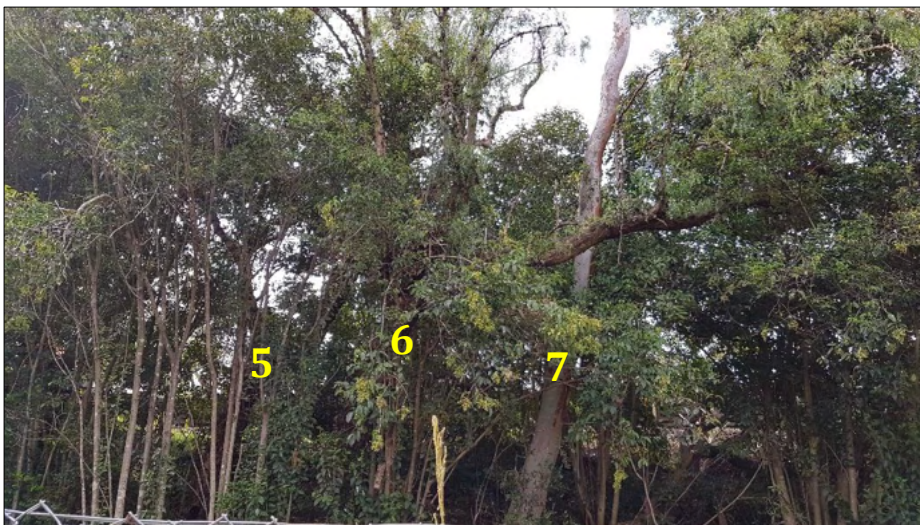
Photograph 3: Trees 5, 6 and 7 *Schinus molle* (Peppercorn Tree) to be removed.

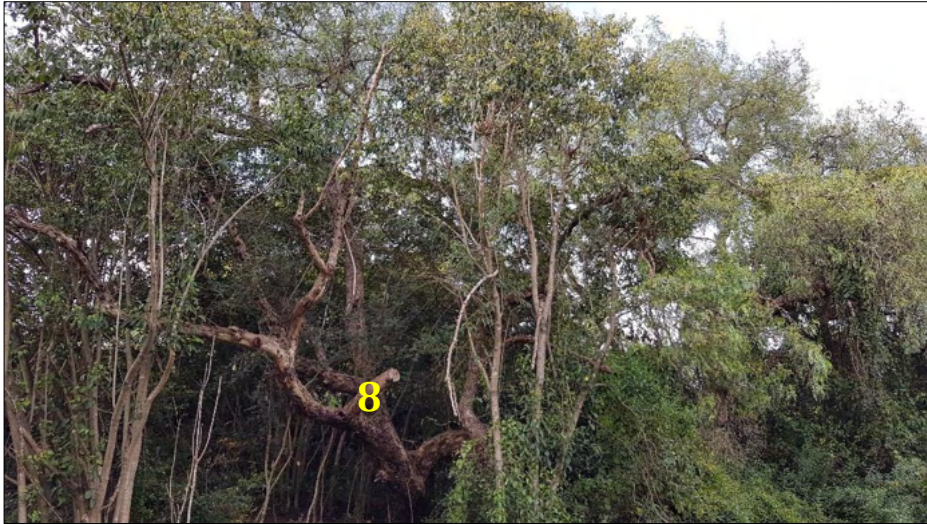
Photograph 4: Tree 8 *Schinus molle* (Peppercorn Tree) to be removed.

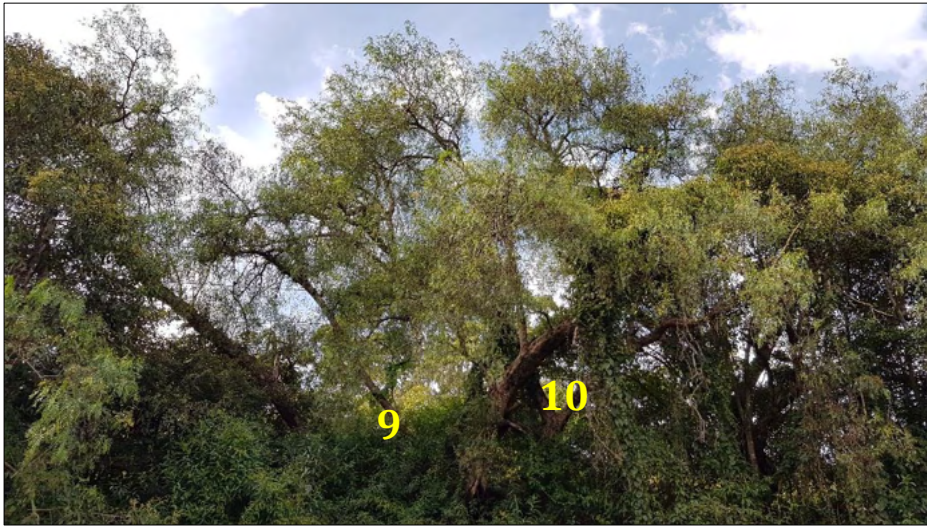
Photograph 5: Trees 9 and 10 *Schinus molle* (Peppercorn Tree) to be removed.

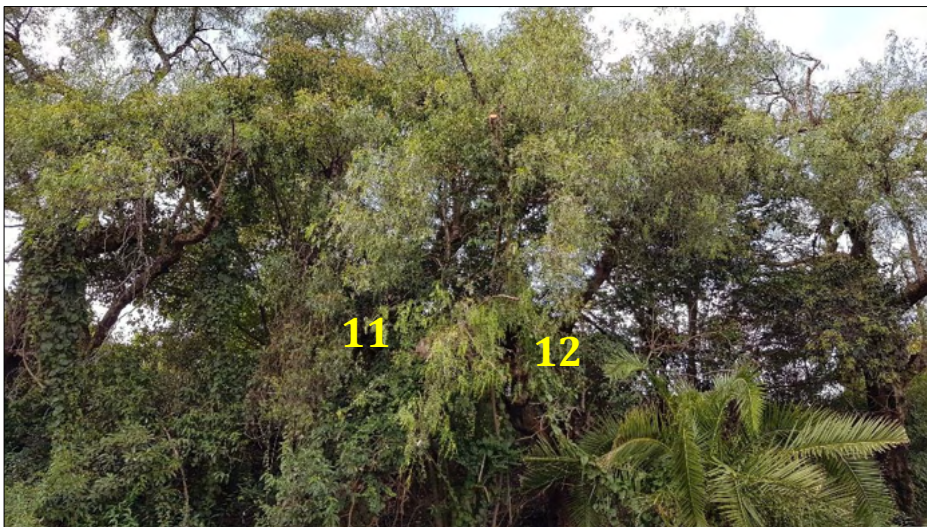
Photograph 6: Trees 11 and 12 *Schinus molle* (Peppercorn Tree) to be removed.

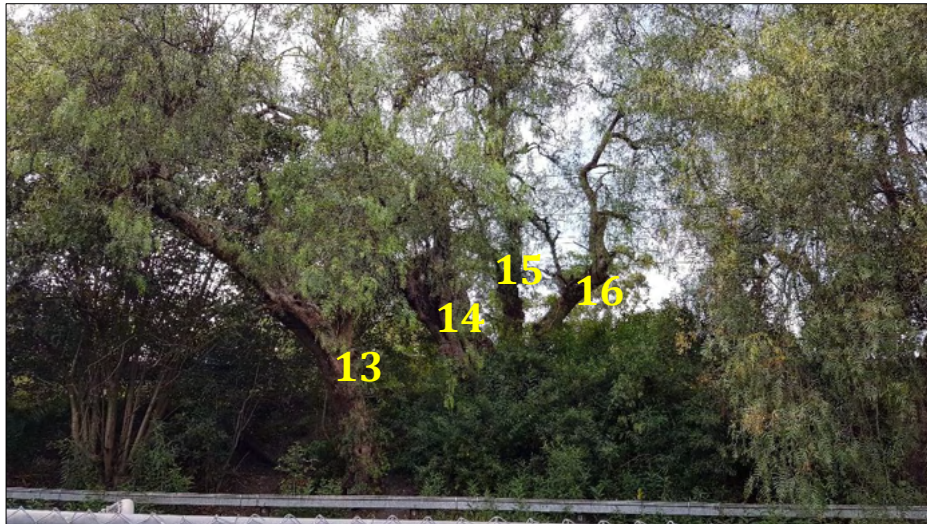
Photograph 7: Trees 13, 14, 15 and 16 *Schinus molle* (Peppercorn Tree) to be removed.

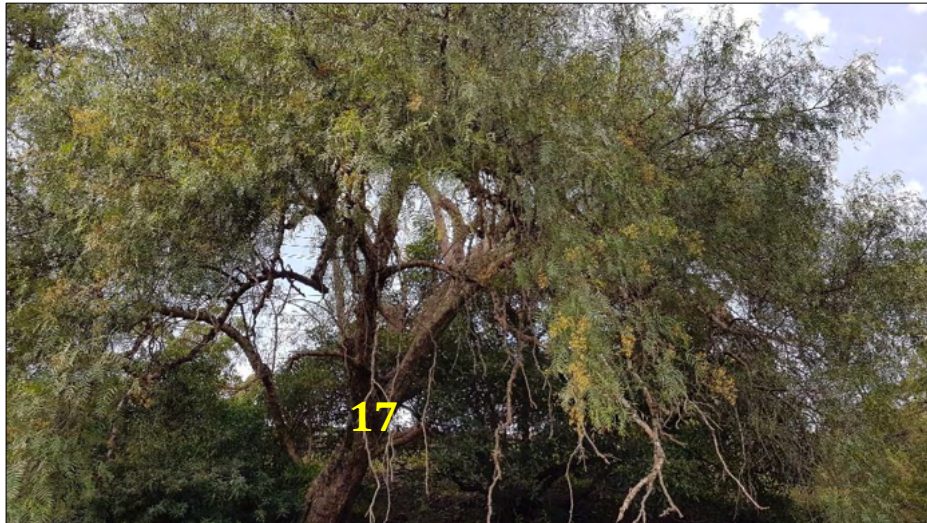
Photograph 8: Tree 17 *Schinus molle* (Peppercorn Tree) to be removed.

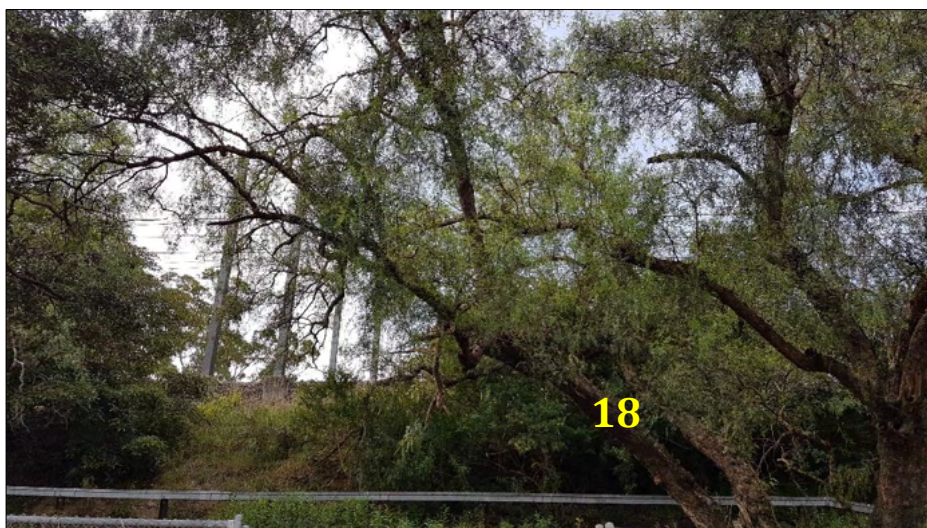
Photograph 9: Tree 18 *Schinus molle* (Peppercorn Tree) to be removed.

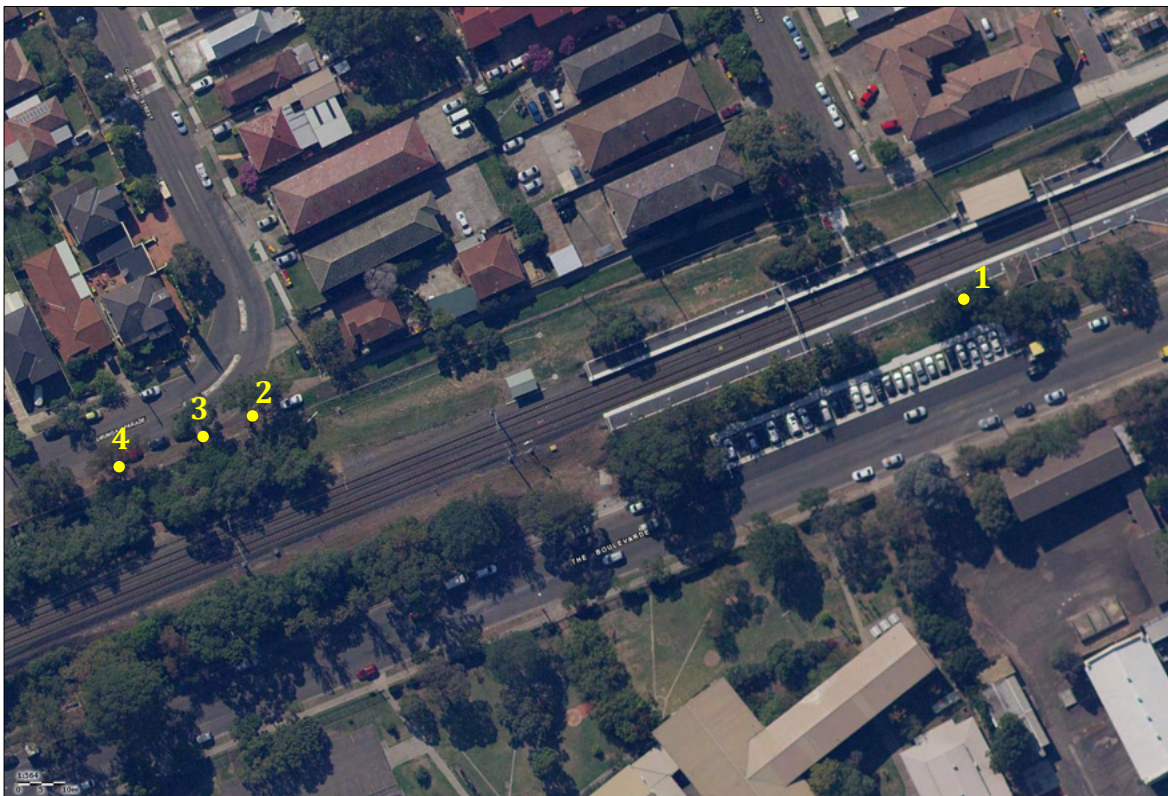
located within the footprint of the proposed works and cannot be retained under the current design. The Sweet Pittosporum is considered to have low landscape significance. Its removal is not expected to have a significant impact upon the local amenity. The Blackbutt, Swamp Mahogany and Wallangarra White Gum are considered to have medium landscape significance. Their removal shall expose the northern end of Urunga parade to the new Metro Services Building, rail corridor and associated infrastructure. The locations of the additional trees to be removed can be found as Image 1. Tree data collected during the site inspection can be found as Appendix 1. Each additional tree for removal has been photographed and can be found as Appendix 2.

Image 1: Aerial image of Wiley Park Station Station showing the location of additional trees to be removed.

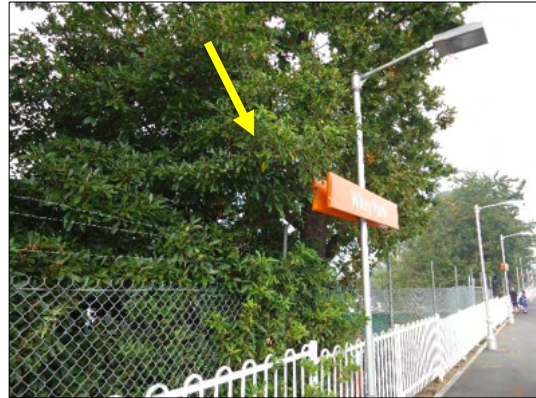
Photograph 2: Tree 2 *Eucalyptus pilularis* (Blackbutt) identified for removal to accommodate Metro services Building driveway and access.

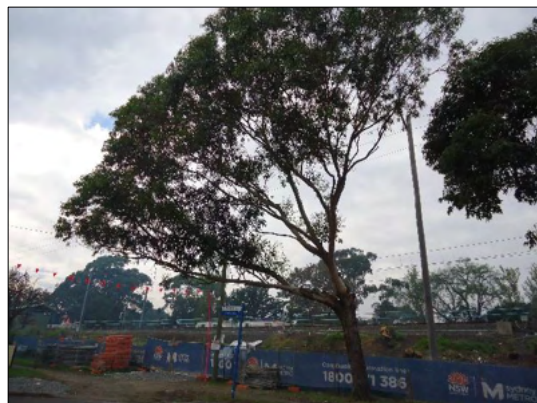
Photograph 3: Tree 3 *Eucalyptus robusta* (Swamp Mahogany) identified for removal to accommodate ULX and permanent fencing.

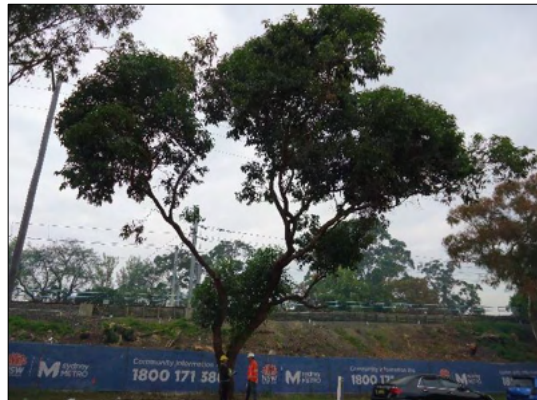
The Wallangarra White Gum (tree 4) is listed as Endangered under the Biodiversity Conservation Act 2016 and Vulnerable under the Environmental Protection Biodiversity Conservation Act 1999. However, the subject specimen is located outside of its naturally occurring range and appears to have been planted as part of the streetscape.

Photograph 4: Tree 4 *Eucalyptus scoparia* (Wallangarra White Gum) identified for removal to accommodate ULX and permanent fencing.

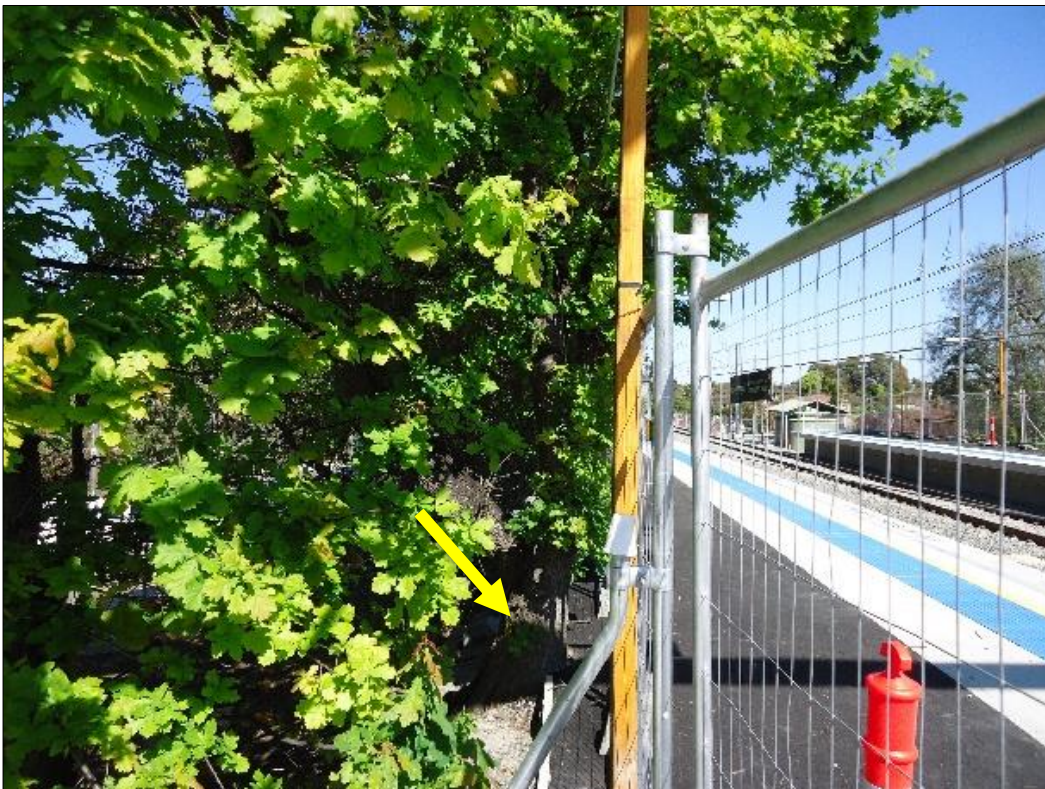
Photograph 2: The position of tree 711 with regards to the alignment of Platform 2 and proposed fence.

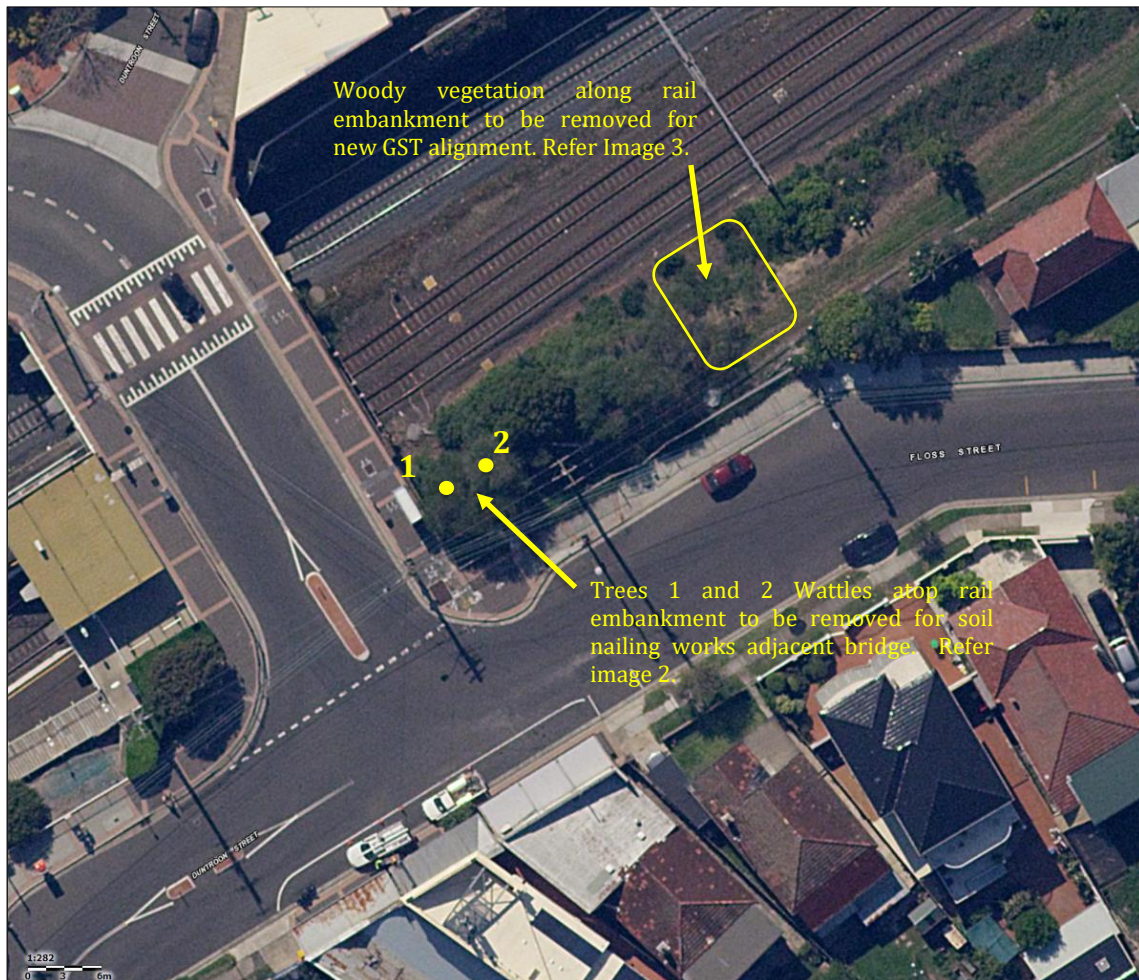
Image 1: Aerial image of Hurlstone Park Station adjacent Floss Street showing additional tree and vegetation removal. (Source Six Maps accessed 10/03/2021).

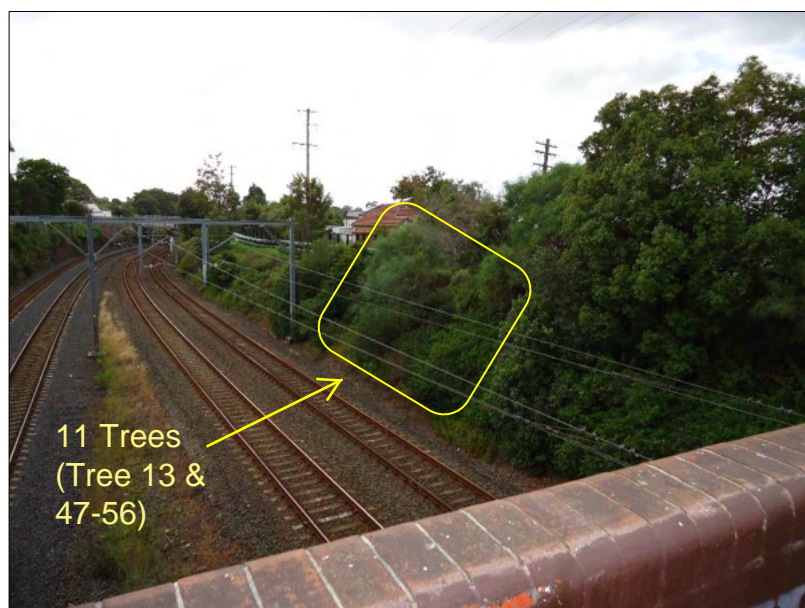
Woody vegetation located along the rail embankment was identified for removal to align the new GST. No access was gained to the rail corridor to assess the vegetation, but it has been confirmed in consultation with the project Ecologist to consist of; one *Pittosporum undulatum* (Sweet Pittosporum) tree 13, seven *Acacia saligna* (Golden Wreath Wattle) trees 47 to 53, one *Grevillea* sp (Grevillea), tree 54 and two *Yucca* sp (Yucca) trees 55 and 56. The vegetation is considered to have a short useful life expectancy and low landscape significance given its location within the rail corridor. Image 3 shows the approximate area to be cleared.

Image 3: Approximate area of woody vegetation along the rail embankment to be cleared to align the new GST.

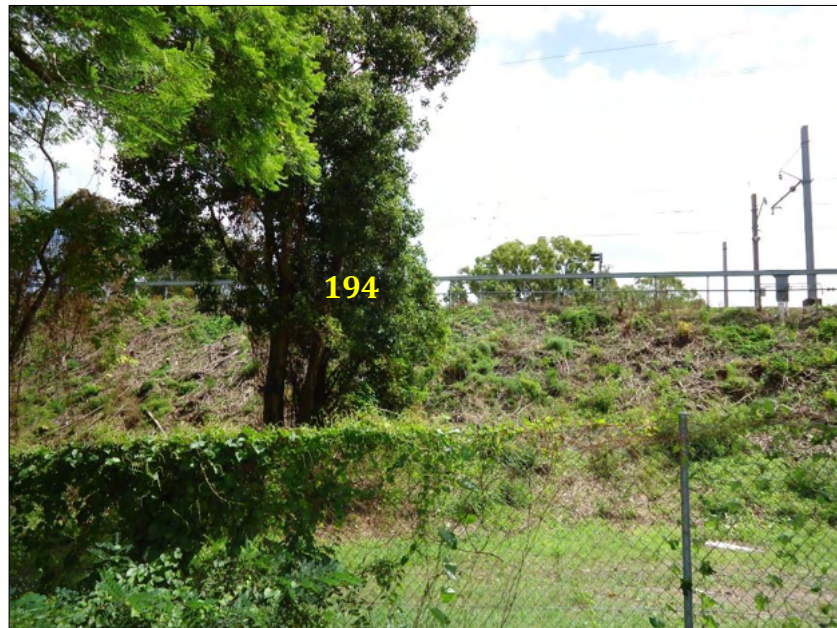
Additional tree removals were identified within the rail corridor associated with the construction of the Metro Services Building. A concrete pad is to be relocated from adjacent trees 166 and 167 to overlay the position of tree 194 *Cinnamomum camphora* (Camphor Laurel) requiring its removal. The tree has been identified for removal on demolition documentation viewed during the on-site inspection. Image 4 shows the tree.

Image 4: Tree 194 as identified within the AIA report shall require removal to accommodate the relocation of the concrete pad. Note the rail embankment to the rear of the tree has been cleared of woody vegetation.

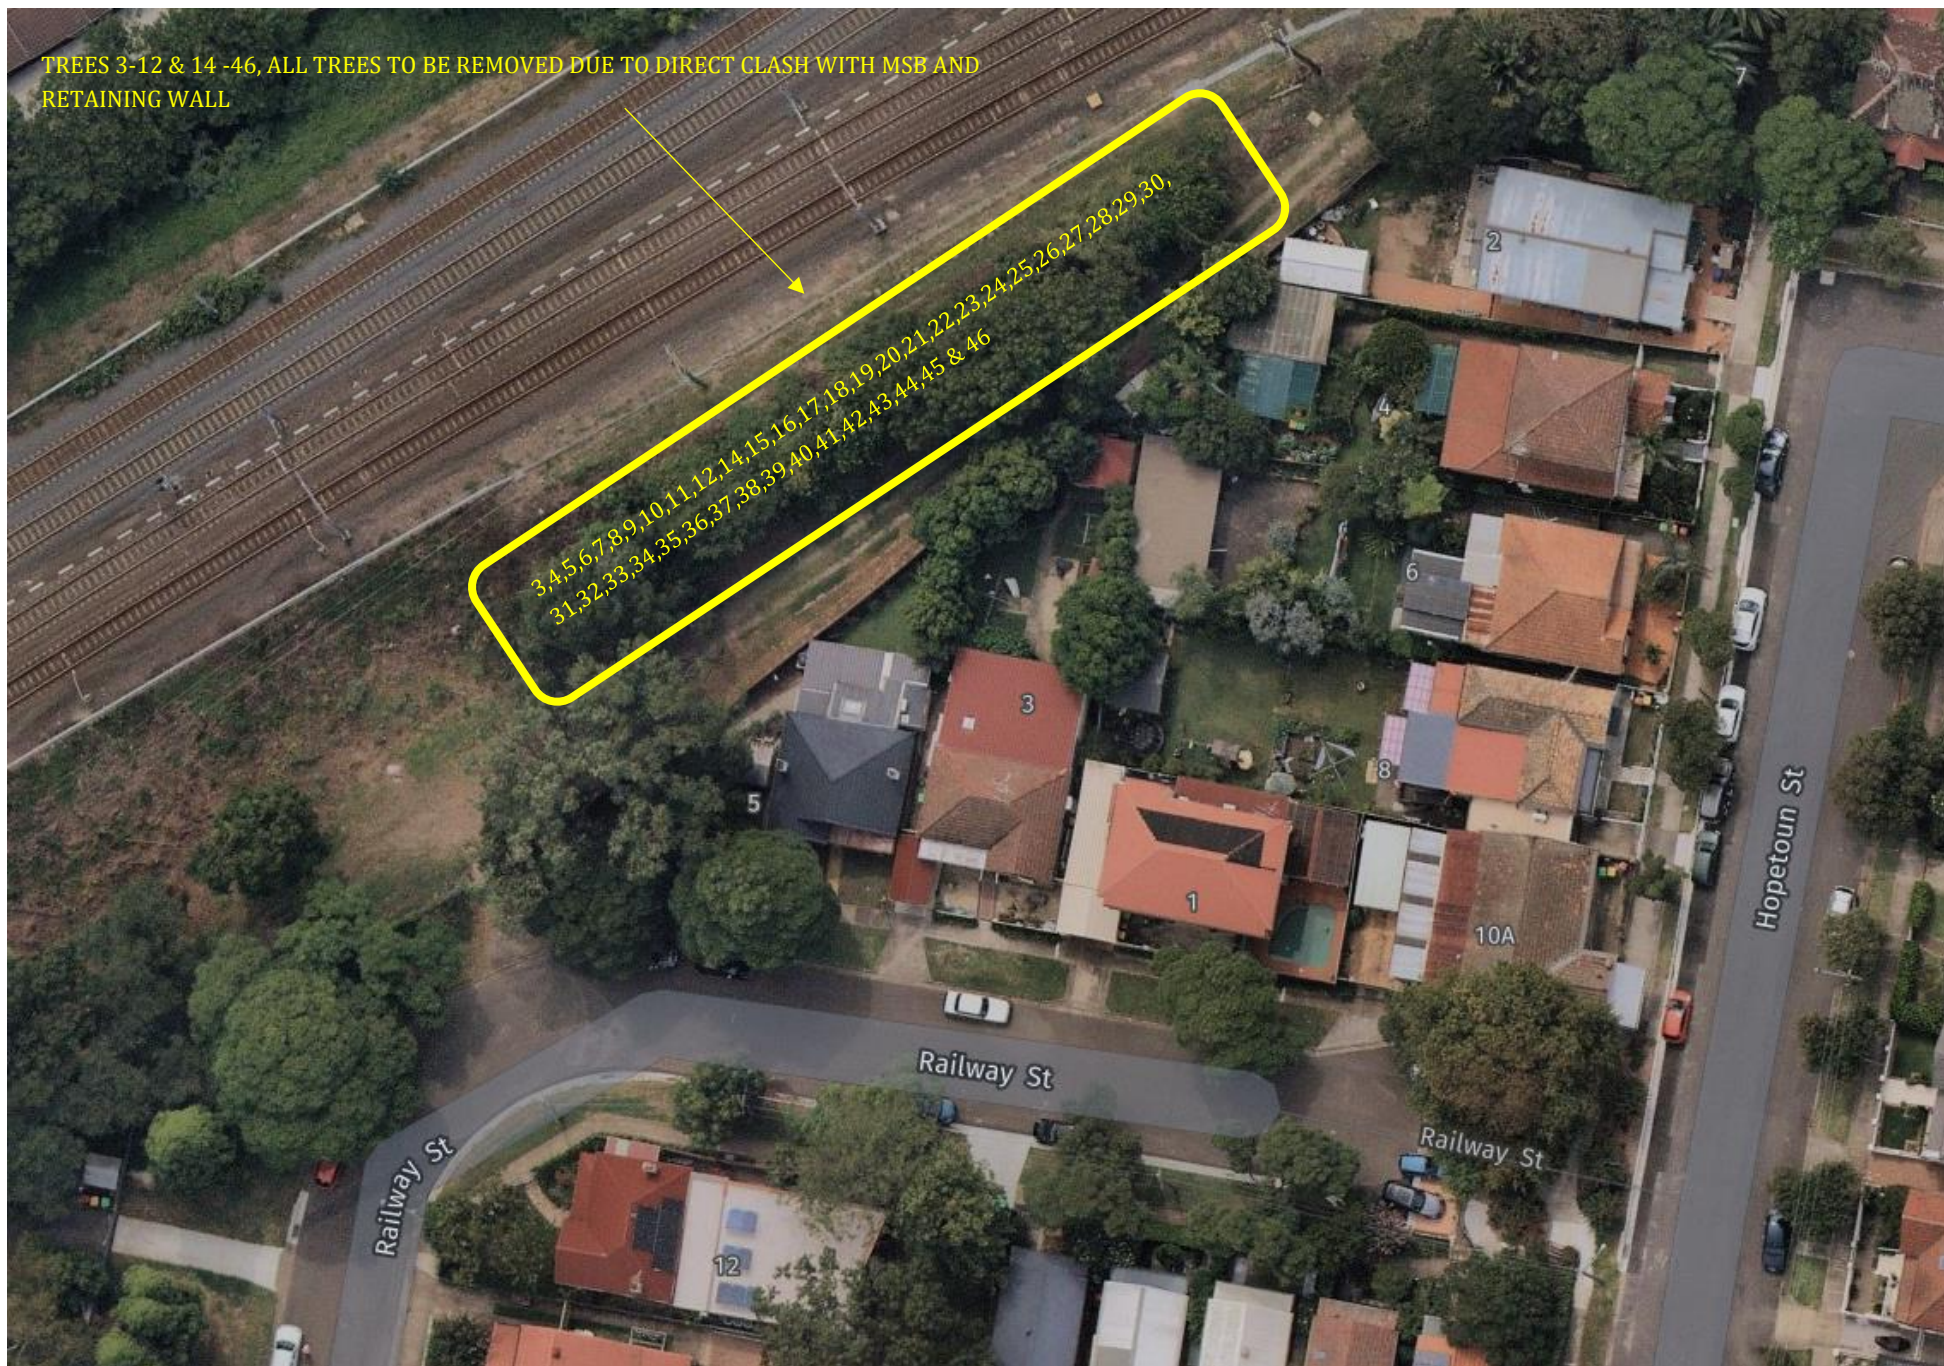
TREES 3-12 & 14-46, ALL TREES TO BE REMOVED DUE TO DIRECT CLASH WITH MSB AND
RETAINING WALL
