Tree Impact Assessment Report

City and Southwest Metro Station Upgrade Works Package 5 & 6

P5 Document No. SMCSWSW5-DEW-WEC-EM-REP-000542

P6 Document No. SMCSWSW6-DEW-WEC-EM-REP-000632

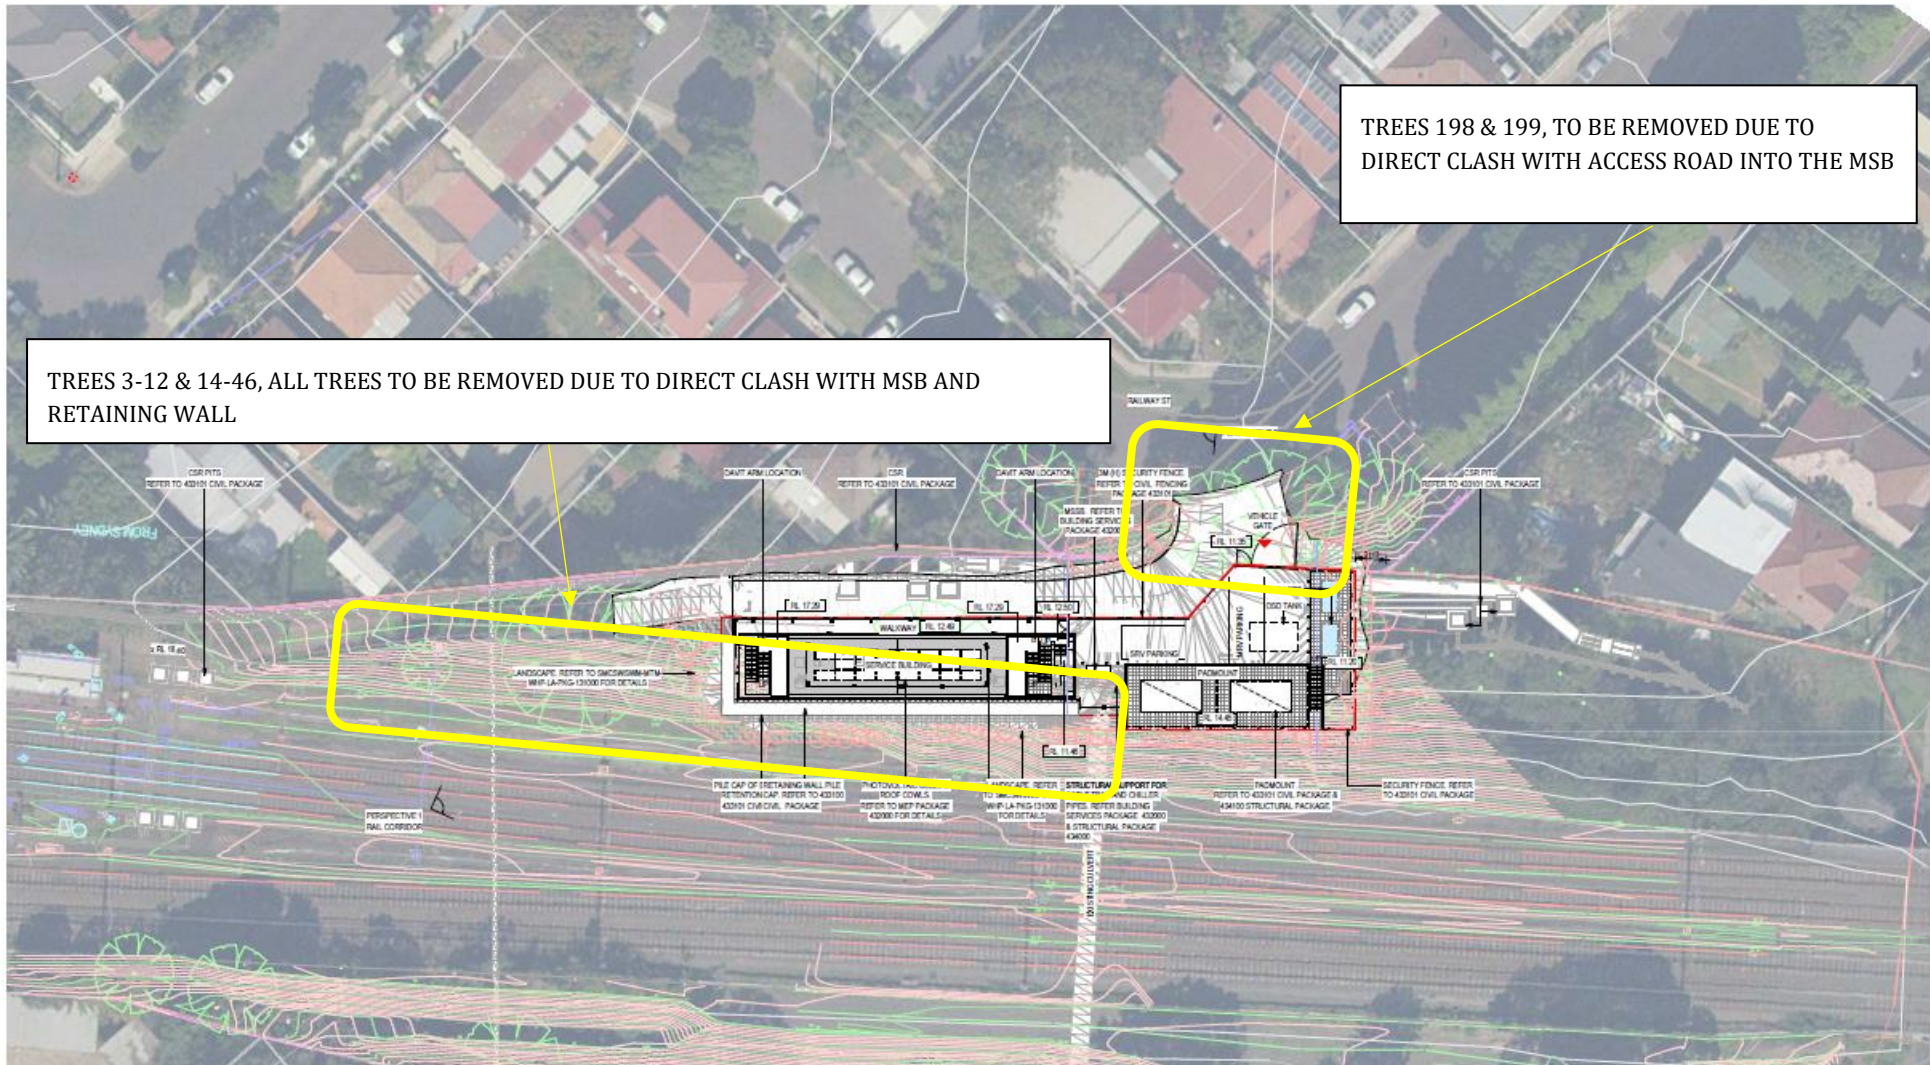
TREES 198 & 199, TO BE REMOVED DUE TO
DIRECT CLASH WITH ACCESS ROAD INTO THE MSB

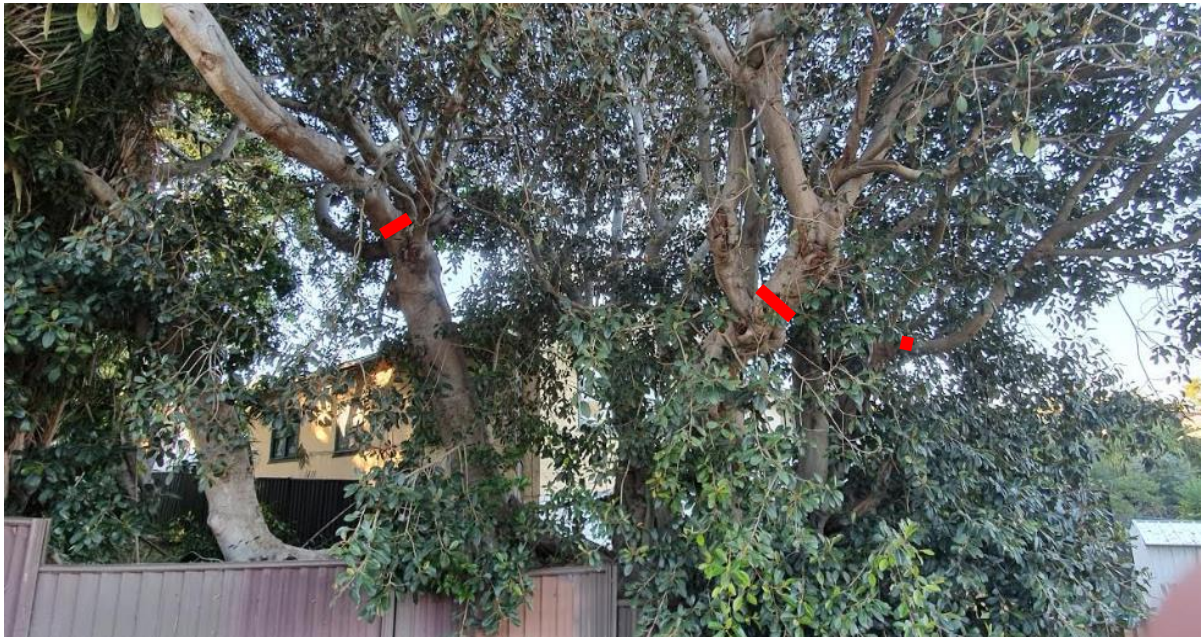
3.1 TREE 1 – MORTON BAY FIG (*FICUS MACROPHYLLA*) SEE FIGURE 2

Figure 2: Cut locations of limbs to be pruned marked in red.

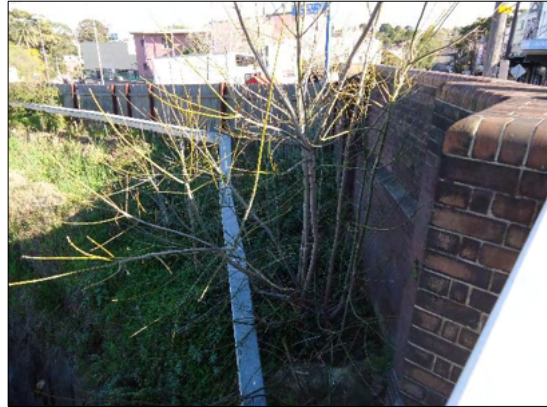
Tree 1 consists of a self-seeded multi-stemmed *Acer negundo* (Box Elder), refer Appendix 2 photograph 1. It has been assessed as having a short useful life expectancy and low landscape value. The wider Southwest Metro Package works require three 300mm diameter piles to be excavated at the location of the tree to

enable the construction of a materials throw screen. As such, the tree cannot be retained.

Photograph 1: Tree 1 *Acer negundo* (Box Elder) growing adjacent rail bridge wall on the northern side of the rail corridor.

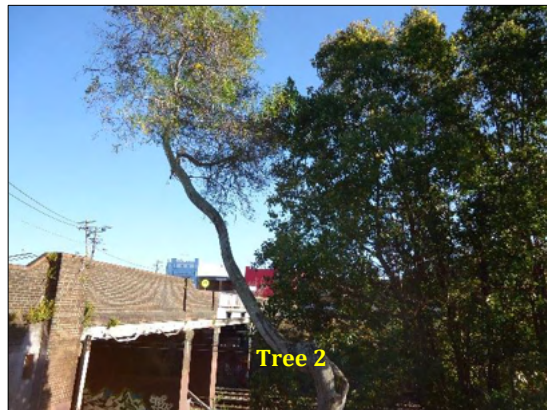
Photograph 2: Tree 2 *Acacia* sp (Wattle) growing on the southern side of the rail corridor atop of the embankment.

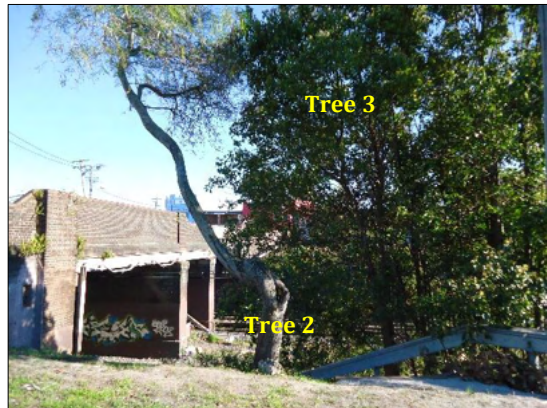
Photograph 3: Tree 3 *Cinnamomum camphora* (Camphor Laurel) growing on the southern side of the rail corridor atop of the embankment. Note the kink and cavity within the trunk of tree 2.

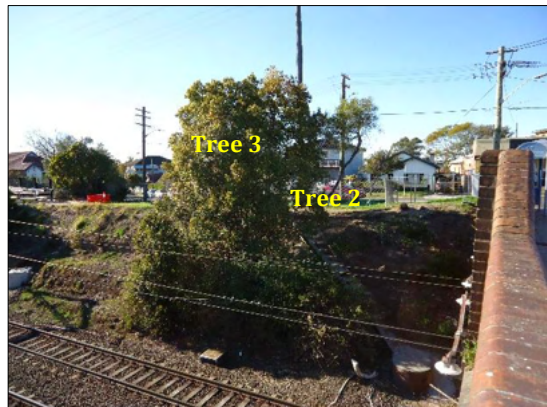
Photograph 4: Trees 2 and 3 as seen from the rail bridge.

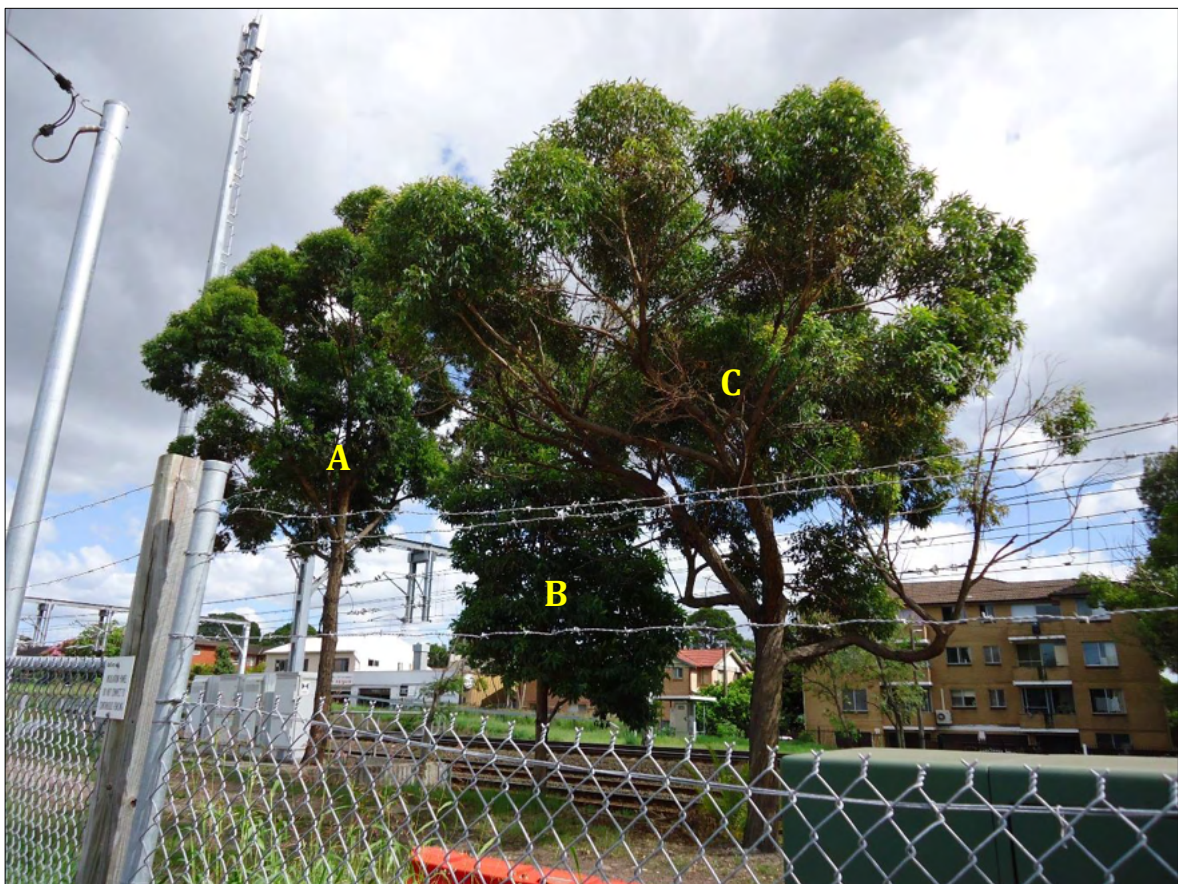
Trees A, Tallowwood and B Brush Box were found to be in good health and condition. They are considered to have a medium useful life expectancy and landscape significance. Tree C Tallowwood was found to have normal vigour and fair condition. Deadwood and canopy dieback was observed within the tree indicating a possible decline in health and condition. As such the tree is considered to have a short useful life expectancy. Image 2 shows the subject trees. The trees provide some screening and relief from the rail corridor and associated infrastructure along Lillian Street.

Image 2: The three additional trees identified for removal as part of the Southwest Metro Package works.

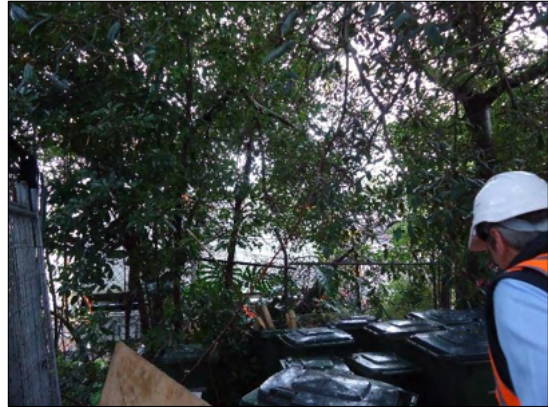
Photograph 1: Clump of vegetation consisting of approximately 14 individual stems of *Cinnamomum camphora* (Camphor Laurel) and a dead tree identified for removal.

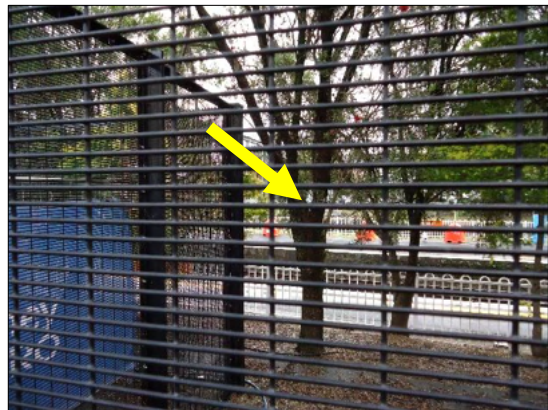
Photograph 2: Tree 632 *Callistemon viminalis* (Bottlebrush) identified for removal to accommodate the new GST alignment.

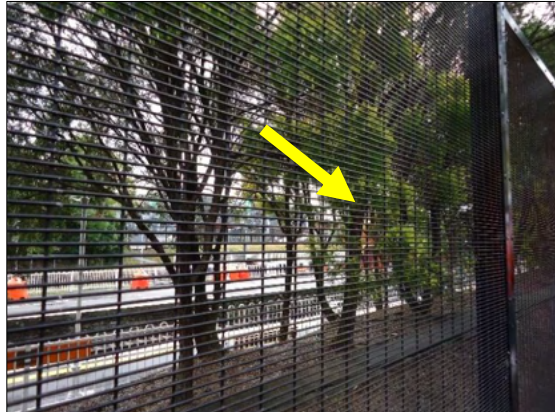
Photograph 3: Tree 627 *Leptospermum petersonii* (Lemon-scented Teatree) identified for selective pruning works create clearances to allow for the new GST alignment.

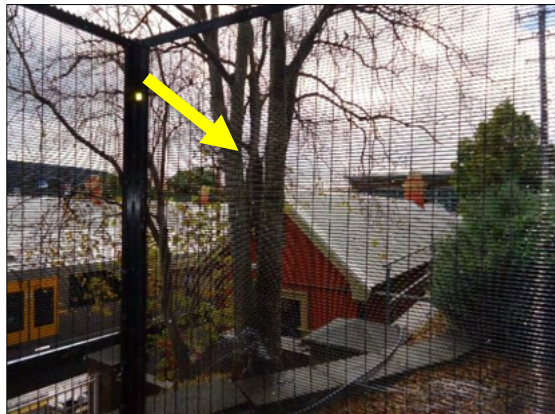
Photograph 4: Tree 614 *Sapium sebiferum* (Chinese Tallowwood) identified for removal to accommodate the new GST alignment.

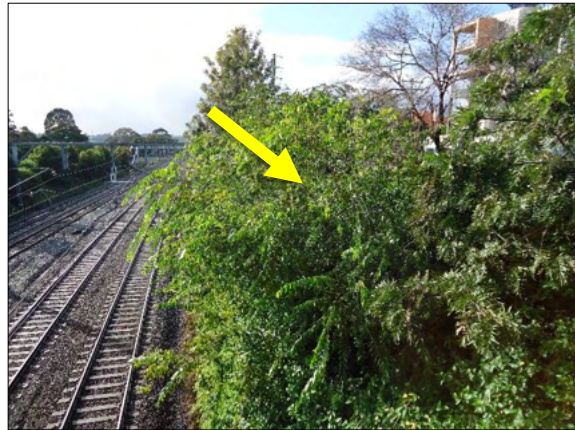
Photograph 5: Tree 6 *Celtis sinensis* (Hackberry) located within rail corridor. Tree to be removed to accommodate the new GST alignment. The surrounding Lantana along the rail embankment is also to be removed.

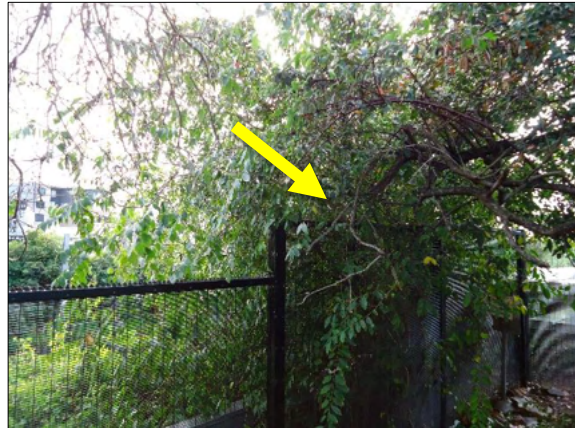
Photograph 6: Tree 7 *Celtis sinensis* (Hackberry) located within rail corridor. Tree to be removed to accommodate the new GST alignment.

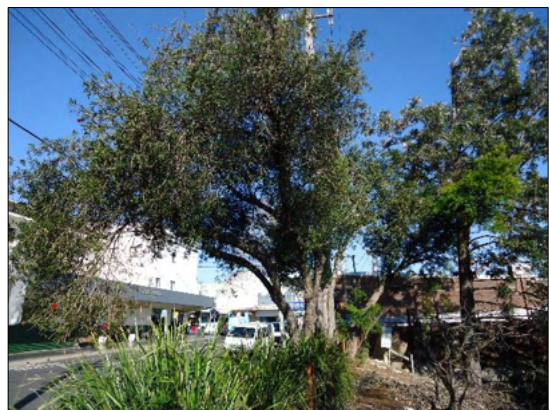
dead. Tree 615 was also found to be in a state of declining health and beyond reasonable attempts to remediate. The AIA report also identifies trees 615 and 620 as being exempt from local tree preservation controls. The additional trees to be removed are not representative of an endangered or threatened species or ecological community. Photographs of the assessed trees have been attached to the rear of this report as Appendix 2 Site Photographs.

Photograph 5: Tree 615 *Acacia podalyrifolia* (Queensland Silver Wattle) located adjacent Platform 2. The adjacent Queensland Silver Wattle's are near dead.

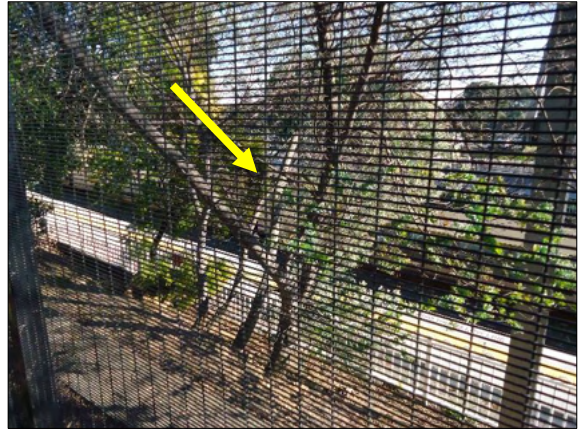
Photograph 6: Tree 5 *Melaleuca bracteata* (Black Teatree) located adjacent Platform 2.

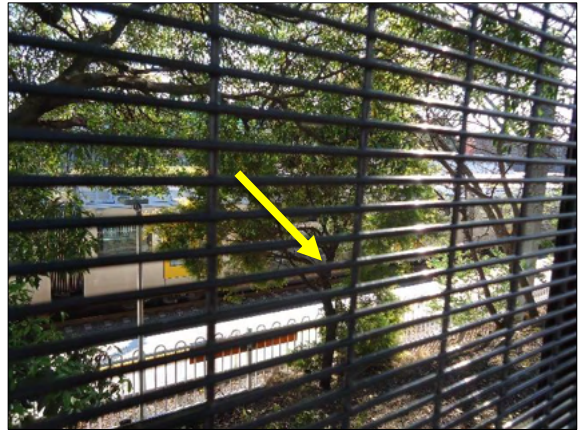
Photograph 7: Showing trees adjacent Platform 2. Tree 621 *Syncarpia glomulifera* (Turpentine) is shown for reference.

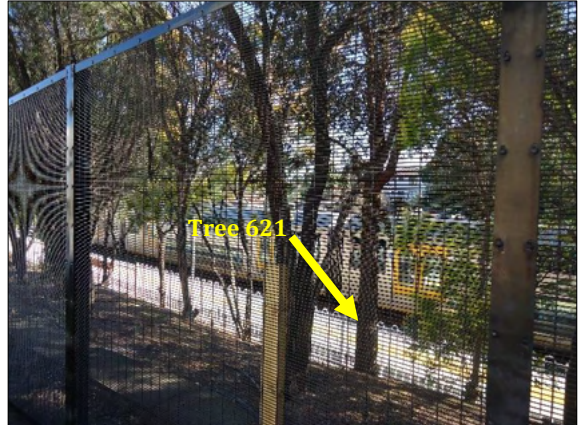
Photograph 8: Showing trees adjacent Platform 2. Tree 621 *Callistemon viminalis* (Weeping Bottlebrush) is shown for reference.

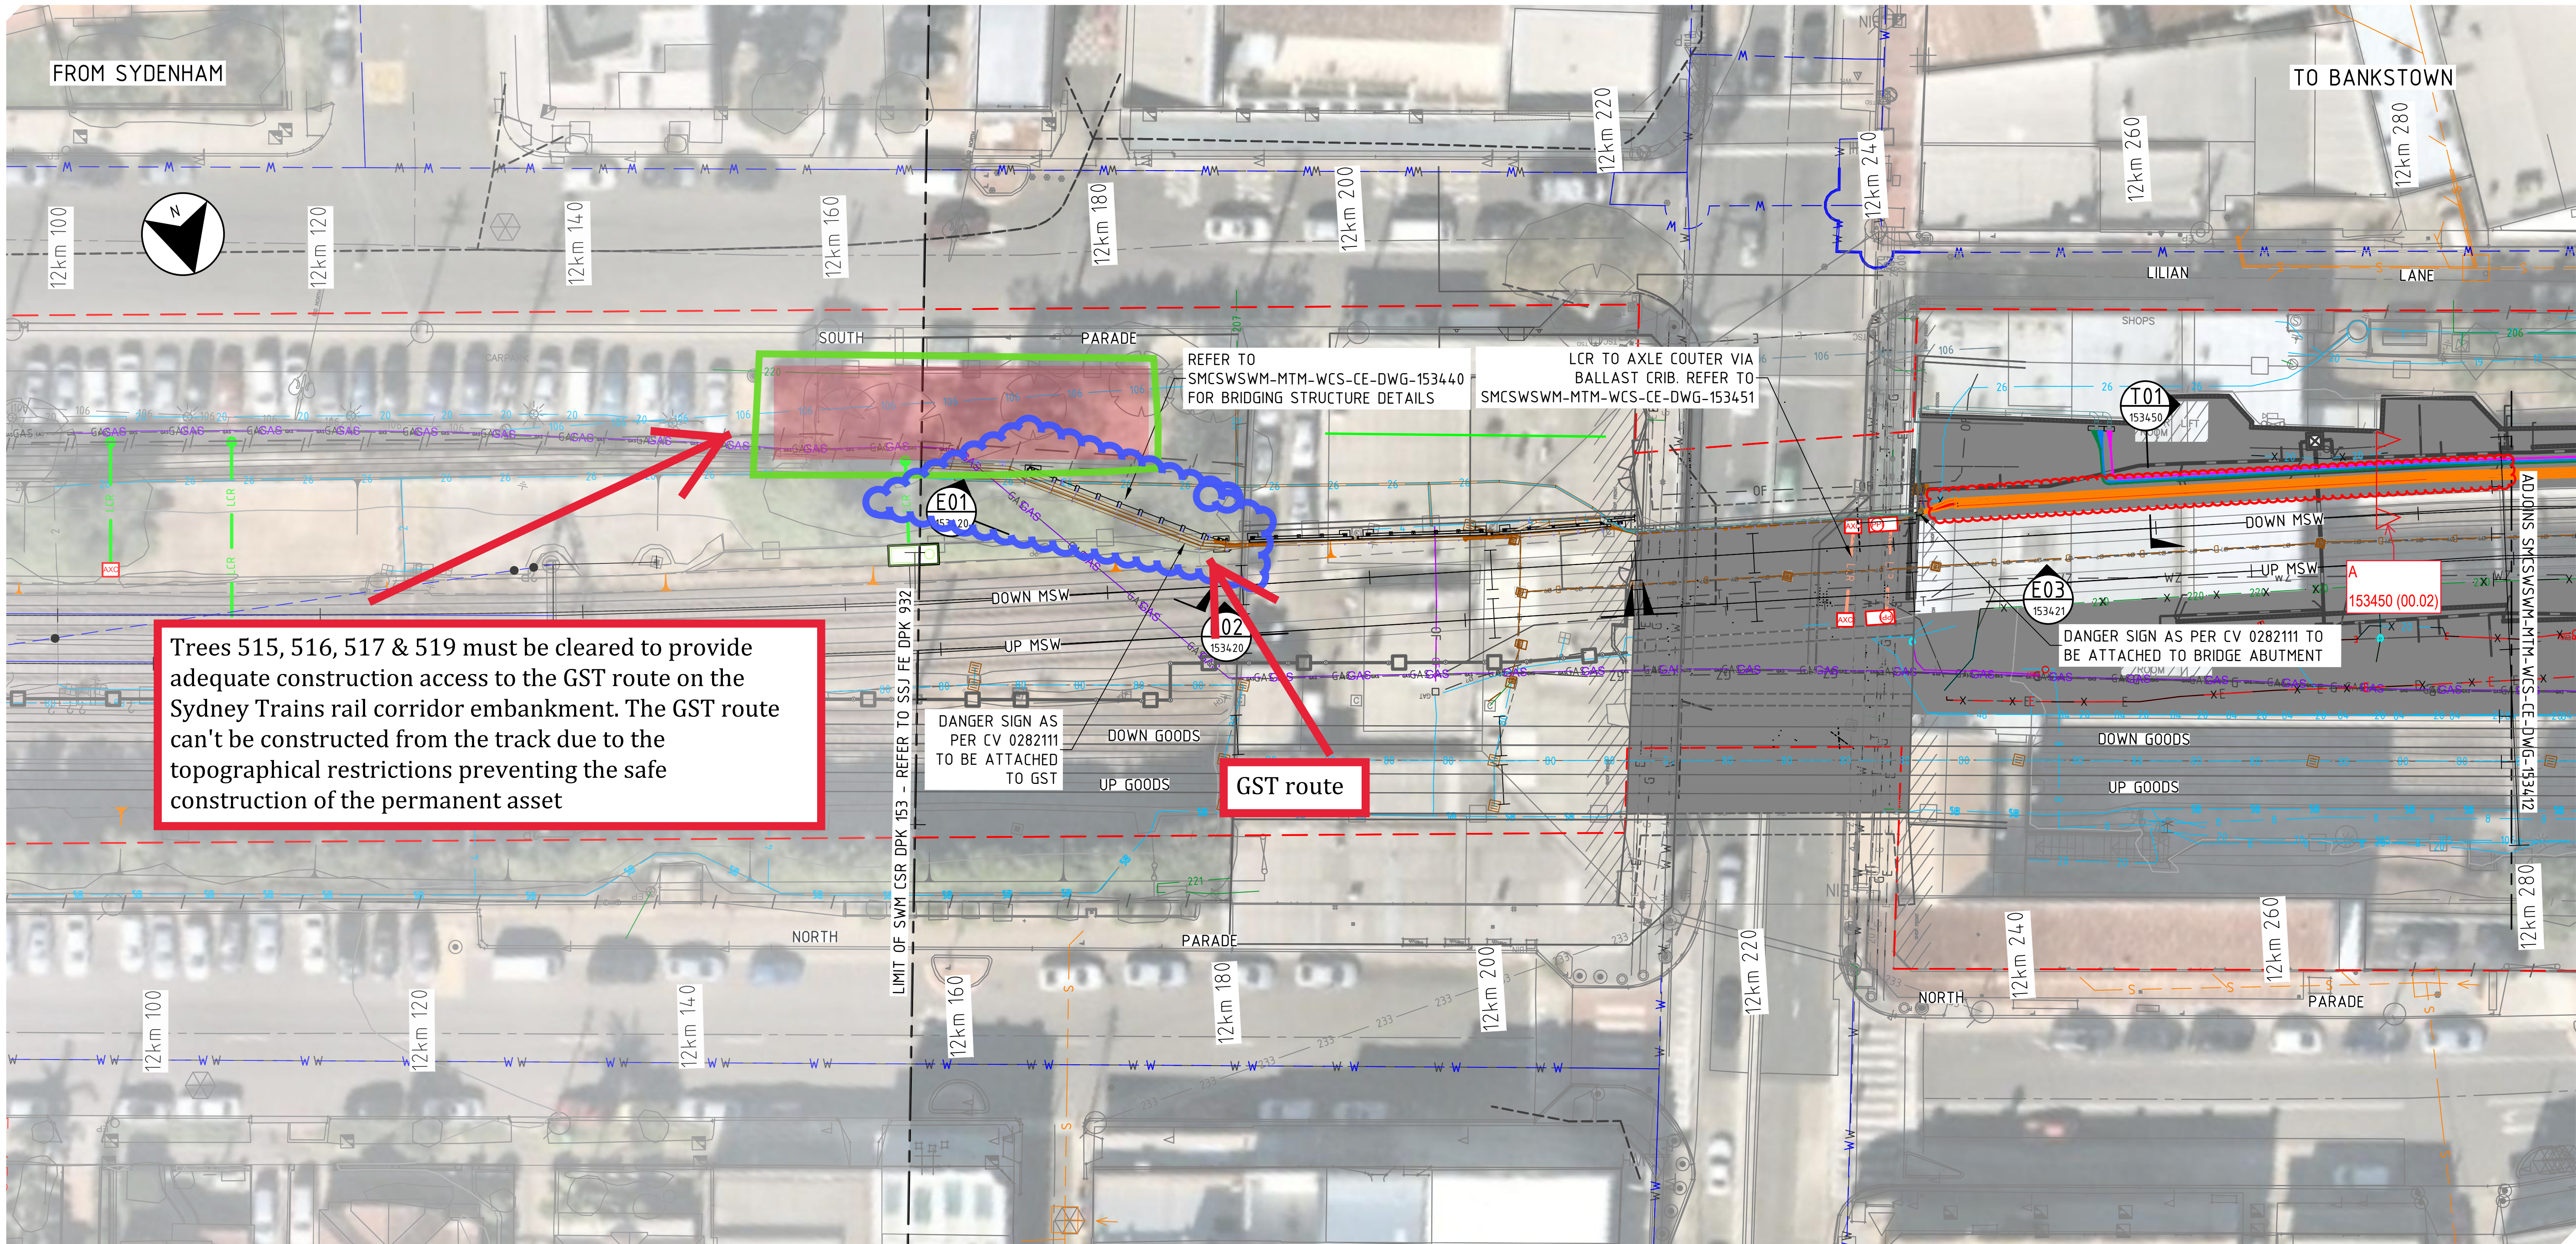
Trees 515, 516, 517 & 519 must be cleared to provide adequate construction access to the GST route on the Sydney Trains rail corridor embankment. The GST route can't be constructed from the track due to the topographical restrictions preventing the safe construction of the permanent asset

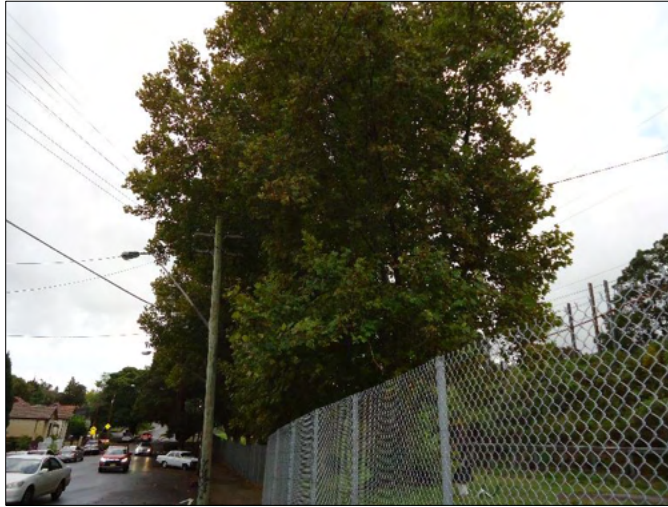
Photograph 1: Tree 1 *Platanus x acerifolia* (London Plane) to be removed.

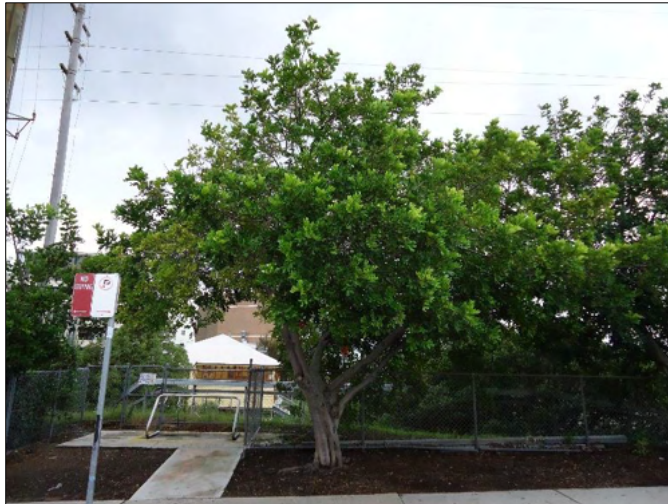
Photograph 2: Tree 2 *Cupaniopsis anacardioides* (Tuckeroo) to be removed.

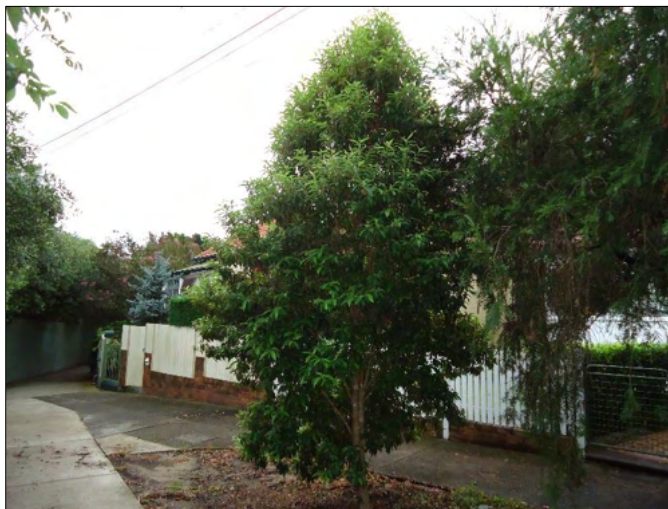
Photograph 3: Tree 3 *Backhousia citriodora* (Lemon-scented Myrtle). Tree is to be transplanted on the site.

One *Backhousia citriodora* (Lemon-scented Myrtle) tree 3, has been identified for transplanting and relocation on the site. As identified within the provided plans the Inner West Council is to advise of its relocation position. The locations of the additional assessed trees are shown within Image 1.

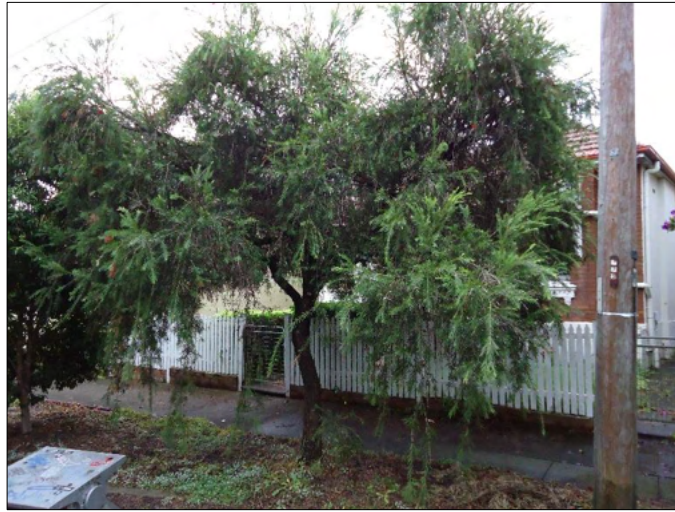
Photograph 4: Tree 4 *Calistemon viminalis* (Bottlebrush) to be removed.

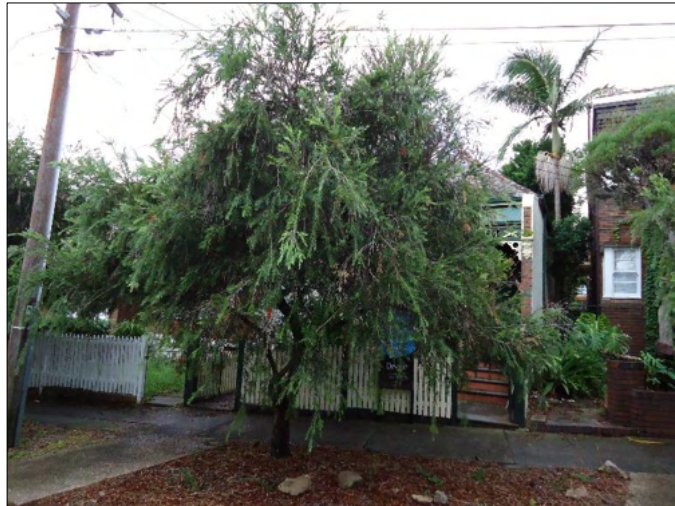
Photograph 5: Tree 5 *Calistemon viminalis* (Bottlebrush) to be removed.

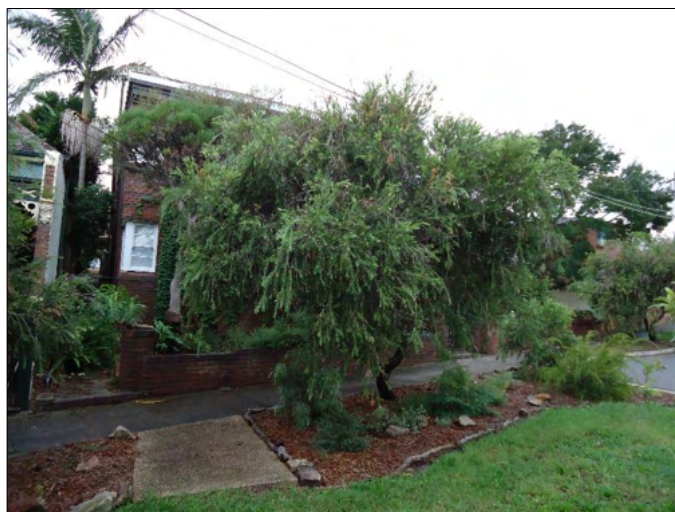
Photograph 6: Tree 6 *Calistemon viminalis* (Bottlebrush) to be removed.

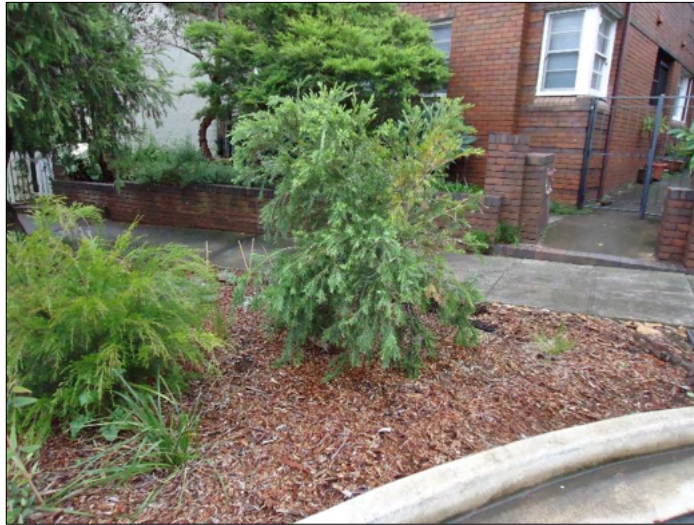
Photograph 7: Tree 7 *Calistemon viminalis* (Bottlebrush) to be removed. Does not meet the criteria for being a tree under *Sydney Metro City & Southwest Sydenham to Bankstown Instrument of Approval* due to height. Currently considered a sapling.

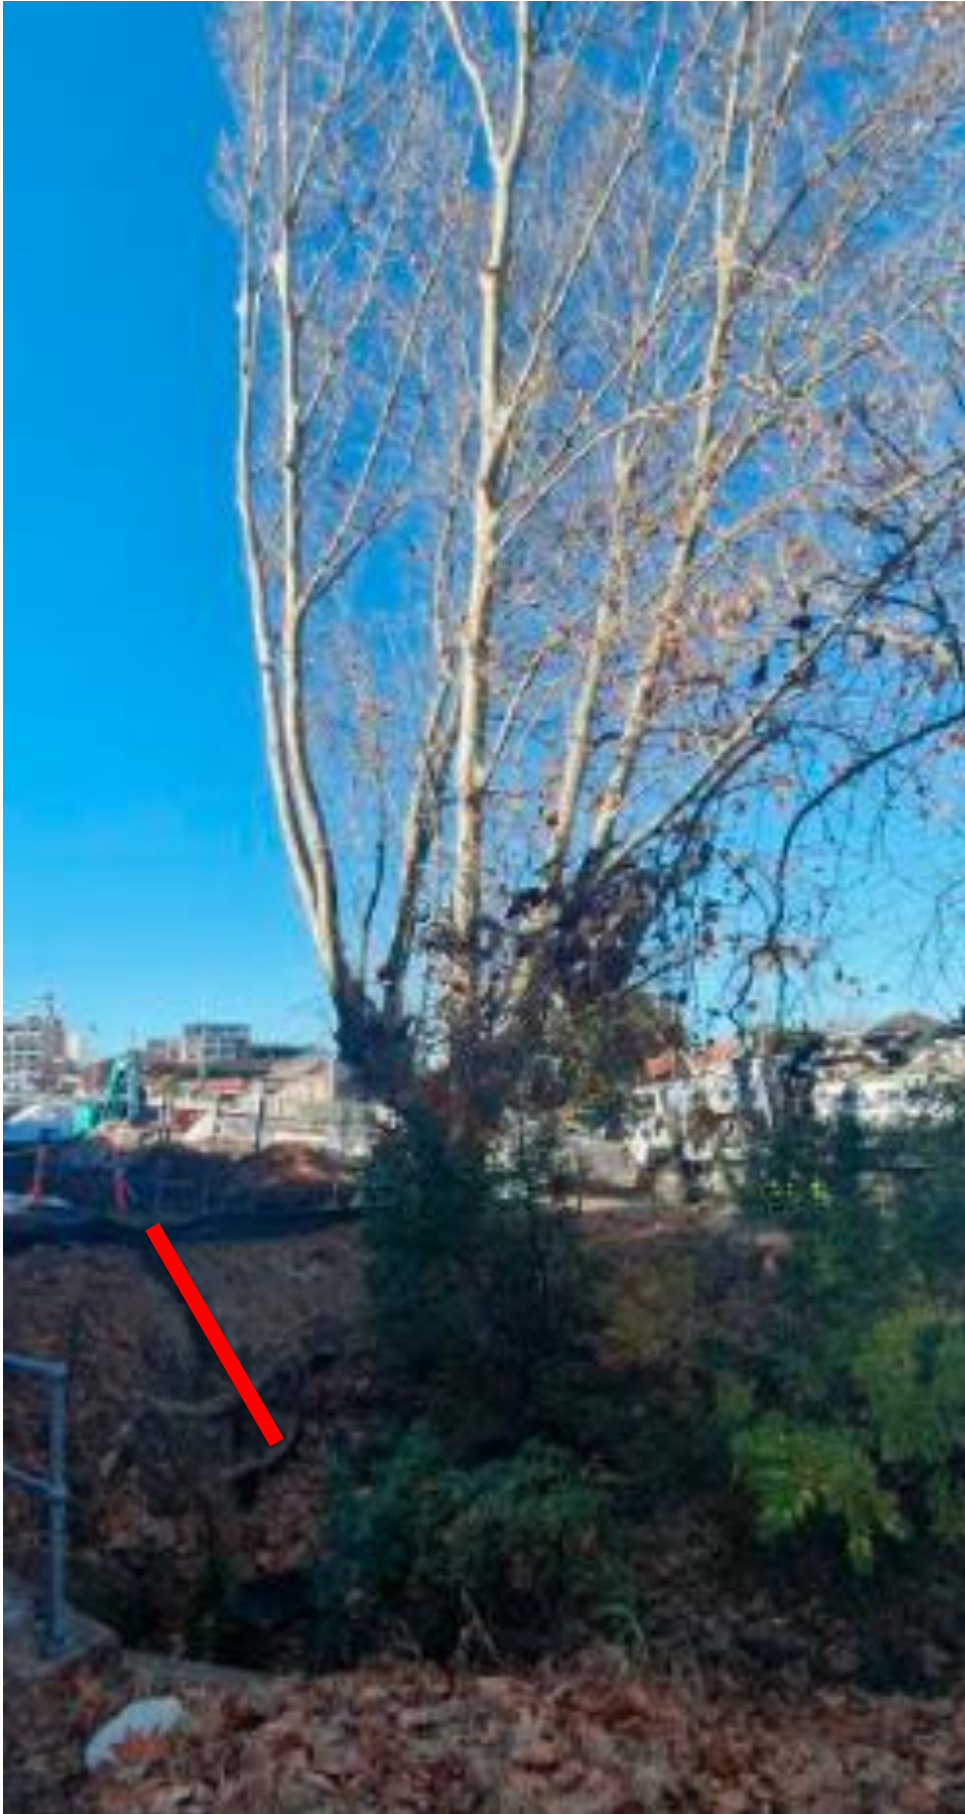
Image of the subject tree (Tree 94) taken on the 15th June 2021 (red line shows approximate location of required excavations).

Tree number	Tree name	Tree dimensions				Vigour	Condition	Age class	ULE	Amenity and Visual Value	Native or Exotic	TPZ (m)	SRZ (m)	Comments	Remove or Retain
	Botanical name Common name	Height (m)	Spread (m)	DBH (cm)	DAB (cm)										
94	<i>Platanus x Hybrida</i> London Plane	20	12	100	120	NV	F	M	M	M	E	15	3.57	To be removed due to a clash with the permanent drainage design.	Remove

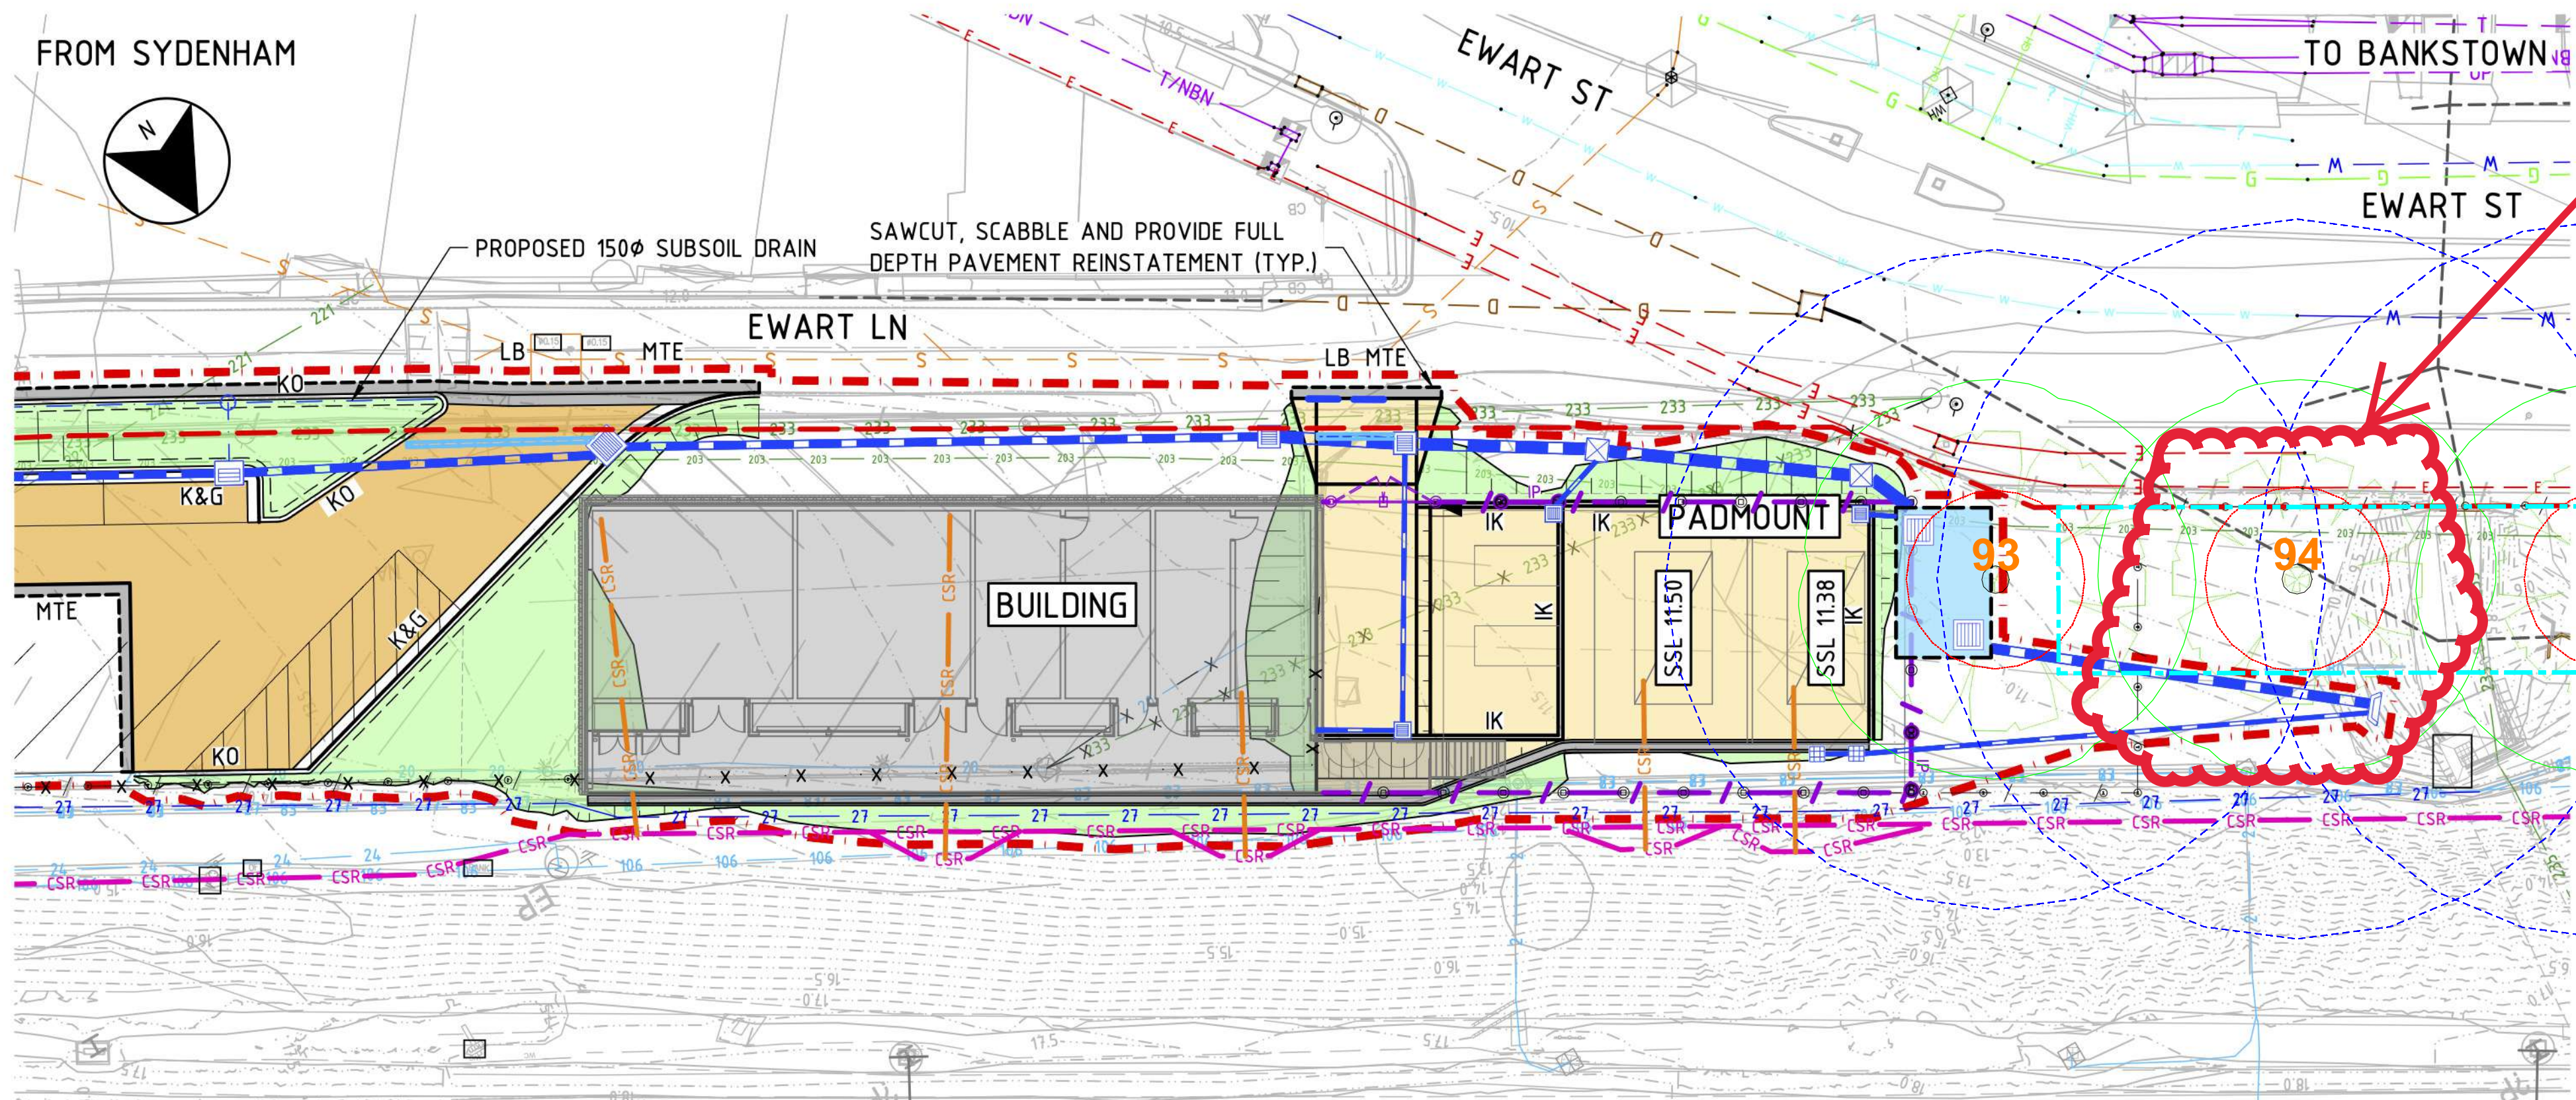
To be cleared due to clash with permanent drainage design. Drainage design indicted by blue and white dotted line.

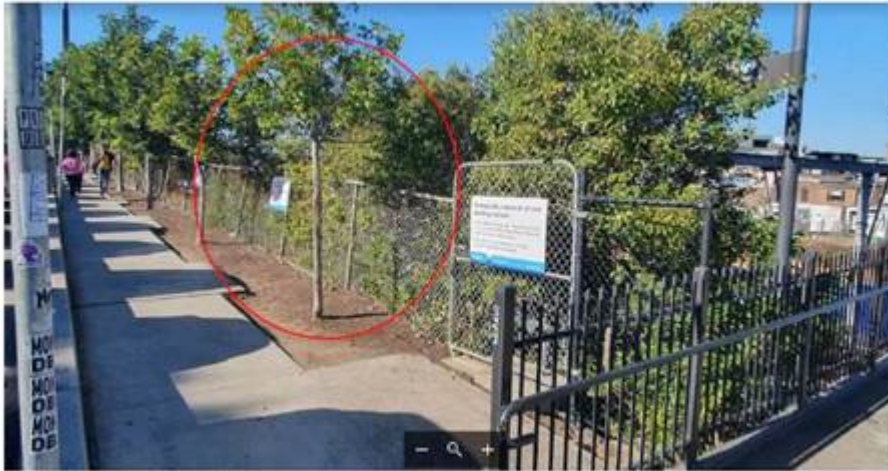
Image 2: Tree A circled in red.

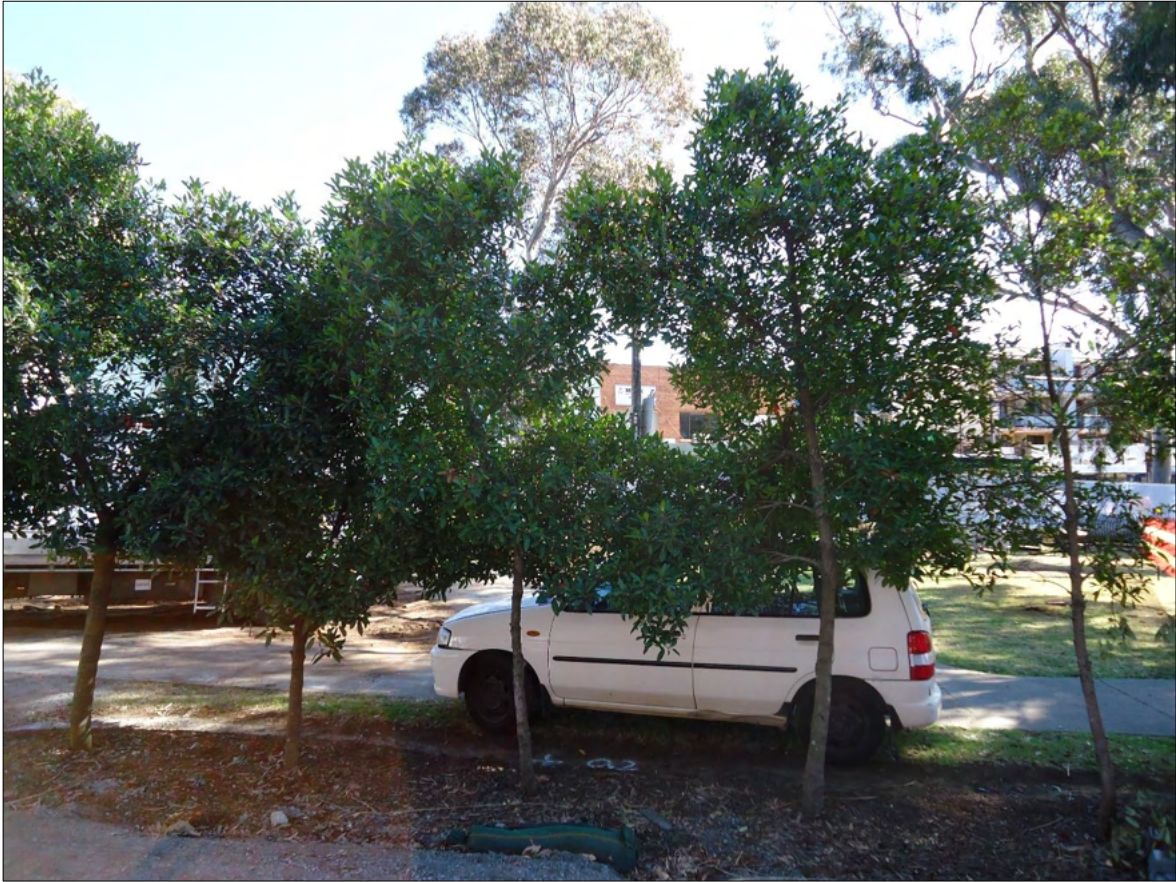
Photograph 1: Showing the five *Elaeocarpus reticulatus* (Blueberry Ash) to be removed.
