# Tree Impact Assessment Report

## City and Southwest Metro Station Upgrade Works Package 5 & 6

**Project wide: Hurlstone Park, Wiley Park, Belmore,  
Campsie, Dulwich Hill and Punchbowl**

**P5 Document No. SMCSWSW5-DEW-WEC-EM-REP-000542**

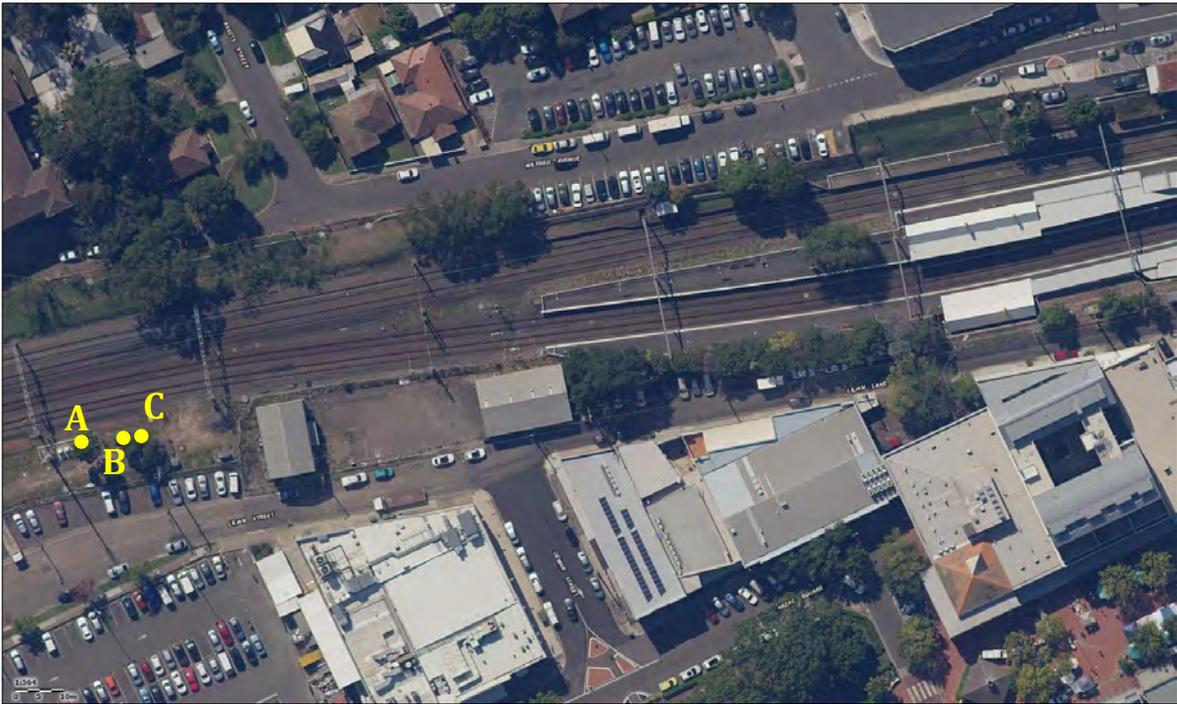
I can confirm that no tree removals were identified within the initial AIA report. Three additional trees located to the rear of the station adjacent the commuter car park off Lillian Street have been identified for removal based on direct design clash and 100% encroachment of TPZ and SRZ. Data for these trees can be found as Appendix 1 of this report. Image 1 shows the location of the additional tree removals.

**Image 1:** Aerial image showing location of additional tree removals.

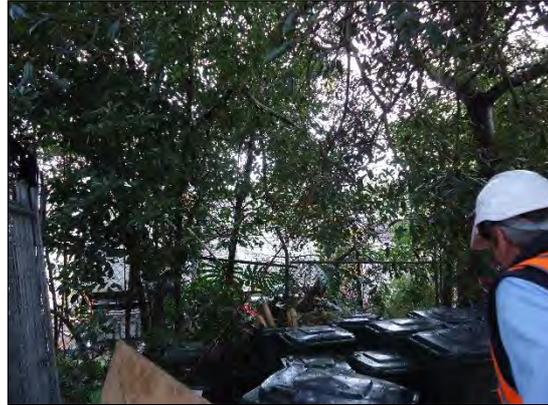
**Photograph 1:** Clump of vegetation consisting of approximately 14 individual stems of *Cinnamomum camphora* (Camphor Laurel) and a dead tree identified for removal.

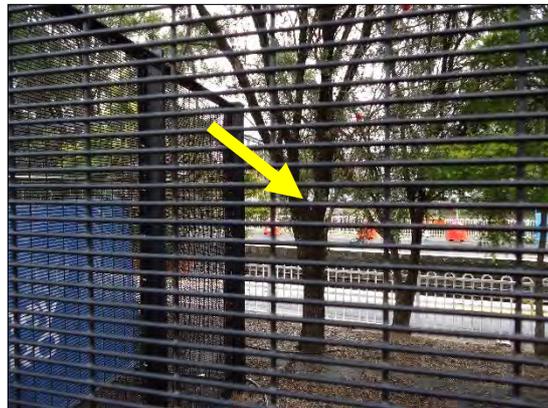
**Photograph 2:** Tree 632 *Callistemon viminalis* (Bottlebrush) identified for removal to accommodate the new GST alignment.

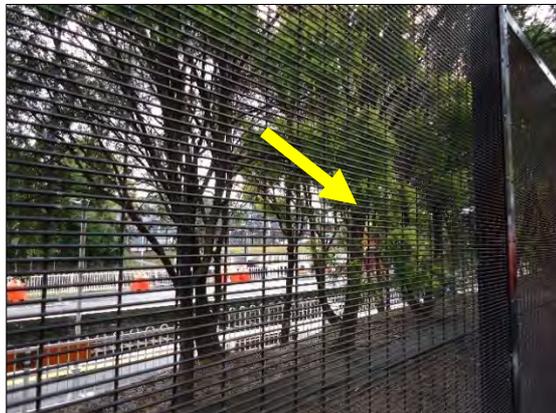
**Photograph 3:** Tree 627 *Leptospermum petersonii* (Lemon-scented Teatree) identified for selective pruning works create clearances to allow for the new GST alignment.

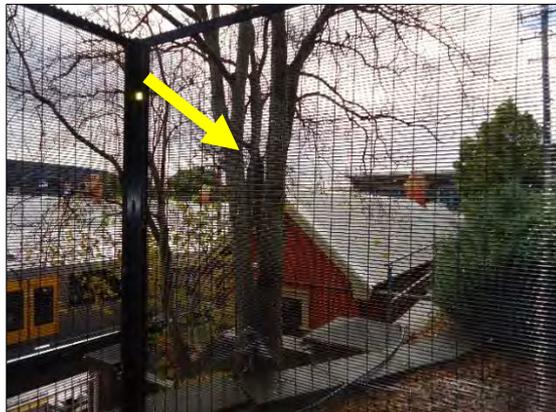
**Photograph 4:** Tree 614 *Sapium sebiferum* (Chinese Tallowwood) identified for removal to accommodate the new GST alignment.

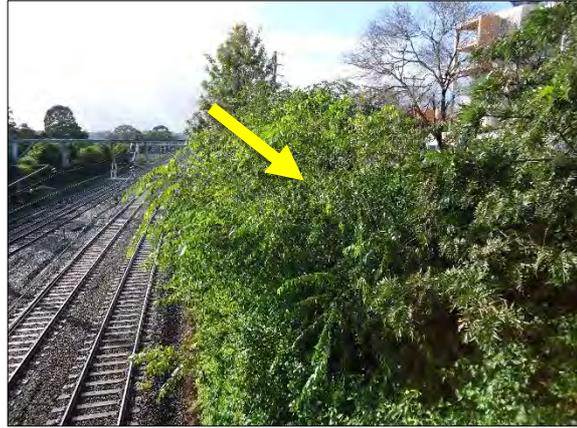
**Photograph 5:** Tree 6 *Celtis sinensis* (Hackberry) located within rail corridor. Tree to be removed to accommodate the new GST alignment. The surrounding Lantana along the rail embankment is also to be removed.

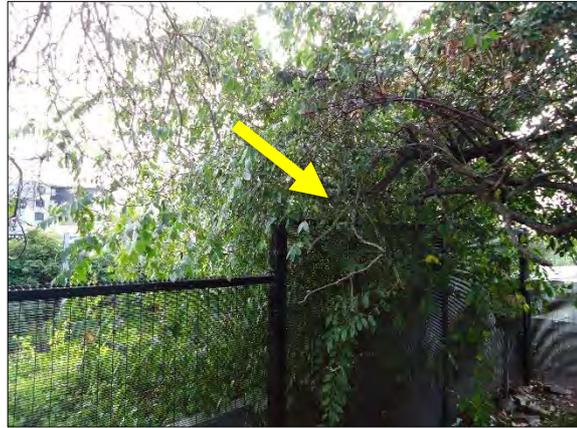
**Photograph 6:** Tree 7 *Celtis sinensis* (Hackberry) located within rail corridor. Tree to be removed to accommodate the new GST alignment.

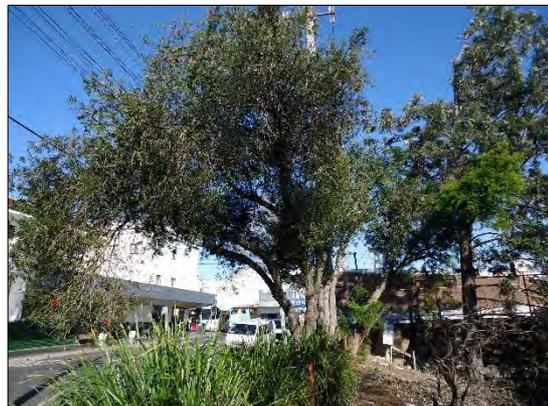
**Photograph 4:** Tree 519 *Callistemon viminalis* (Weeping Bottlebrush) located adjacent the northern side of South Parade.

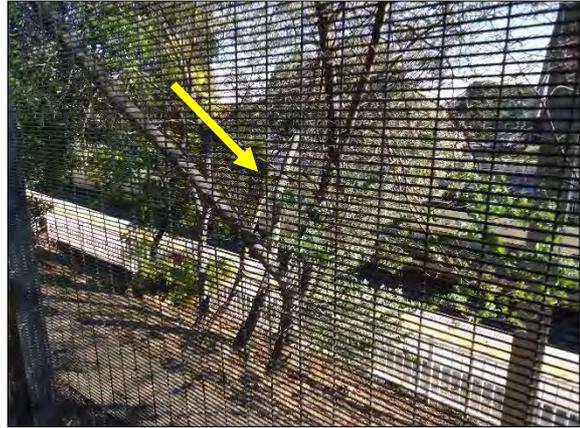
**Photograph 5:** Tree 615 *Acacia podalyrifolia* (Queensland Silver Wattle) located adjacent Platform 2. The adjacent Queensland Silver Wattle's are near dead.

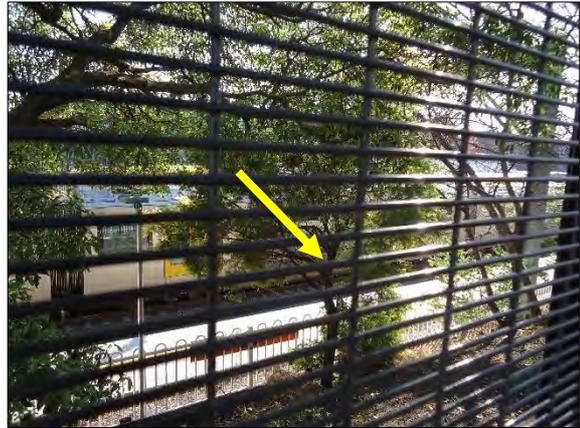
**Photograph 6:** Tree 5 *Melaleuca bracteata* (Black Teatree) located adjacent Platform 2.

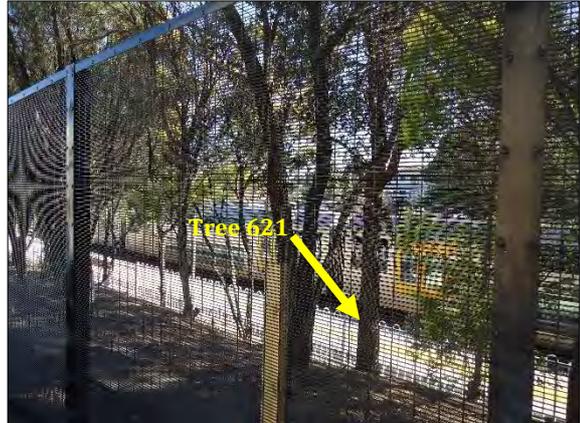
**Photograph 7:** Showing trees adjacent Platform 2. Tree 621 *Syncarpia glomulifera* (Turpentine) is shown for reference.

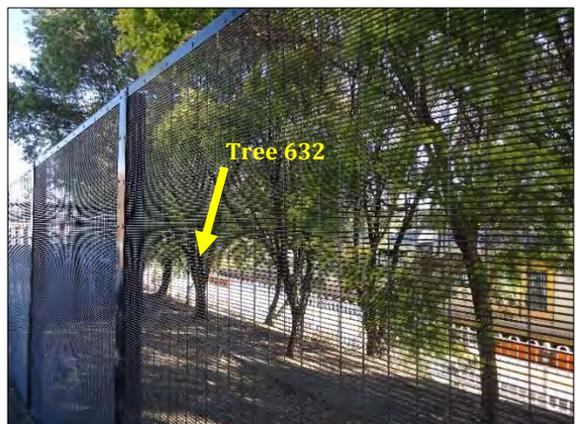
**Photograph 8:** Showing trees adjacent Platform 2. Tree 632 *Callistemon viminalis* (Weeping Bottlebrush) is shown for reference.

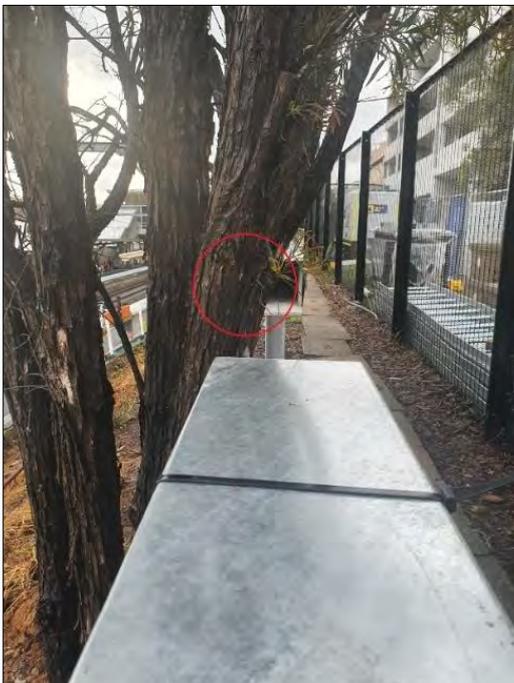
**Photograph 2:** Looking east along the alignment of the GST. Selective stem removal is required to allow for the GST alignment.

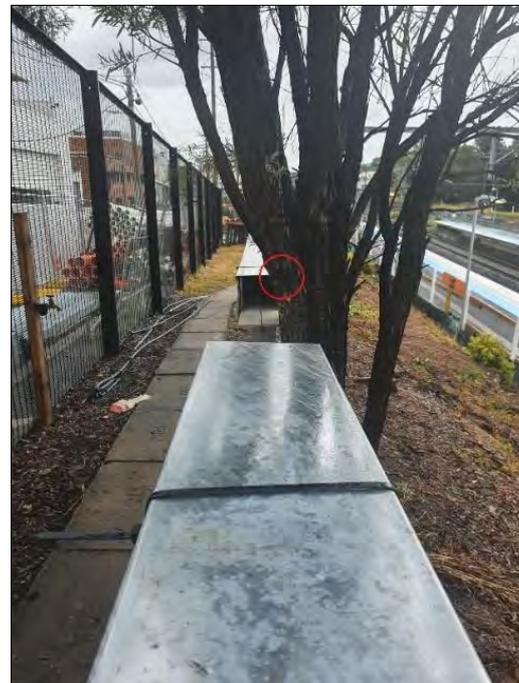
**Photograph 3:** Looking west along the alignment of the GST. Selective stem removal is required to allow for the GST alignment.

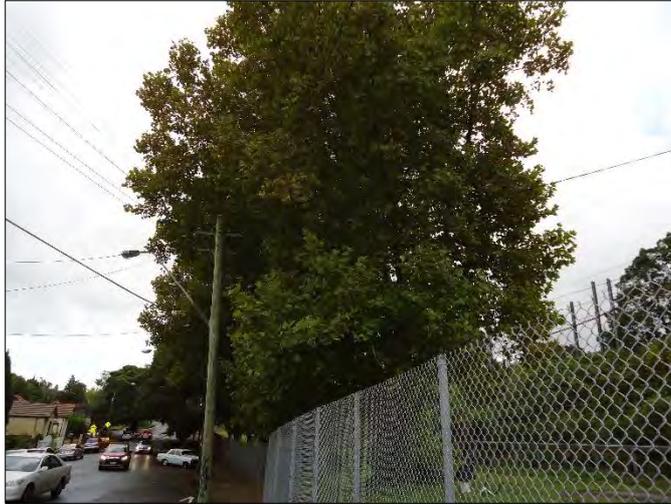
**Photograph 1:** Tree 1 *Platanus x acerifolia* (London Plane) to be removed.

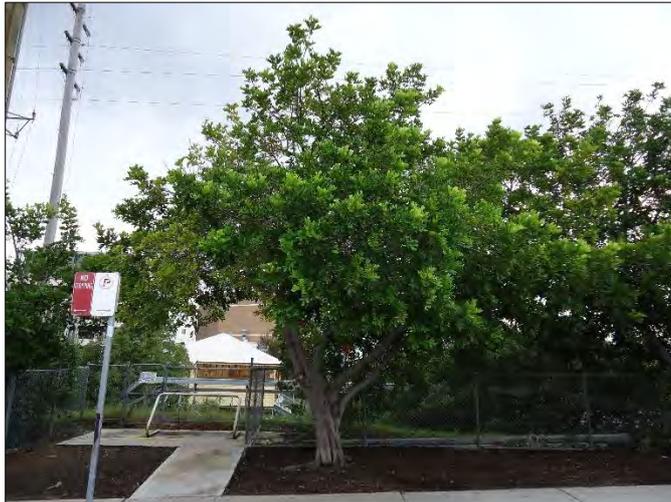
**Photograph 2:** Tree 2 *Cupaniopsis anacardioides* (Tuckeroo) to be removed.

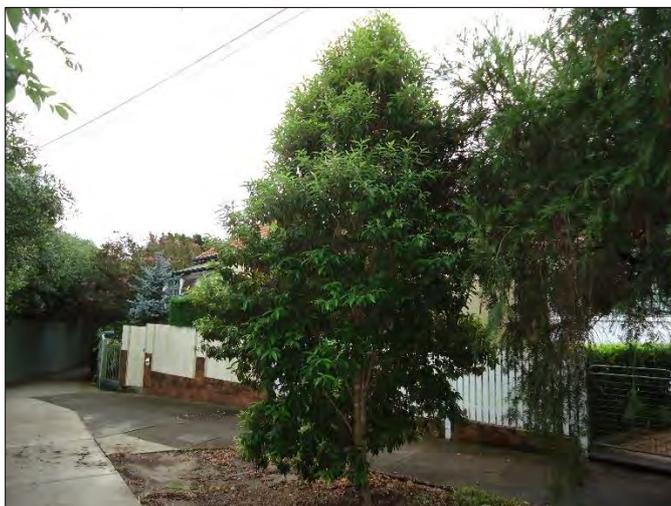
**Photograph 3:** Tree 3 *Backhousia citriodora* (Lemon-scented Myrtle). Tree is to be transplanted on the site.

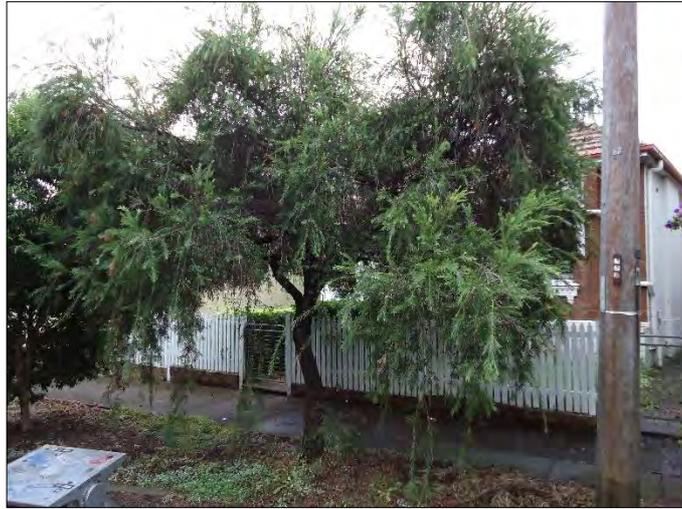
**Photograph 4:** Tree 4 *Calistemon viminalis* (Bottlebrush) to be removed.

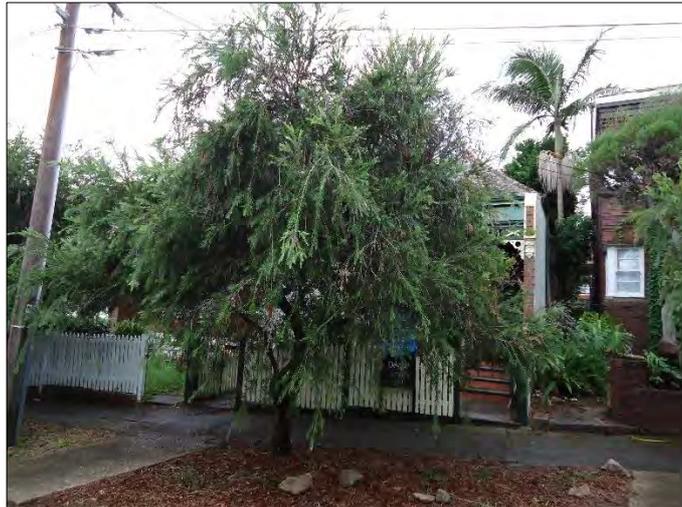
**Photograph 5:** Tree 5 *Calistemon viminalis* (Bottlebrush) to be removed.

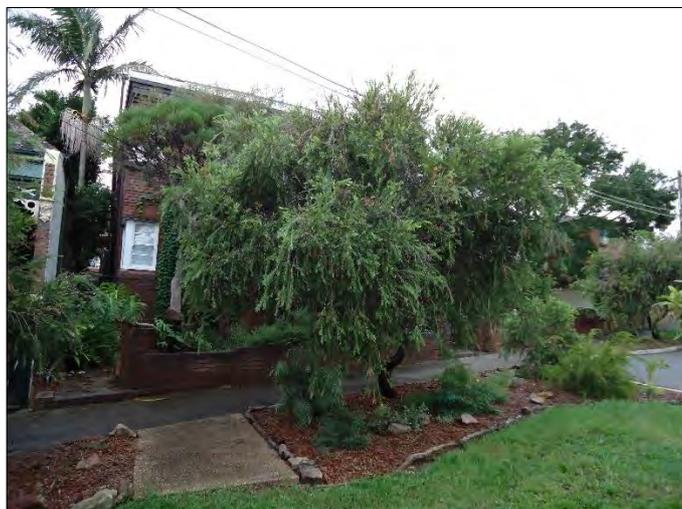
**Photograph 6:** Tree 6 *Calistemon viminalis* (Bottlebrush) to be removed.

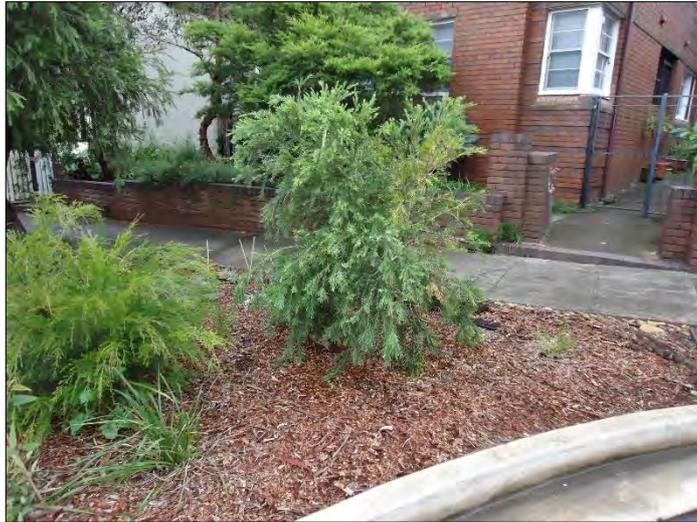
**Photograph 7:** Tree 7 *Calistemon viminalis* (Bottlebrush) to be removed. Does not meet the criteria for being a tree under *Sydney Metro City & Southwest Sydenham to Bankstown Instrument of Approval* due to height. Currently considered a sapling.

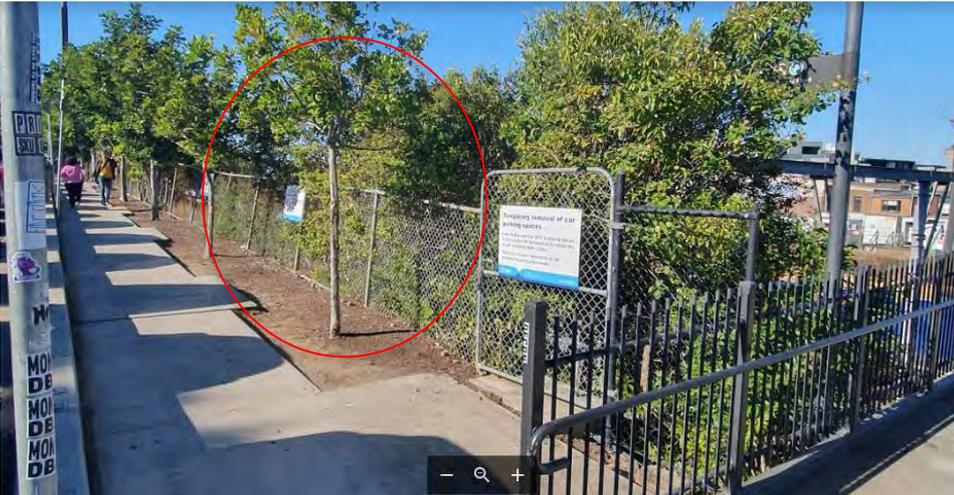
Image 2: Tree A circled in red.

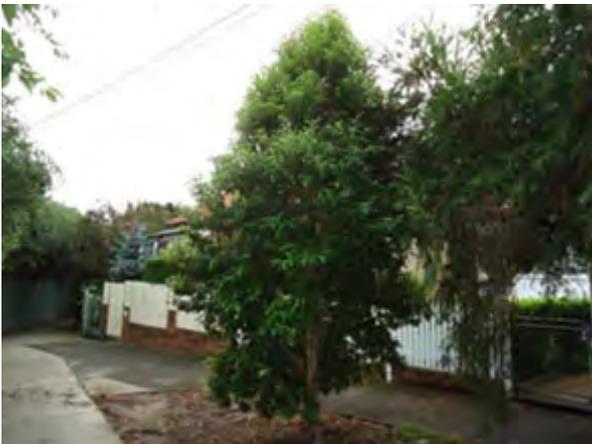
During the phone call with your colleague, it was noticed that the original photo was actually the wrong tree nominated to be relocated (refer to below correct image). Irrespective, the below correspondence is still relevant and we are seeking advise from Inner West Council whether they wish to retain the tree and transplant locally or shall the project add it to the tree offset planting requirements.

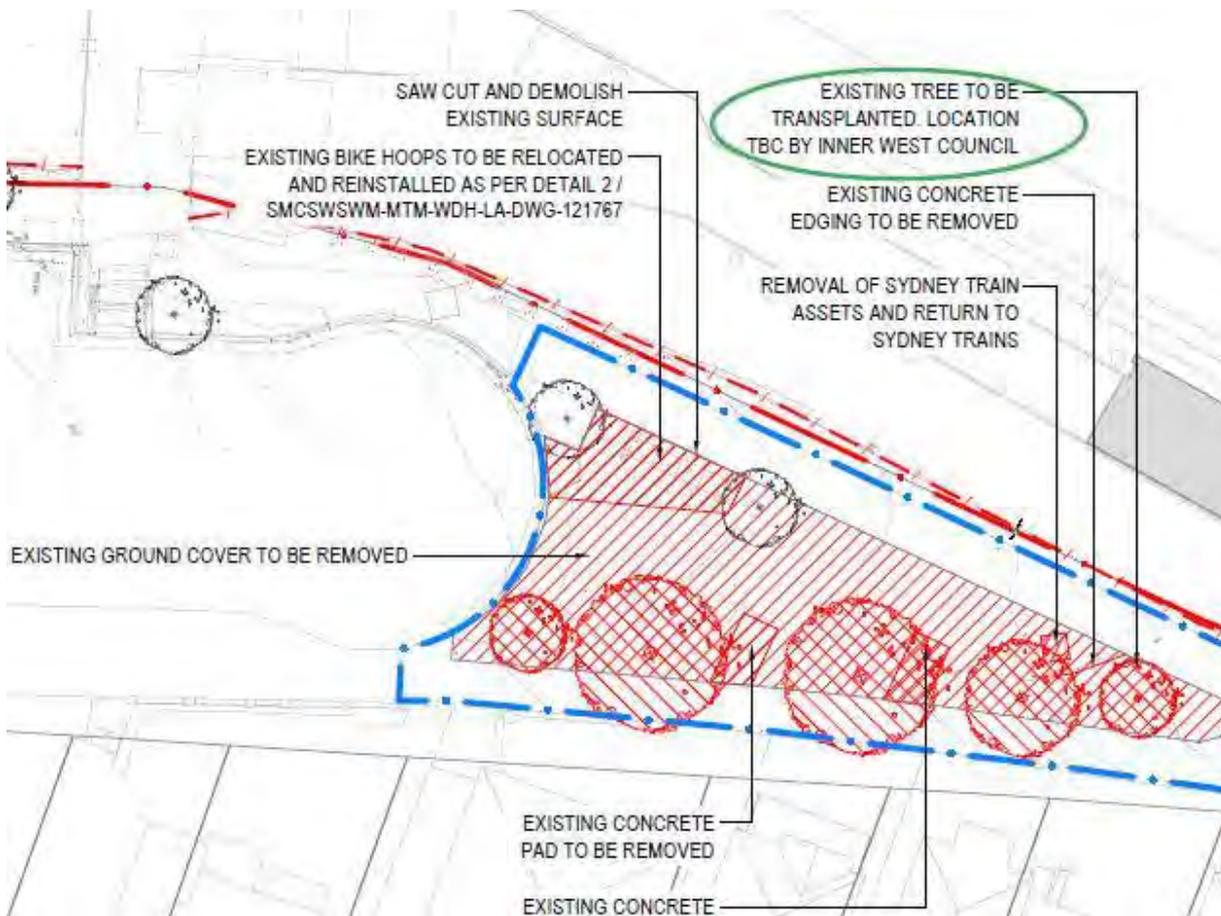
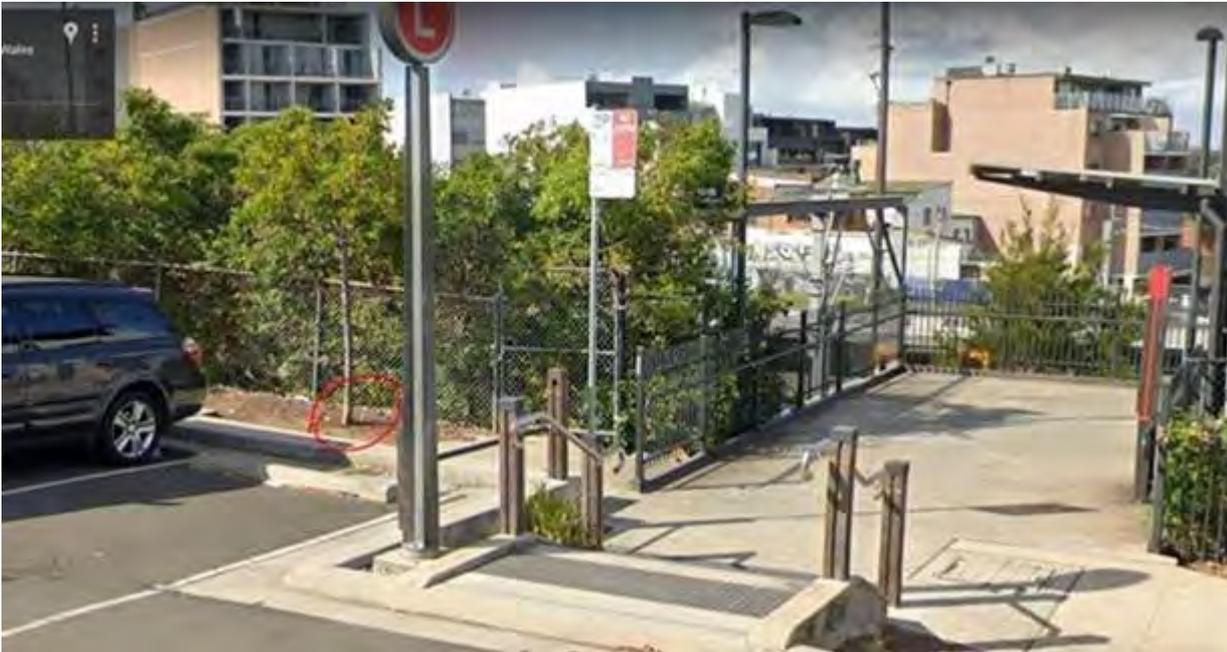
In short, the design has nominated a singular tree at Dulwich Hill Station to be relocated (see below design excerpt and street view image of tree circled in red). The tree is quite young and doesn't offer any significant value which leads me to ask whether IWC actually wish to retain the tree. Relocating the tree will pose a few logistical issues given that we (Downer) will need to remove the tree being in our PC and the transplant/ relocation works would need to be undertaken by IW Council given that the new location is likely to be outside of the project boundary.

The alternative to transplanting is for the project to remove the tree along with the remaining vegetation (separate tree clearance request) and add to the project tree offset planting. I believe this would be the most favourable option for both parties, however am seeking initial input from Inner West Council.

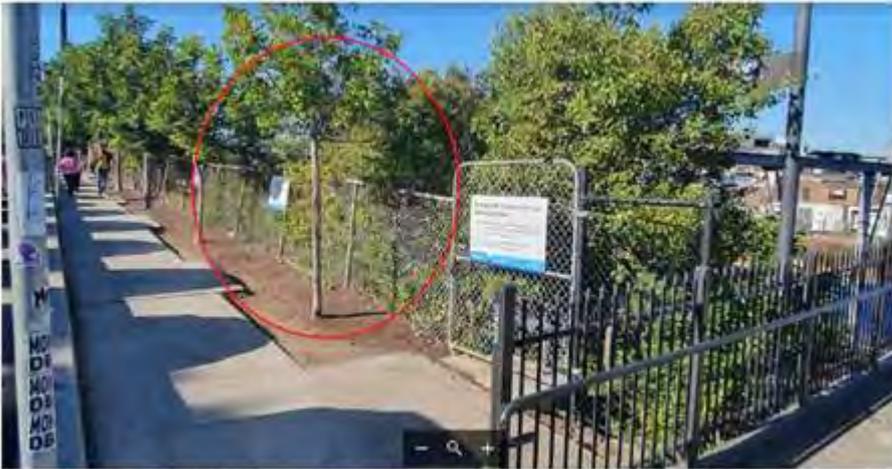
**Tree A:**

Image 2: Tree A circled in red.

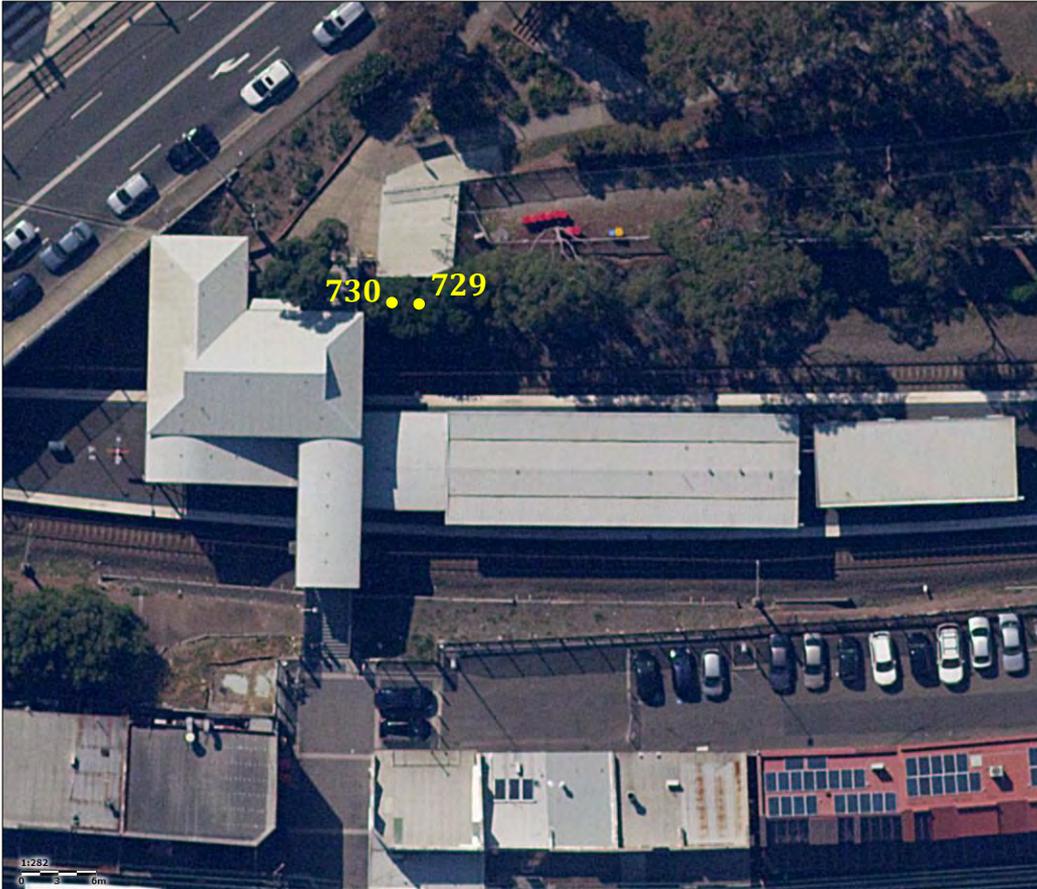
The trees are considered to be in good health and condition and provide minor screening of the rail corridor from the area adjacent the station entry. They are

not representative of an endangered or threatened species or ecological community.

**Image 1:** Aerial image of Punchbowl Station showing the location of trees 729 and 730.

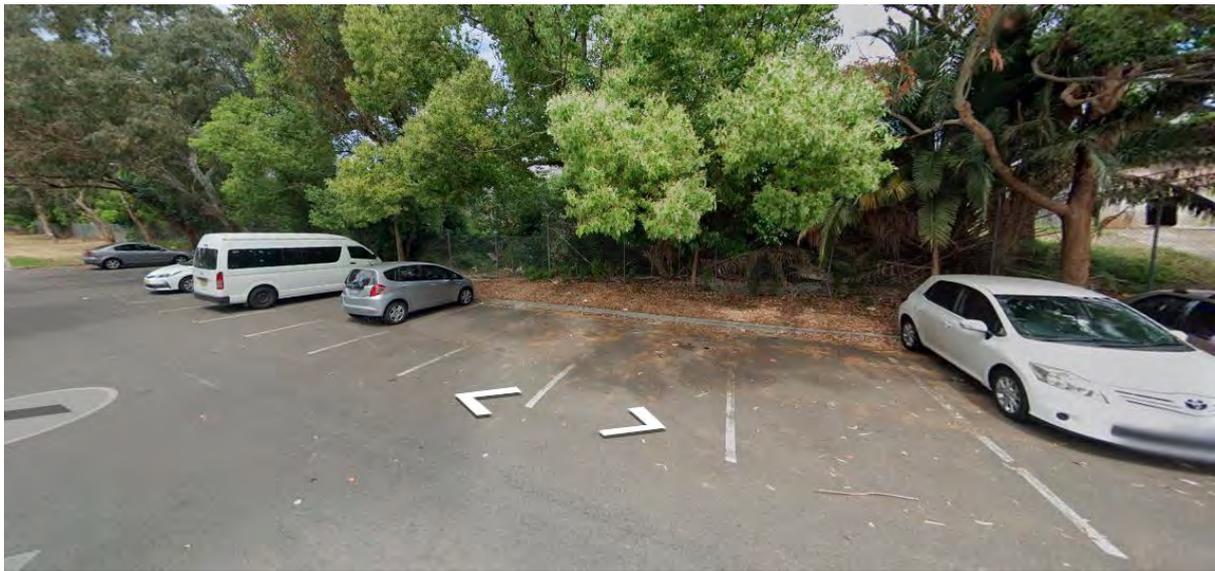
**Figure 1:** Street view of the subject trees taken from Urunga Parade, Punchbowl (*nearmap 2021*).

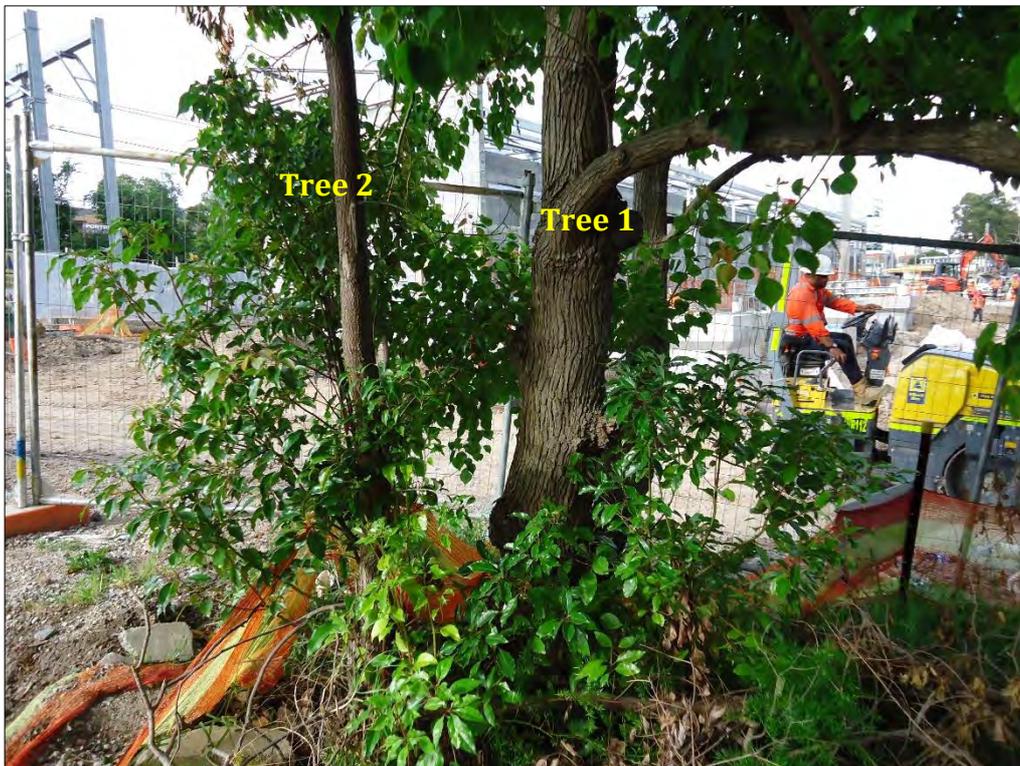
**Photograph 1:** Showing the individual trunks of the subject trees.

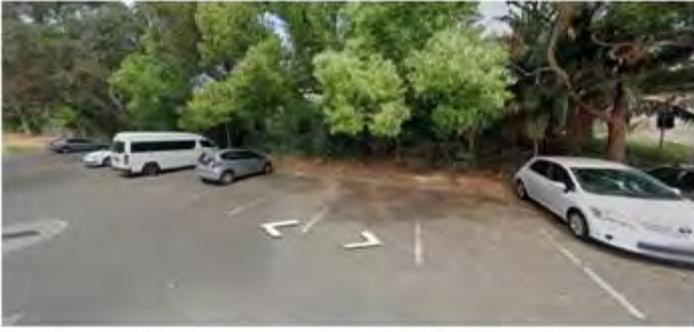
Figure 1: Street view of the subject trees taken from Urunga Parade, Punchbowl (neommap 2021).
