Tree Impact Assessment Report

City and Southwest Metro Station Upgrade Works Package 5 & 6

P5 Document No. SMCSWSW5-DEW-WEC-EM-REP-000542

P6 Document No. SMCSWSW6-DEW-WEC-EM-REP-000632

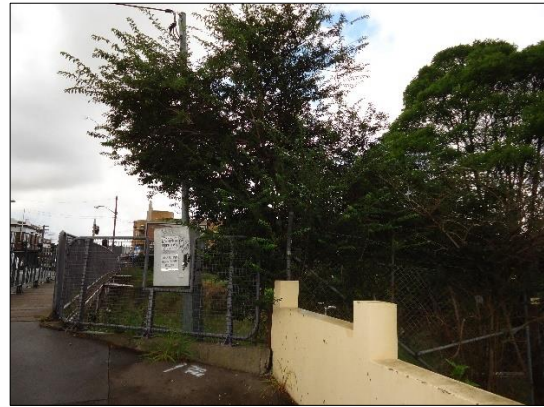
Photograph 1: Tree 1 *Ligustrum sinensis* (Small-leaved Privet) to be removed for pilling works adjacent rail bridge.

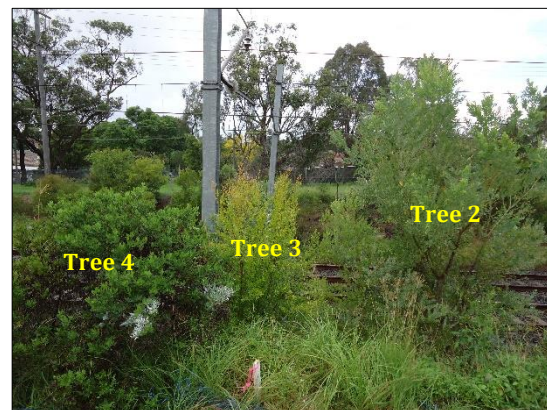
Photograph 2: Trees 2 *Acacia* sp (Wattle), 3 *Leptospermum* sp (Tee Tree) and 4 Unknown species to be removed for MSB works.

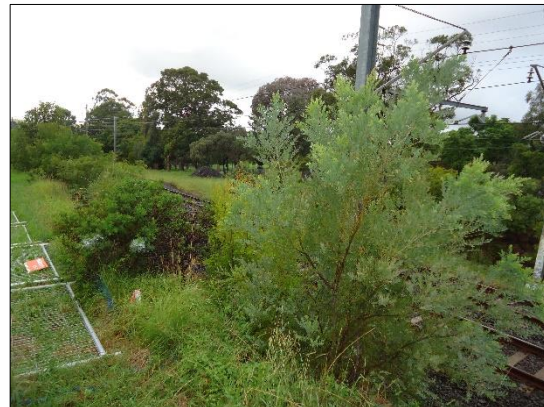
Photograph 3: Tree 5 *Acacia* sp (Wattle) to be selectively pruned for clearance along the embankment.

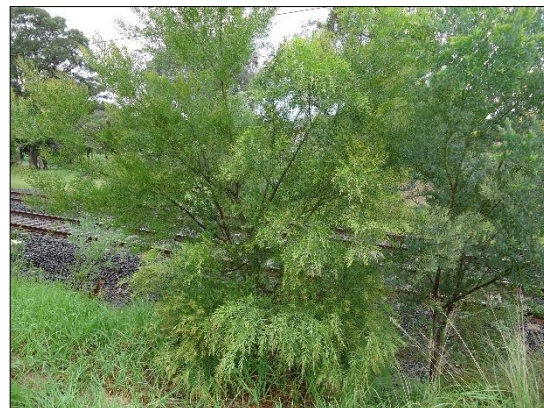
Photograph 4: Tree 6 *Acacia* sp (Wattle) to be removed for MSB works.

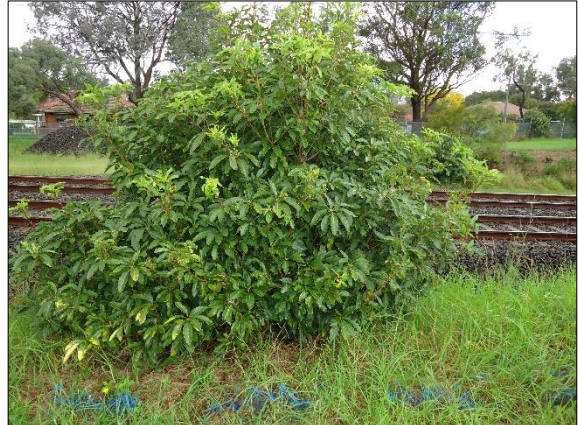
Photograph 7: Tree 9 *Pittorporum undulatum* (Sweet Pittosporum) to be removed for MSB works.

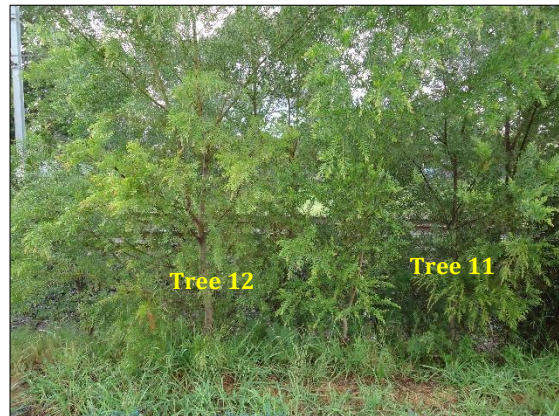
Photograph 9: Trees 11 and 12 *Acacia* sp (Wattle) to be removed for MSB works.

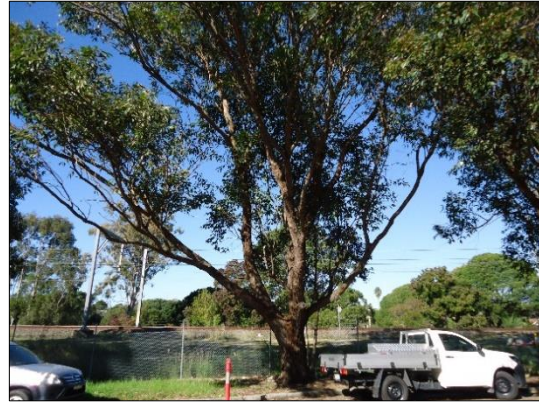
It was advised by Downer Group that two trees being a Swamp Mahogany, tree 1, and a Brown Pine, tree 2, are to be removed. Both trees were considered to be in good health and have medium useful life expectancies of 15 to 40 years. These trees are located within the road reserve area adjacent to the rail corridor and form part of the existing streetscape. Their removal, in particular the Swamp Mahogany is likely to be visually significant. The Swamp Mahogany and Brown Pine are not representative of an endangered or threatened species or ecological community. Photographs 1 and 2 show these trees.

Photograph 1: Tree 1 *Eucalyptus robusta* (Swamp Mahogany) to be removed due to direct clash with permanent design access road to MSB.

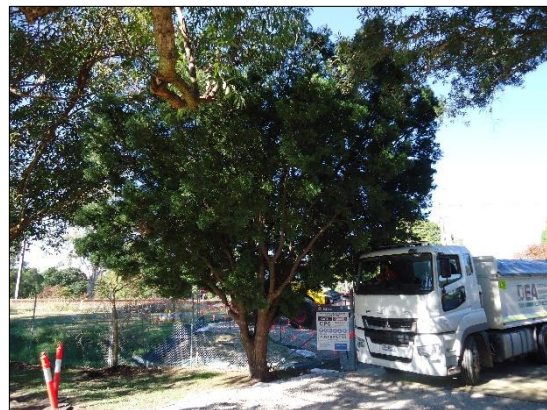
Photograph 2: Tree 2 *Podocarpus elatus* (Brown Pine) to be removed due to direct clash with permanent design access road to MSB.

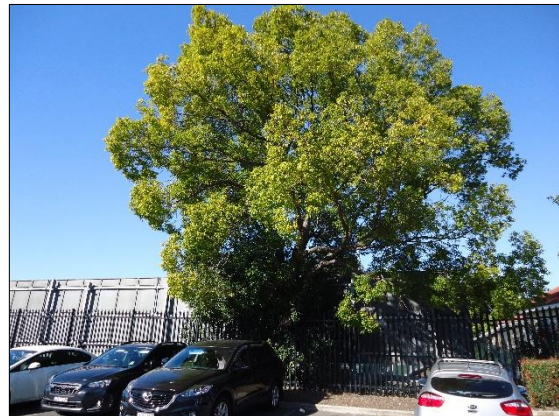
Photograph 3: Tree 3 *Cinnamomum camphora* (Camphor Laurel) within northern side of rail corridor.

The new GST is aligned past tree 3, Camphor Laurel and shall require the removal of the suckers and epicormics from around the base of its trunk. Any excavation within 6m of the trunk (refer to **Appendix 1** Tree Assessment Schedule for TPZ offset) to install the troughing posts is to be undertaken using methods that do not damage tree roots. There is to be enough flexibility in the GST's design and alignment to reposition posts if roots greater than 30mm in diameter are exposed within the excavations. Although commonly regarded as a weed species this specimen is protected under local tree preservation controls due to its height. Photographs 3 and 4 show the tree and suckering around the base of the trunk to be removed.

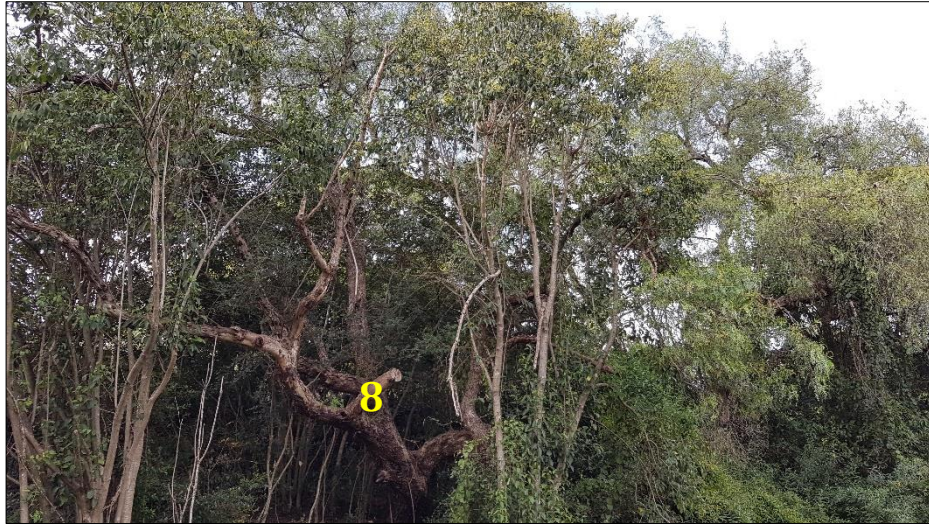
Photograph 4: Tree 8 *Schinus molle* (Peppercorn Tree) to be removed.

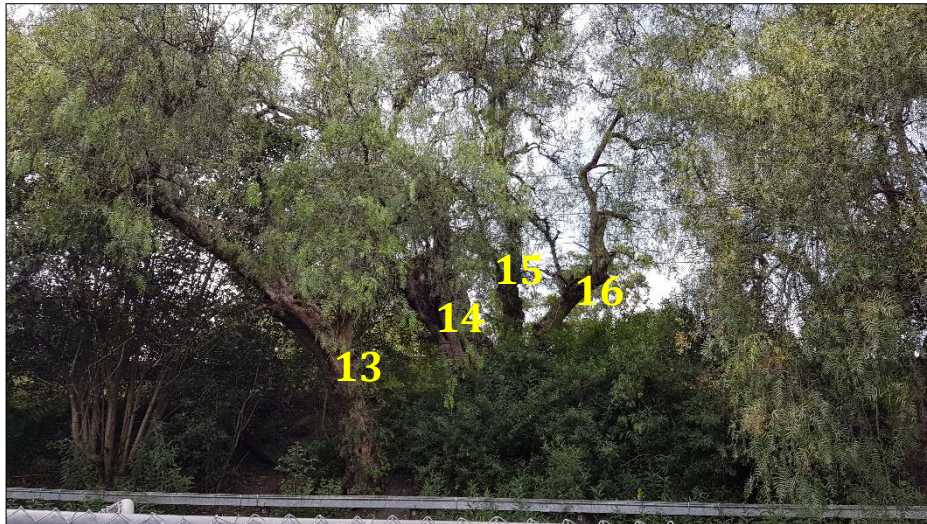
Photograph 7: Trees 13, 14, 15 and 16 *Schinus molle* (Peppercorn Tree) to be removed.

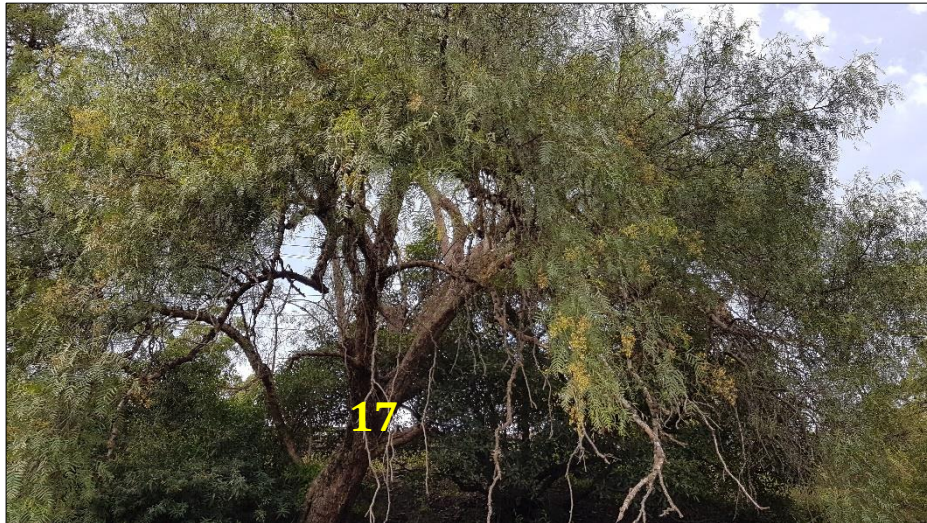
Photograph 8: Tree 17 *Schinus molle* (Peppercorn Tree) to be removed.

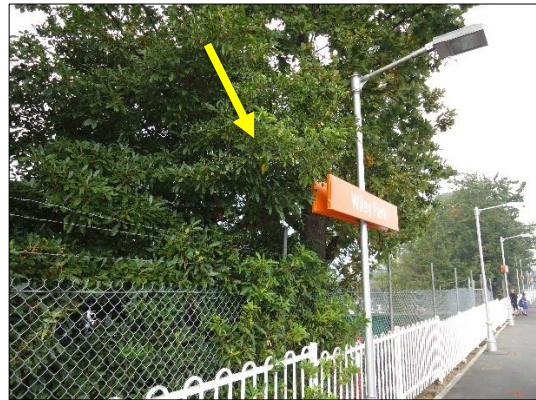
Photograph 2: Tree 2 *Eucalyptus pilularis* (Blackbutt) identified for removal to accommodate Metro services Building driveway and access.
