# Tree Impact Assessment Report

## City and Southwest Metro Station Upgrade Works Package 5 & 6

**P5 Document No. SMCSWSW5-DEW-WEC-EM-REP-000542**

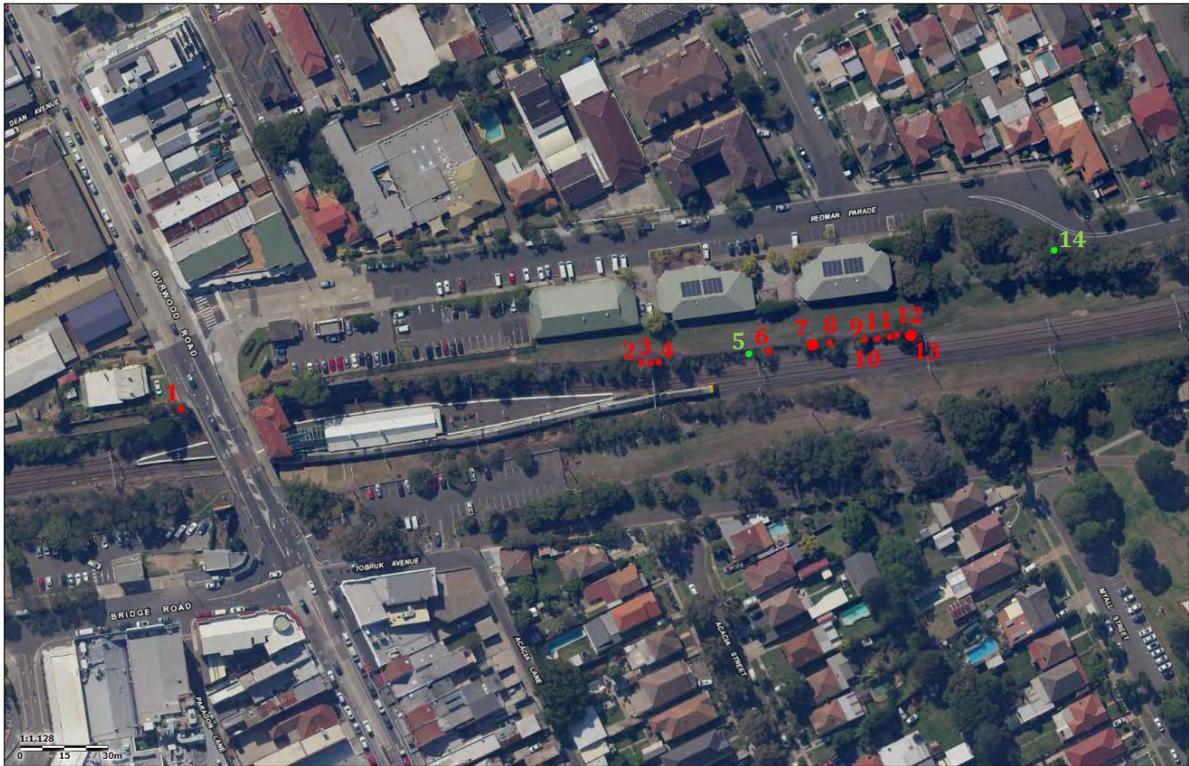
All appropriate approvals and consents are to be obtained prior to tree and vegetation removal works commencing. Given their size and location, it is felt that trees 2, 3, 4, 6, 7, 8, 9, 10, 11, 12 and 13 may be removed using an excavator without significant impact on tree 5.

**Image 1:** Aerial image of Belmore station showing approximate tree locations. Red dots indicate trees to be removed, green dots indicate trees to be pruned.

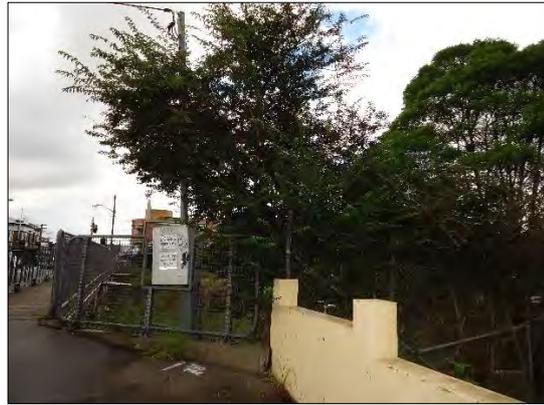
Total impact to tree 1 due to direct clash with pile required for anti-throw screen.

**Photograph 1:** Tree 1 *Ligustrum sinensis* (Small-leafed Privet) to be removed for pilling works adjacent rail bridge.

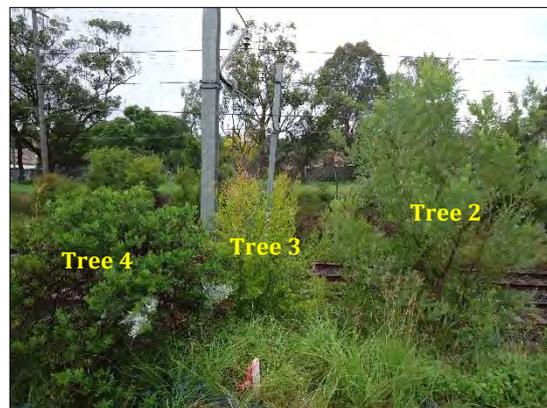
**Photograph 2:** Trees 2 *Acacia* sp (Wattle), 3 *Leptospermum* sp (Tee Tree) and 4 Unknown species to be removed for MSB works.

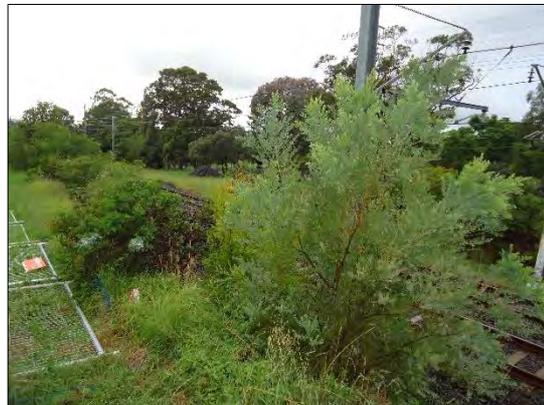
**Photograph 3:** Tree 5 *Acacia* sp (Wattle) to be selectively pruned for clearance along the embankment.

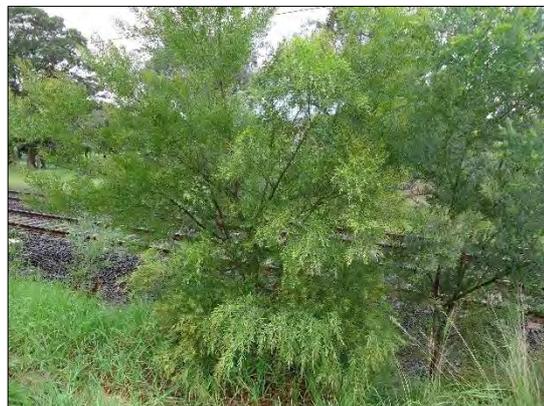
**Photograph 4:** Tree 6 *Acacia* sp (Wattle) to be removed for MSB works.

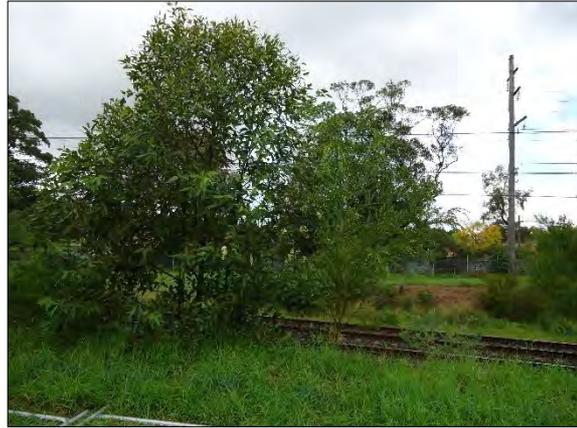
**Photograph 5:** Tree 7 *Eucalyptus robusta* (Swamp Mahogany) to be removed to accommodate the new GST alignment.

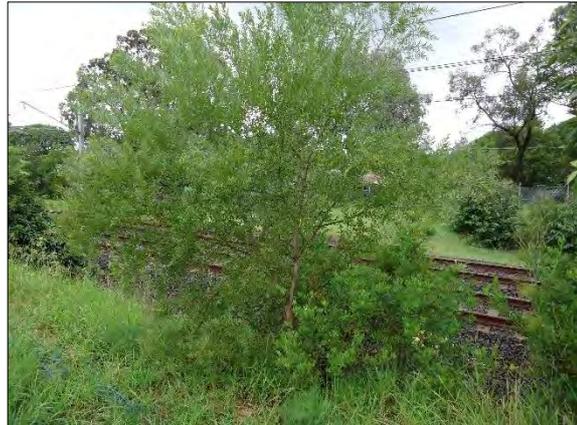
**Photograph 6:** Tree 8 *Acacia* sp (Wattle) to be removed for MSB works.

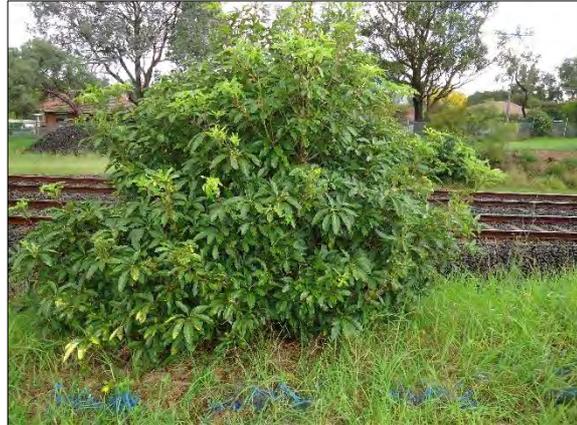
**Photograph 7:** Tree 9 *Pittorporum undulatum* (Sweet Pittosporum) to be removed for MSB works.

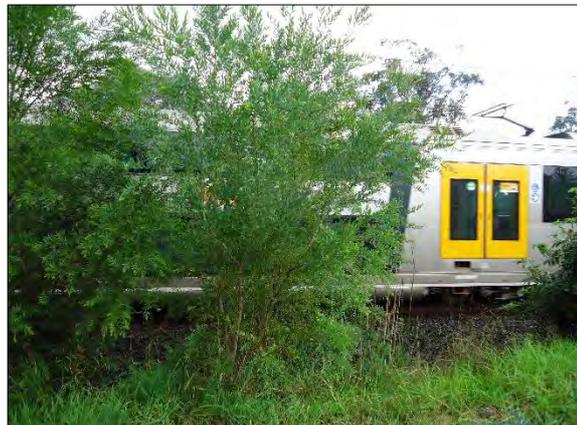
**Photograph 8:** Tree 10 *Acacia* sp (Wattle) to be removed for MSB works.

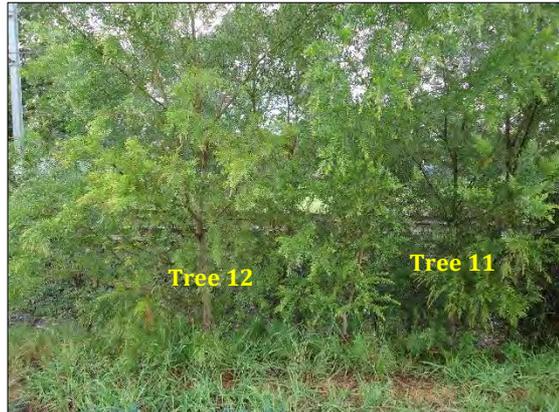
**Photograph 9:** Trees 11 and 12 *Acacia* sp (Wattle) to be removed for MSB works.

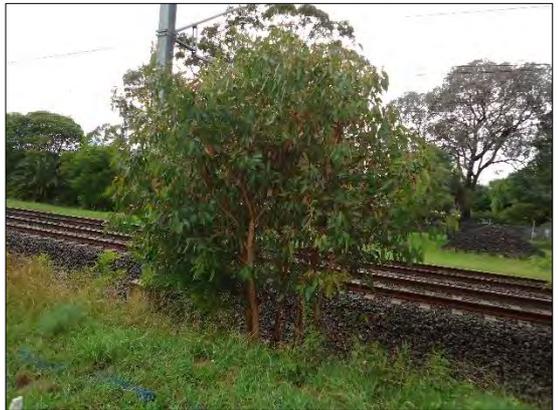
**Photograph 10:** Tree 13 *Eucalyptus robusta* (Swamp Mahogany) to be removed to accommodate the new sewer alignment.

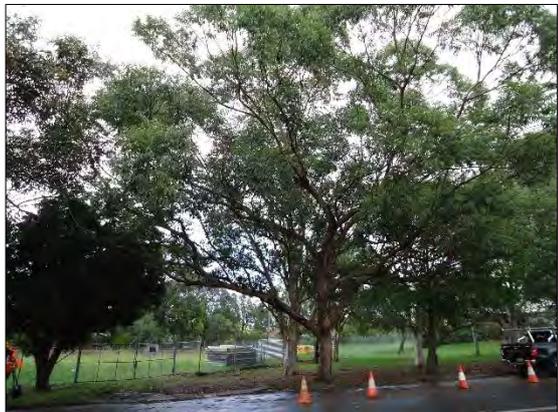
**Photograph 11:** Tree 14 *Eucalyptus robusta* (Swamp Mahogany) located within road reserve to be selectively pruned for site access clearances.

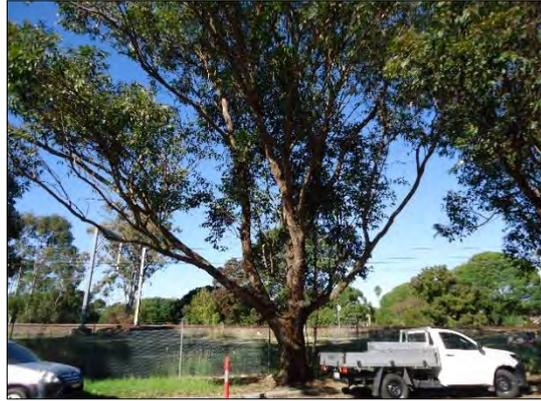
**Photograph 1:** Tree 1 *Eucalyptus robusta* (Swamp Mahogany) to be removed due to direct clash with permanent design access road to MSB.

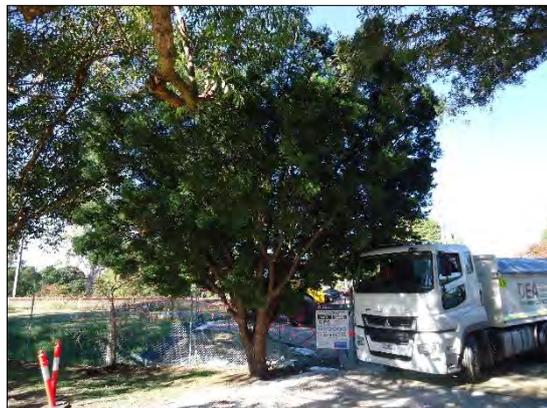
**Photograph 2:** Tree 2 *Podocarpus elatus* (Brown Pine) to be removed due to direct clash with permanent design access road to MSB.

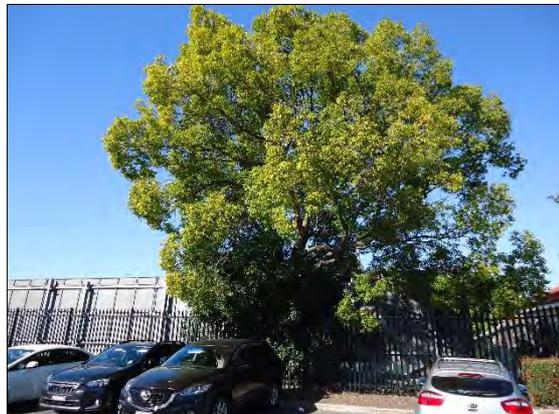
**Photograph 3:** Tree 3 *Cinnamomum camphora* (Camphor Laurel) within northern side of rail corridor.

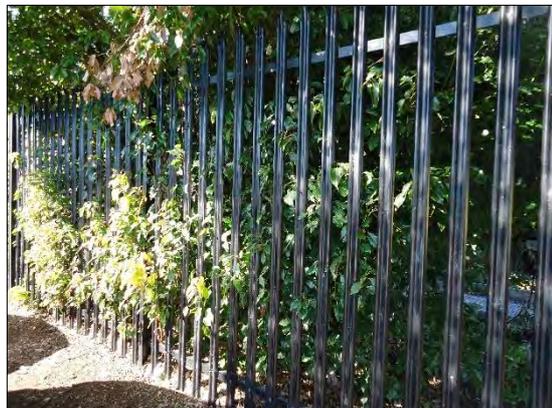
**Photograph 4:** Suckering around the base of tree 3 is to be removed to allow for the proposed alignment of the new GST.

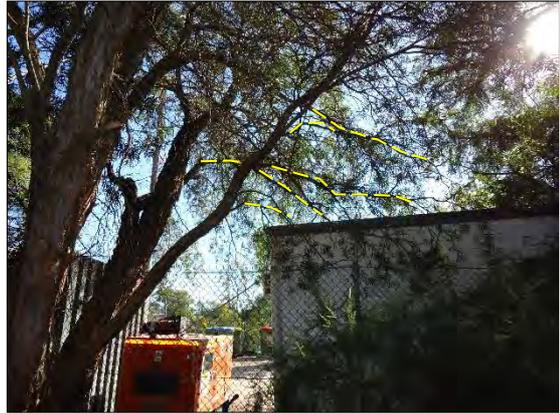
**Photograph 5:** Tree 4 *Callistemon slaignus* (Weeping Bottlebrush) to be selectively pruned to clear site sheds.

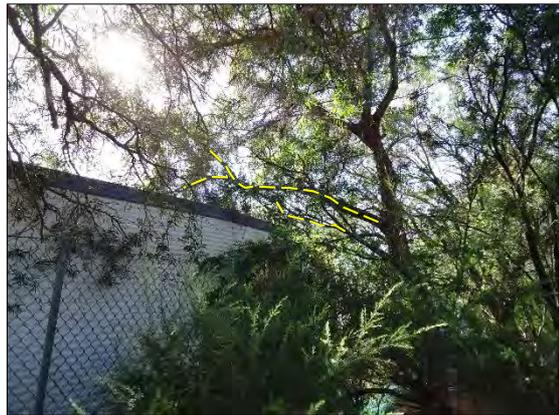
**Photograph 6:** Tree 5 *Leptospermum petersonii* (Lemon-scented Tee Tree) to be selectively pruned to clear site sheds.

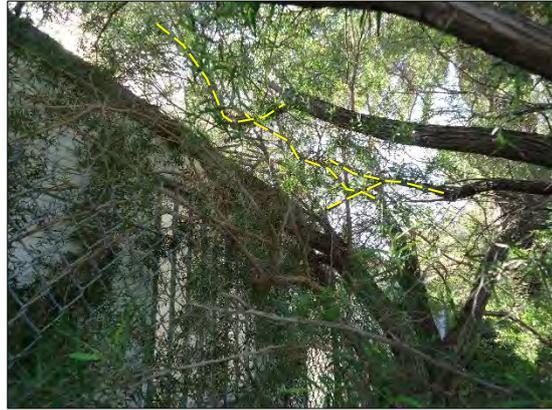
**Photograph 9:** Tree 8 *Leptospermum petersonii* (Lemon-scented Tee Tree) to be selectively pruned to clear site sheds.

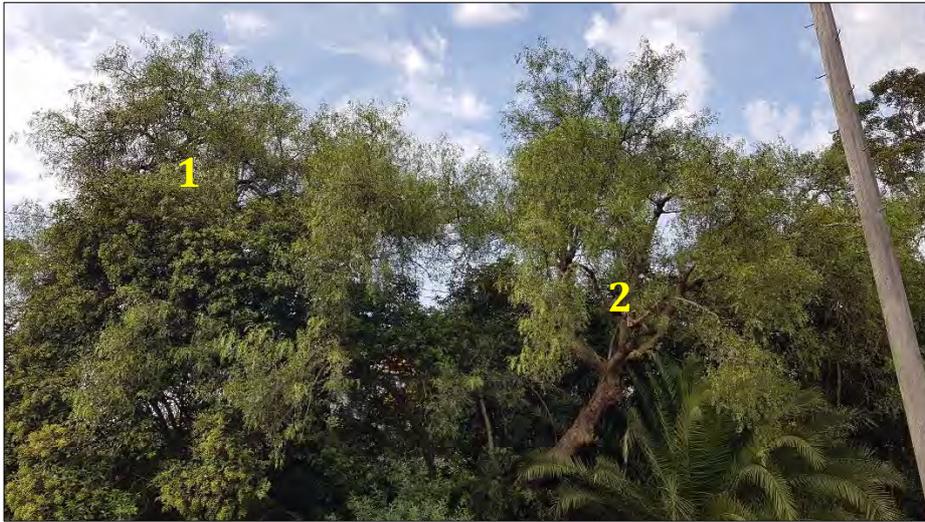
**Photograph 1:** Trees 1 and 2 *Schinus molle* (Peppercorn Tree) to be removed.

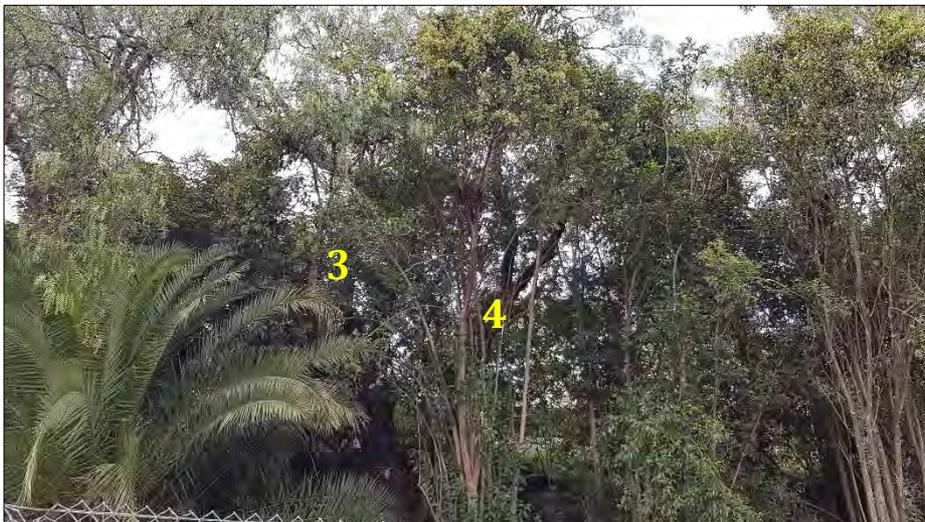
**Photograph 2:** Trees 3 and 4 *Schinus molle* (Peppercorn Tree) to be removed.

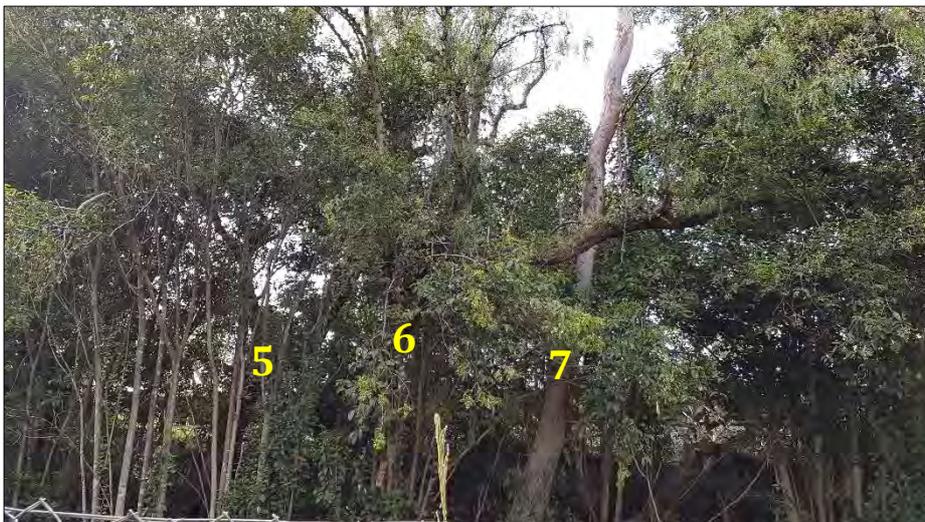
**Photograph 3:** Trees 5, 6 and 7 *Schinus molle* (Peppercorn Tree) to be removed.

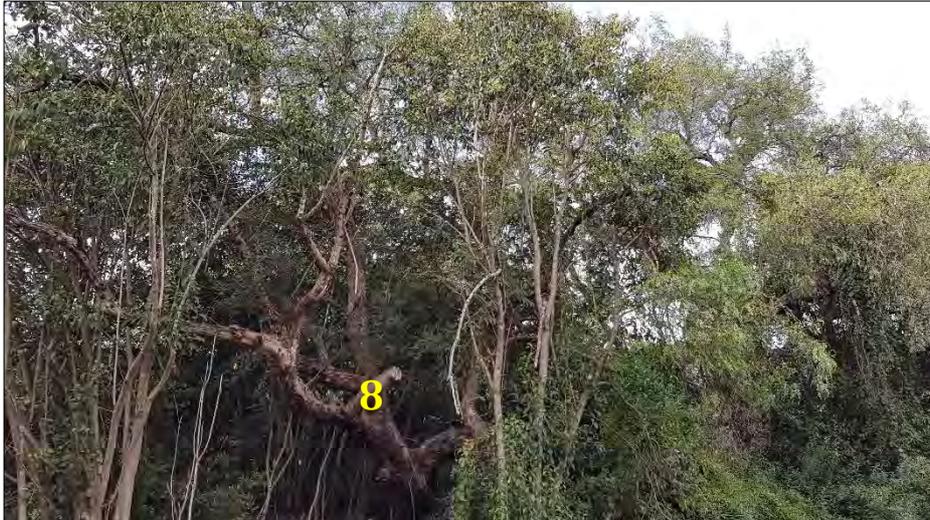
**Photograph 4:** Tree 8 *Schinus molle* (Peppercorn Tree) to be removed.

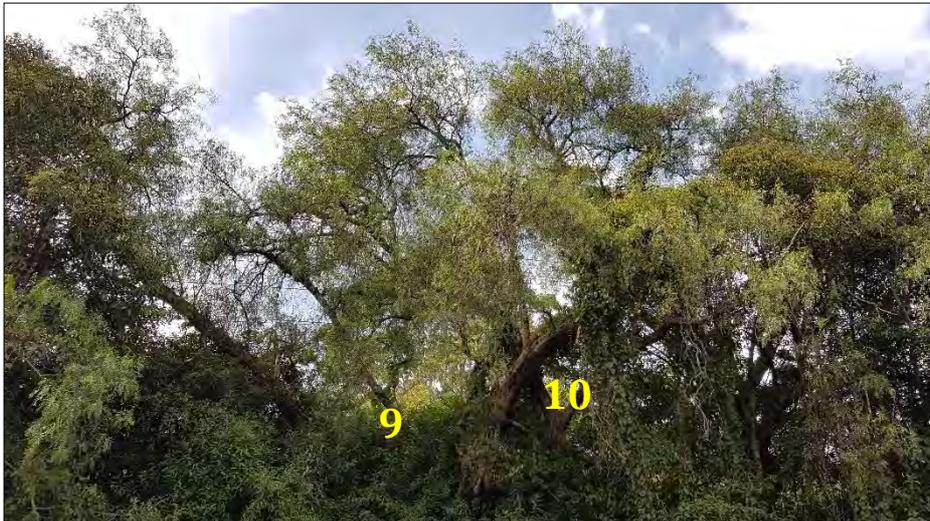
**Photograph 5:** Trees 9 and 10 *Schinus molle* (Peppercorn Tree) to be removed.

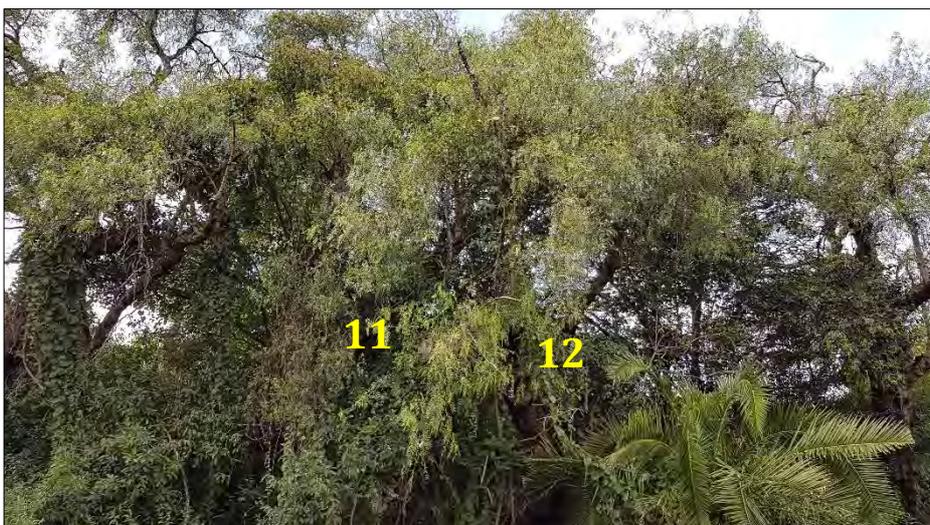
**Photograph 6:** Trees 11 and 12 *Schinus molle* (Peppercorn Tree) to be removed.

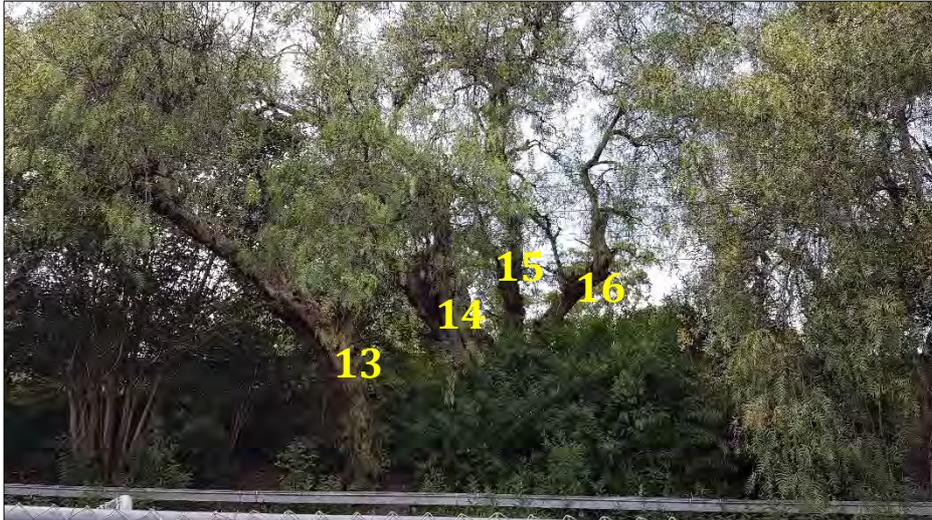
**Photograph 7:** Trees 13, 14, 15 and 16 *Schinus molle* (Peppercorn Tree) to be removed.

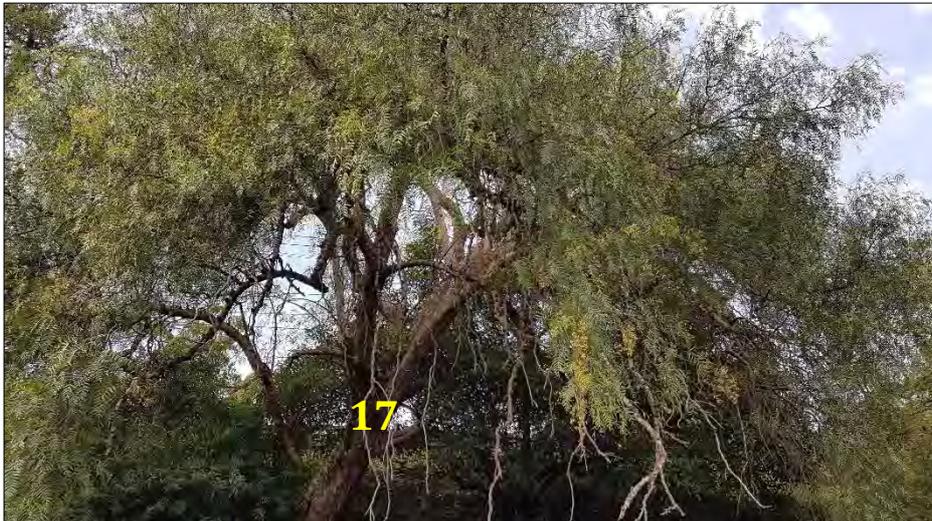
**Photograph 8:** Tree 17 *Schinus molle* (Peppercorn Tree) to be removed.

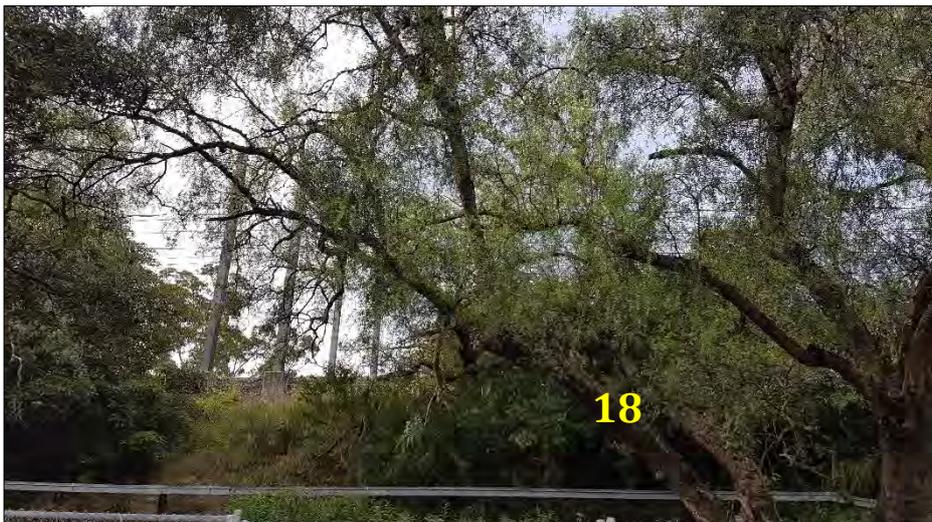
**Photograph 9:** Tree 18 *Schinus molle* (Peppercorn Tree) to be removed.

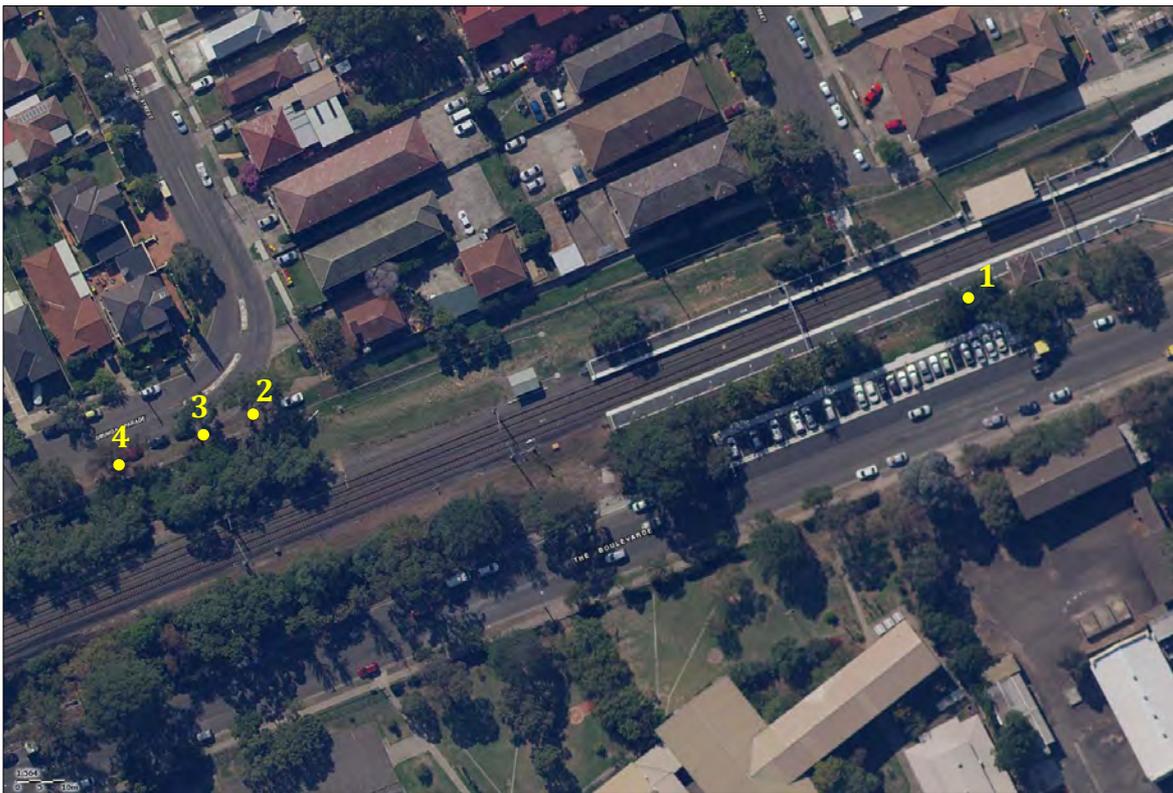
The Wallangarra White Gum (tree 4) is listed as Endangered under the Biodiversity Conservation Act 2016 and Vulnerable under the Environmental Protection Biodiversity Conservation Act 1999. However, the subject specimen is located outside of its naturally occurring range and appears to have been planted as part of the streetscape.

**Image 1:** Aerial image of Wiley Park Station Station showing the location of additional trees to be removed.

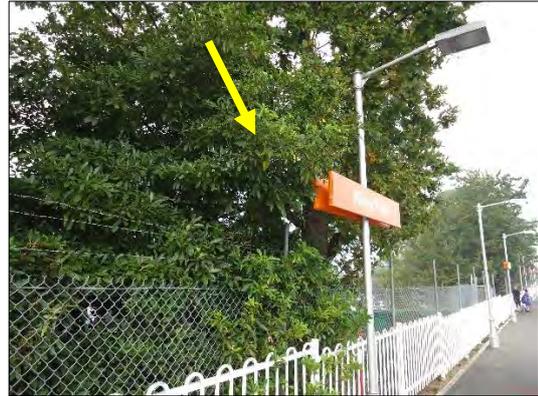
**Photograph 1:** Tree 1 *Pittosporum undulatum* (Sweet Pittosporum) identified for removal to accommodate Station Services Building adjacent platform 2.

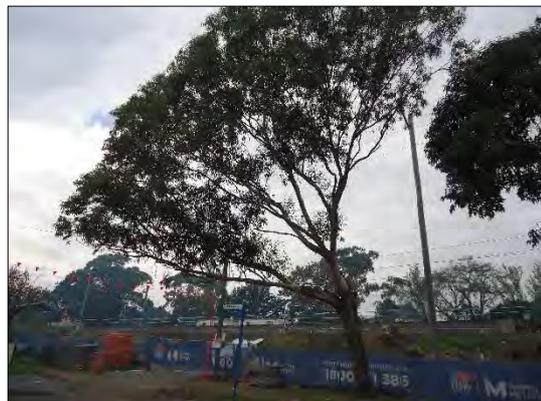
**Photograph 2:** Tree 2 *Eucalyptus pilularis* (Blackbutt) identified for removal to accommodate Metro services Building driveway and access.

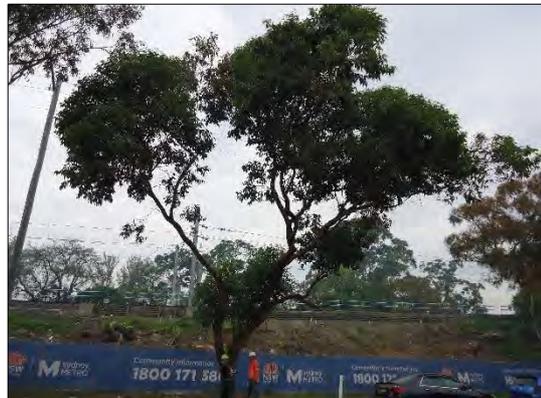
**Photograph 3:** Tree 3 *Eucalyptus robusta* (Swamp Mahogany) identified for removal to accommodate ULX and permanent fencing.

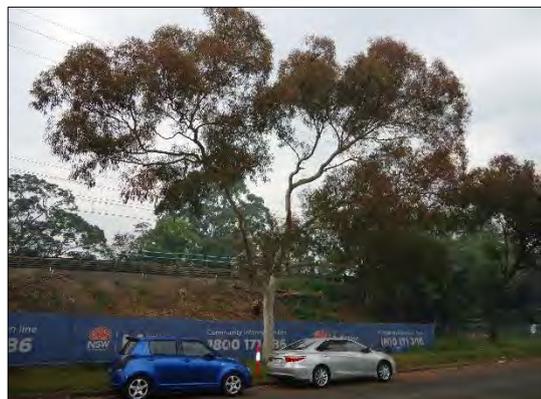
**Photograph 4:** Tree 4 *Eucalyptus scoparia* (Wallangarra White Gum) identified for removal to accommodate ULX and permanent fencing.

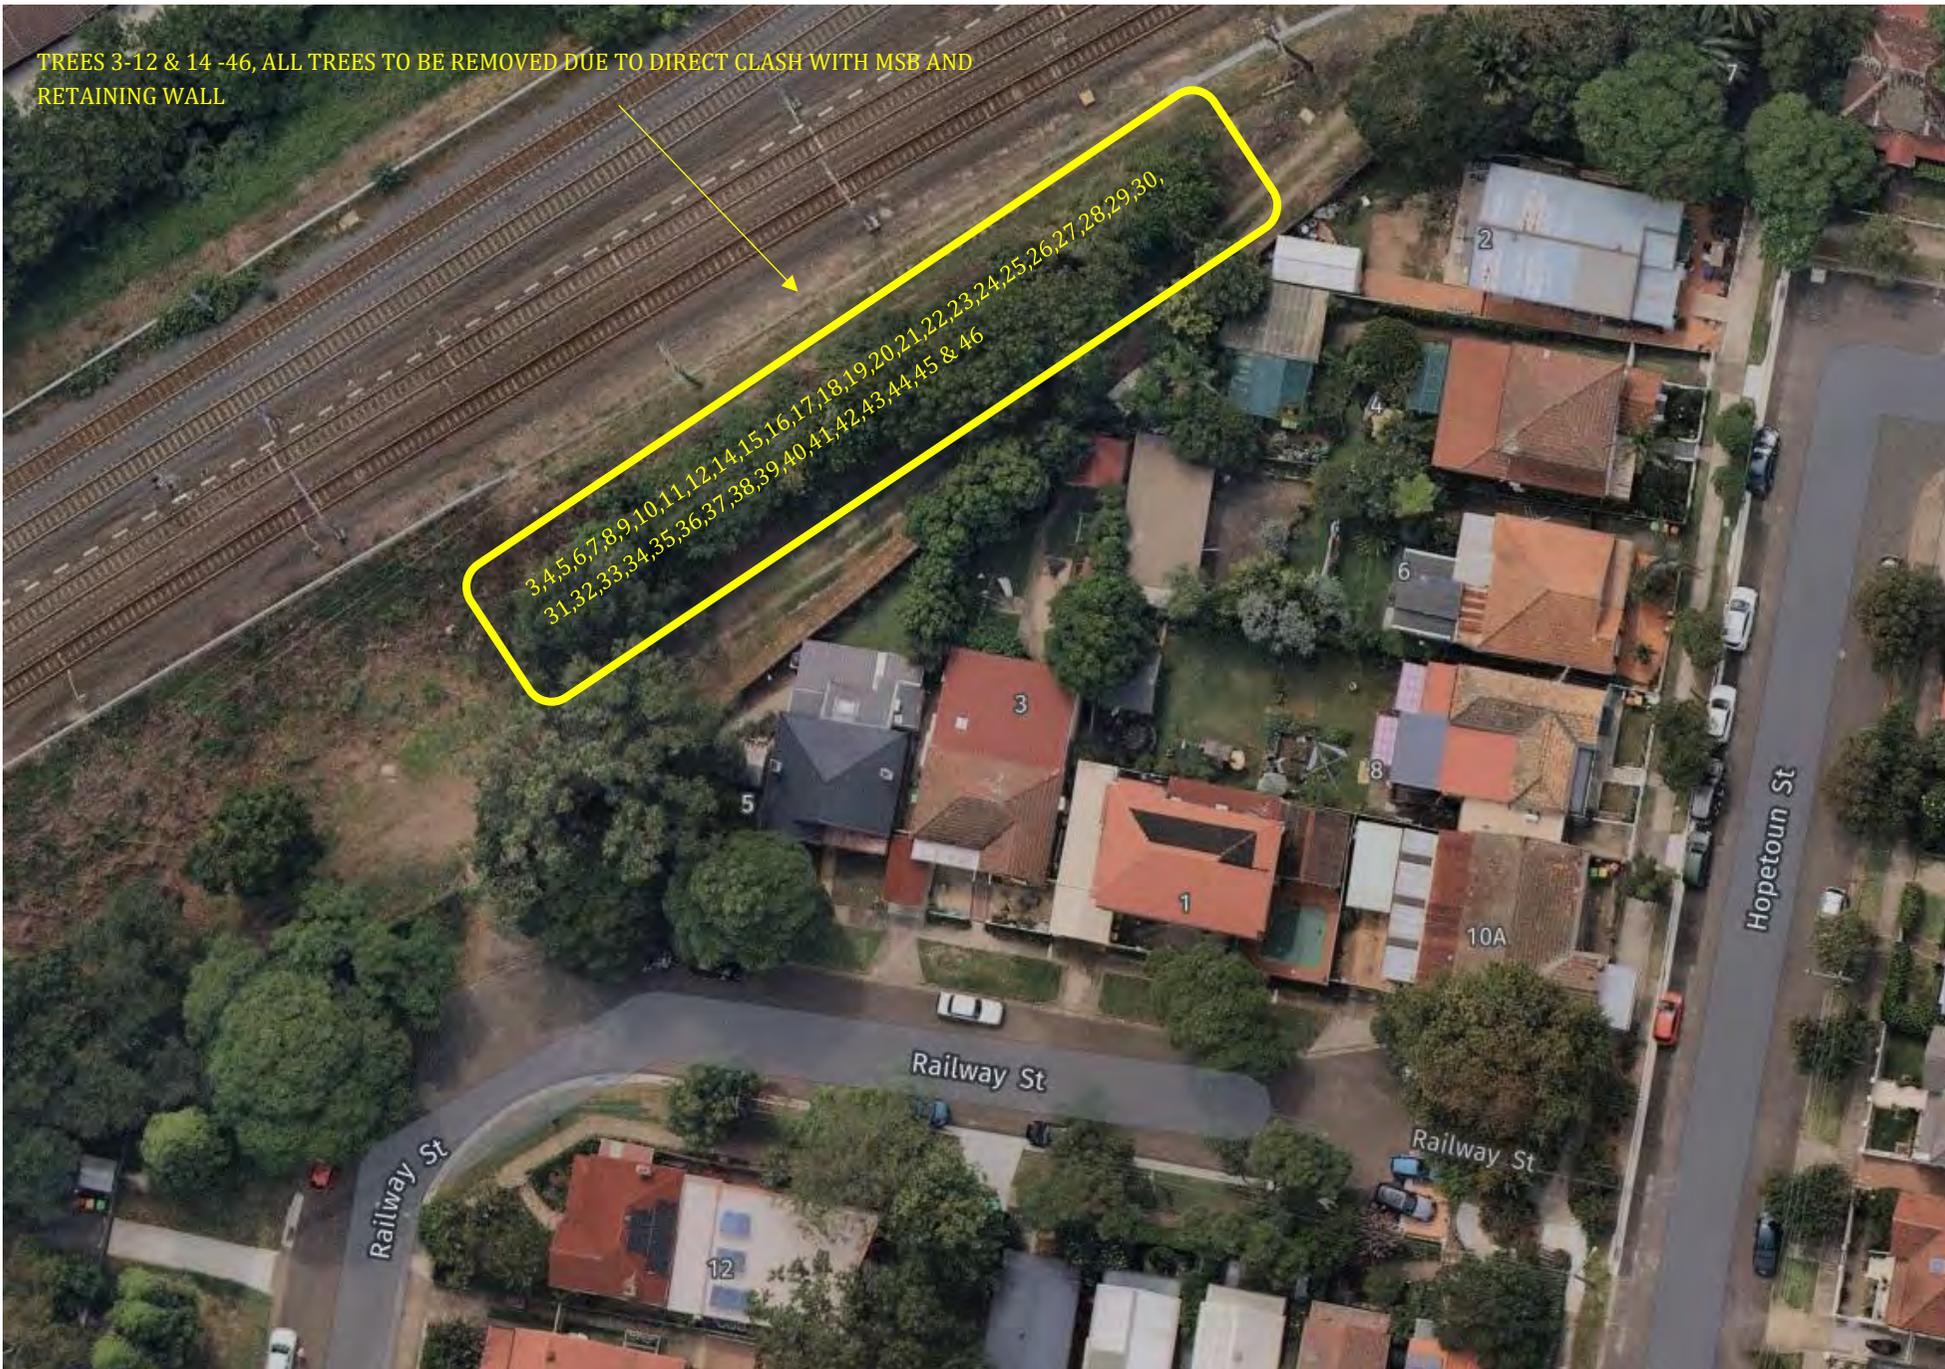
**Figure 4 Sydney Metro Hurlstone Park Station upgrades**

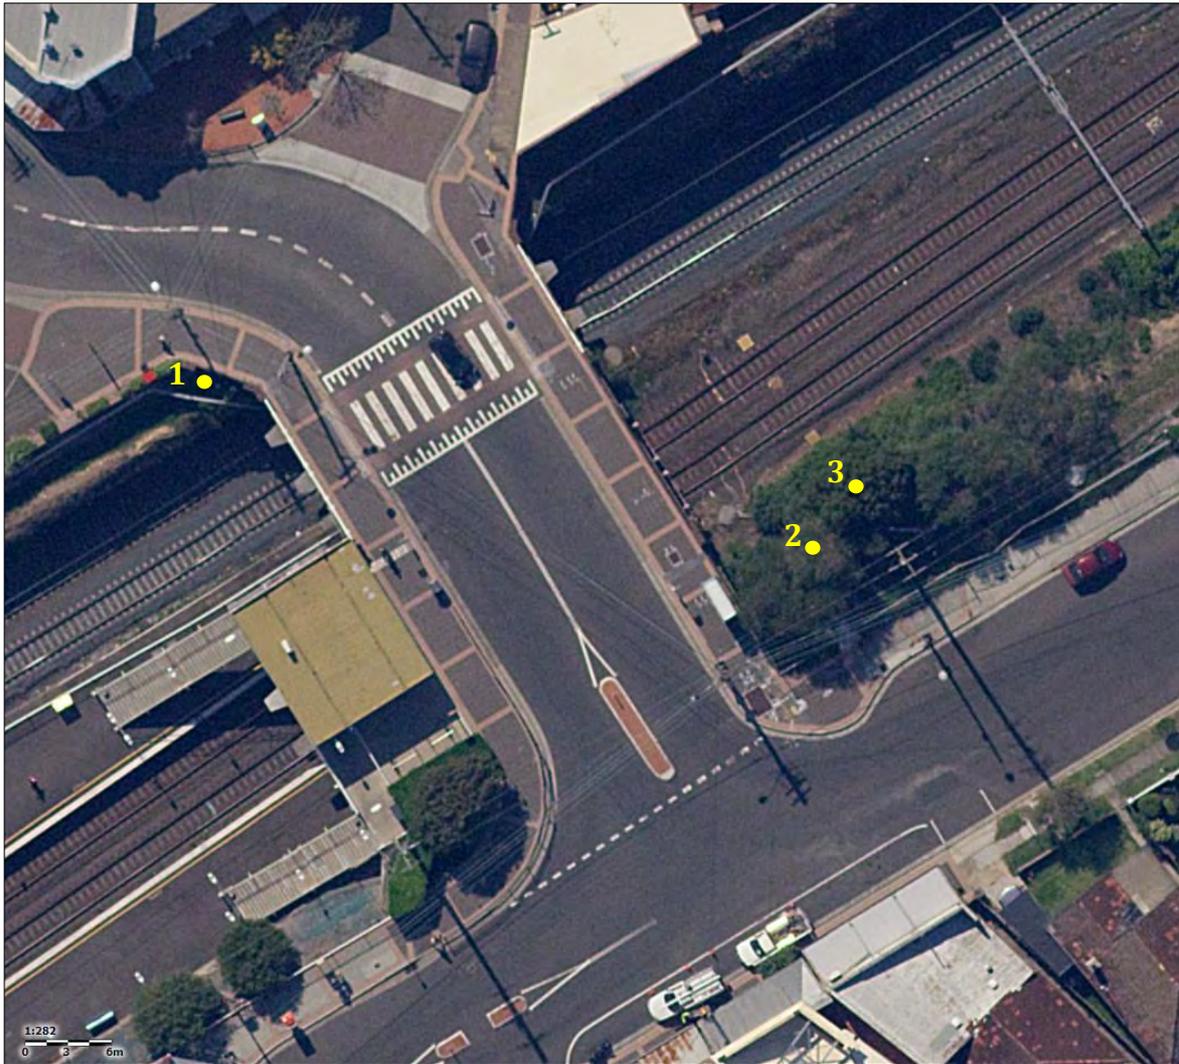
Downer and Sydney Metro design contract will implement a number of measures to ensure the design development and construction processes ensure the correct vegetation and trees are removed and to mitigate the risk of damage to trees and vegetation that will remain. These mitigation measures include;

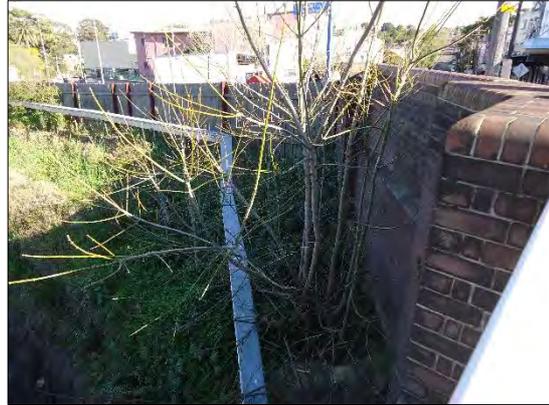
however, have been identified for removal in the Approved for Construction (AFC) Civil Engineering Plans for Punchbowl: SMCSWSWM-MTM-WPS-CE-DWG-4931560. As the trees reside within CCBC owned land, further council approvals and all other authority approvals shall be sought prior to any impact to the trees.

- Undertake all Protection Measures as identified within the appendices of this report (protection measures as stated in Urban Arbor reports and Plateau reports specific to each Project site and detailed in the appendices of this report)

- Equipment storage and stockpiling would be restricted to identified compound sites and already cleared land in accordance with **REMM B5**.
- A trained ecologist would be present during the clearing of native vegetation or removal of potential fauna habitat to avoid impacts on resident fauna and to salvage habitat resources as far as is practicable in accordance with **REMM B6**.

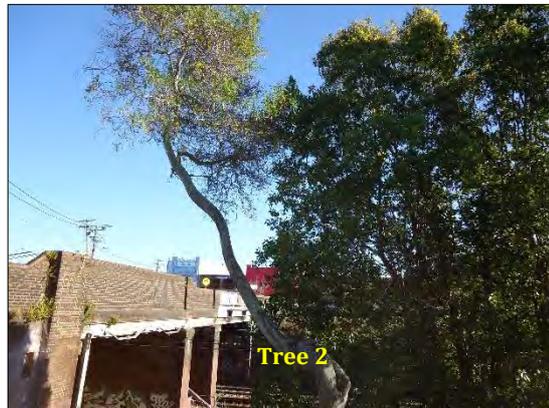
This report will be submitted to the Secretary for information prior to the removal, damage and/or pruning of any trees.

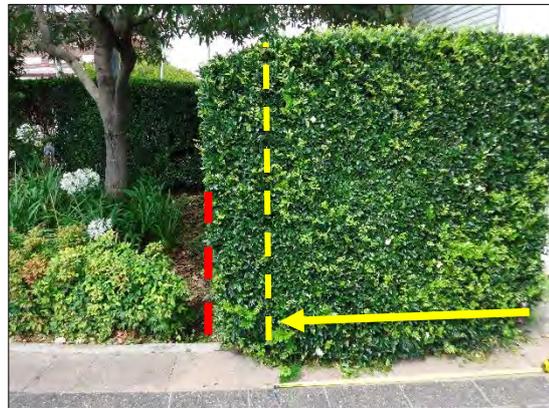
Site Address: Belmore Station, Belmore, NSW.
